Artikel: Some remarks on the service behaviour of steel railway bridges

Some Remarks on the Service Behaviour of Steel Railway Bridges

R.A.P. SWEENEY

CN Rail

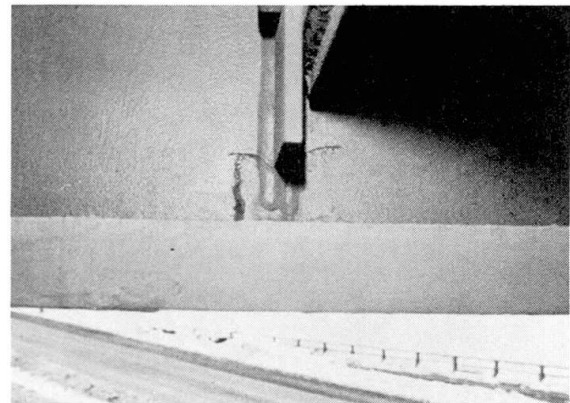
Fig. 4 "U" shape crack

The first group of problems to turn up on our railway on welded structures were cracks at the bottom of stiffeners on skewed structures. Figure 4 is typical of this detail with a diaphragm or brace frame attached to the stiffener. Note that the stiffeners are not extended to the bottom flange. This was in blind obedience to the dictum of an early researcher in welded construction that one should not weld to the tension flange. Because of the stresses introduced by the differential deflections of the connected girders, and to small out-of-plane movements, the first cracks appeared in less than 5 years on heavily travelled lines.

The crack would start at the bottom of the stiffener and form a "U" shape crack around the bottom of the stiffener. If the original stiffener-web weld was of good quality, this crack would turn out into the web and slow down considerably.

Unfortunately in many cases the only adequate cure is not to have the detail in the first place. If the crack isn't going to go anywhere, and if it has not damaged the structure too severely, it is best left alone as the retrofit may make things worse. Cracks at the bottom of stiffeners tend to be in this category.

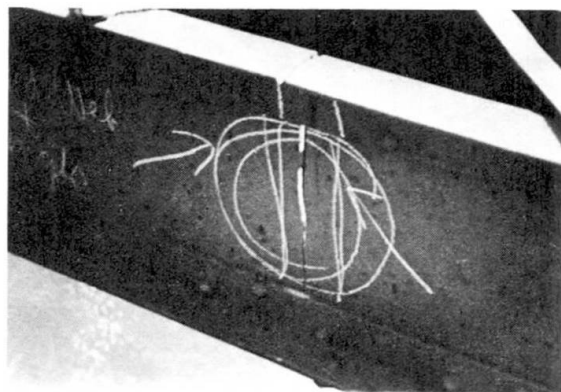
Fig. 13 Crack in chord

Most riveted structures were internally member redundant in that they were fabricated of several components (Figure 3). Their advantage is that cracks do not jump from piece to piece. The chord member of the truss shown in Figure 13 cracked on one side, but not on the other side of the member, and carried rail traffic for some time before detection and repair. In a welded box like member the crack would have propagated all around.

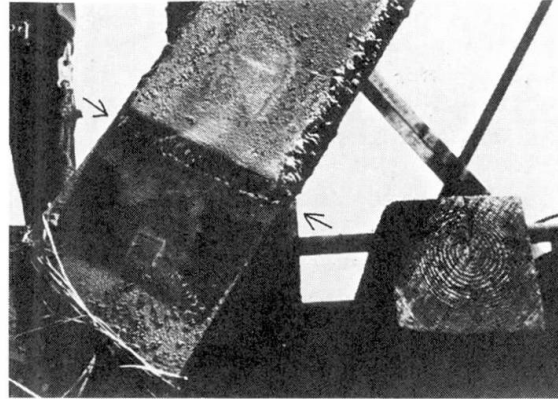
Fig. 18 Eye Bar Weld

The type of repair shown in Figure 18, the addition of welded plates to an eye bar member could be a disaster in a non-redundant load path structure. The crack is illustrated by the light line of magnaflux at the toe of the weld. In this bridge, because of its multiple load paths, collapse will not occur if one of these members cracks through.
