Artikel: Some remarks on the service behaviour of steel railway bridges

Autor: Sweeney, R.A.P.

Some Remarks on the Service Behaviour of Steel Railway Bridges

CN Rail

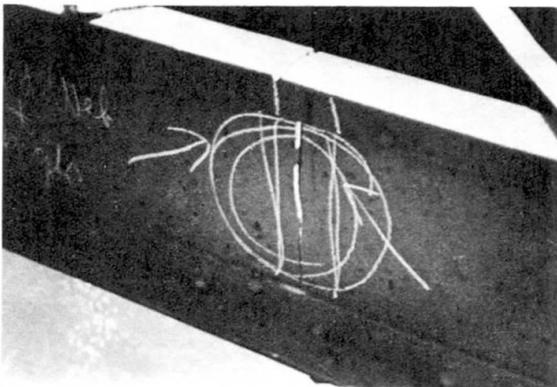
Fig. 13 Crack in chord

Most riveted structures were internally member redundant in that they were fabricated of several components (Figure 3). Their advantage is that cracks do not jump from piece to piece. The chord member of the truss shown in Figure 13 cracked on one side, but not on the other side of the member, and carried rail traffic for some time before detection and repair. In a welded box like member the crack would have propagated all around.

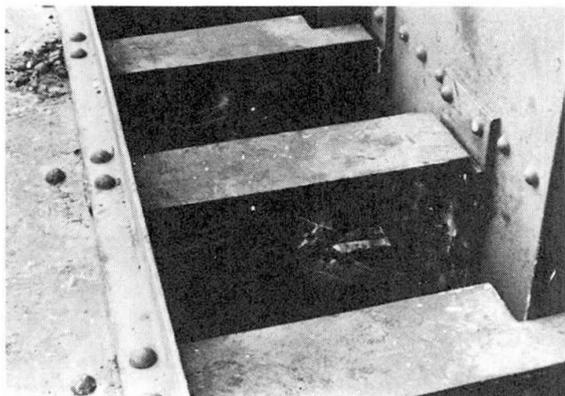
Fig. 17 Torsional loading

This (Figure 17) structure cracked due to torsional loading caused by constant train breaking. Although the floor beams are not welded there is no component redundancy as the beams are rolled. Nevertheless, the redundancy of the deck system has permitted regular train operations for over a year with 4 adjacent floor beams failed.

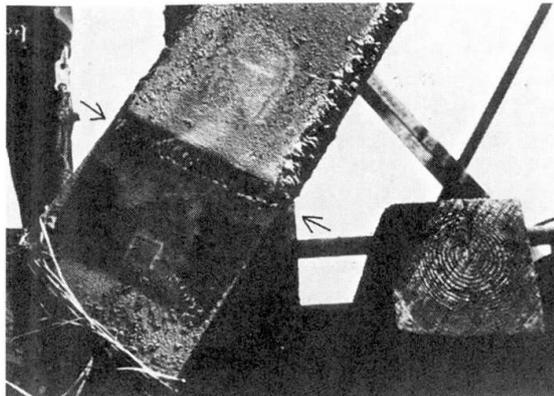
Fig. 18 Eye Bar Weld

The type of repair shown in Figure 18, the addition of welded plates to an eye bar member could be a disaster in a non-redundant load path structure. The crack is illustrated by the light line of magnaflux at the toe of the weld. In this bridge, because of its multiple load paths, collapse will not occur if one of these members cracks through.
