Artikel: The long-term behaviour of viaducts subjected to heavy traffic and situated in an aggressive environment: the viaduct on the Polcevera in Genoa

Autor: Morandi, R.

The Long-Term Behaviour of Viaducts Subjected to Heavy Traffic and Situated in an aggressive Environment. The Viaduct on the Polcevera in Genoa.

Professor of Engineering
Rome, Italy

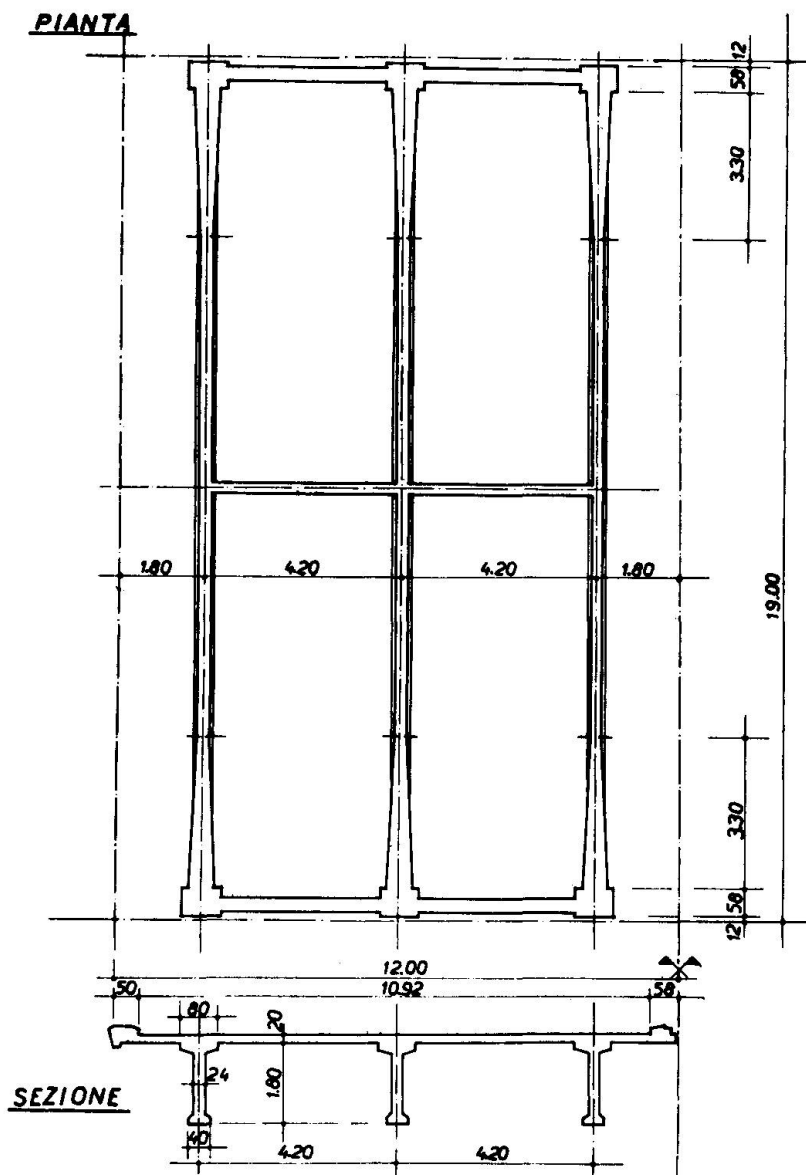
Fig. 1 - Geometry of the standard bay.

During my visit I found some superficial distress in the paving joints, some excessive crushing of the bearings (although nothing really serious) but, most important of all, that all the parallel beams of the deck showed a diffused pattern of cracks of very similar length, frequency and width on all the bays.

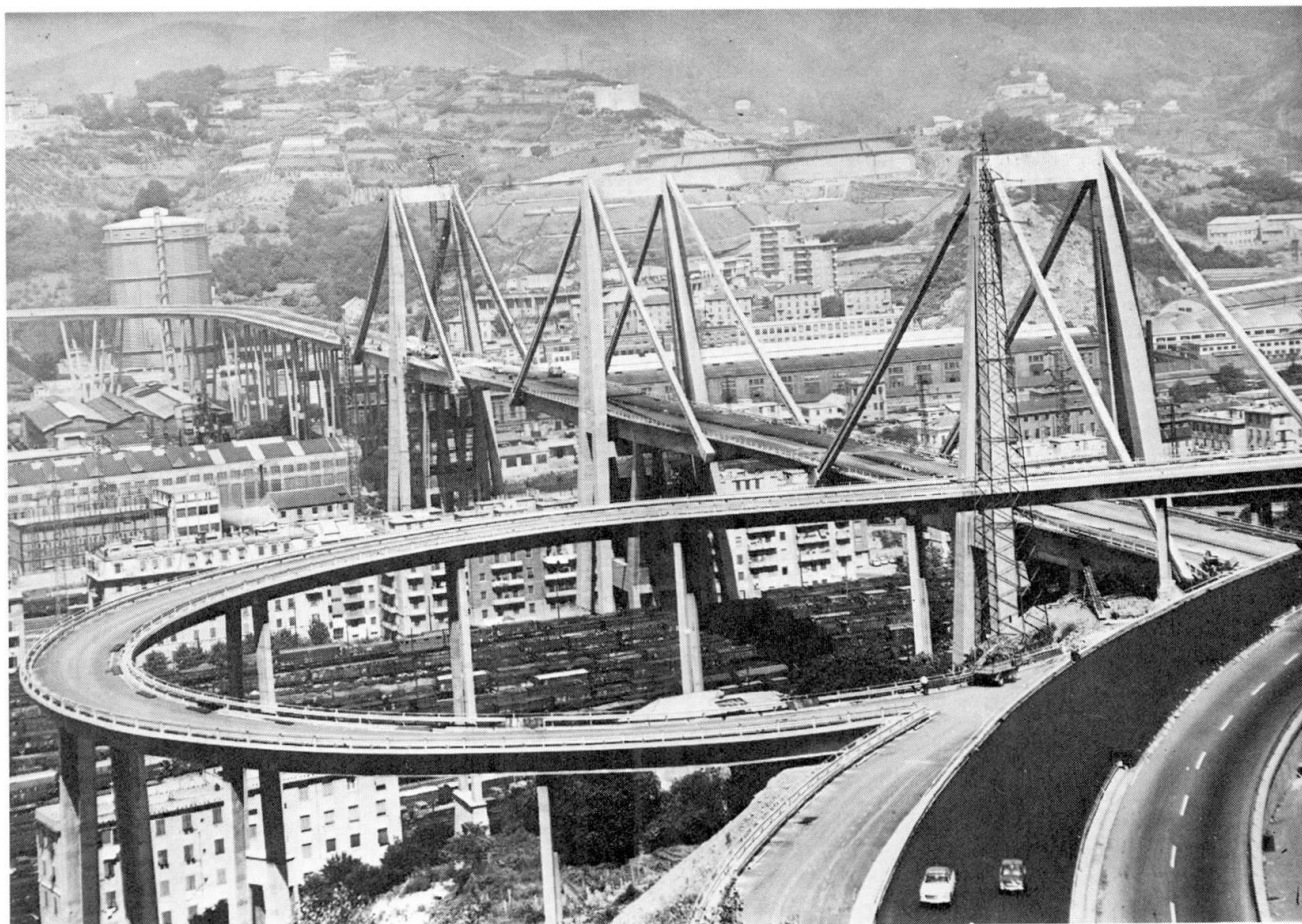
Figure 3 - General view of the structure.

The work has been completed in 1966 and was regularly opened to traffic in 1967. Since then it underwent a series of controls about its state of preservation.

Essentially, it has been ascertained that the structure stands the very heavy traffic to which it is continuously submitted without signs of deterioration or static inadequacy.

Some slight cracks of a very 'small size (much below 0.2 mm) have been noticed in the secondary connecting cross elements - which obviously had not been prestressed - and which were surely due to the vibration caused by the traffic.

Furthermore, in these last years the external surfaces of the structures and especially those exposed towards the sea and therefore more directly attacked by the acid fumes of the chimneys, start showing an aggression phenomenon of a chemical origin.

This is obviously due to the production of soluble salts resulting from the combination of the acids of the fumes with the free lime of the concrete : the well-known loss of superficial chemical resistance of the concrete itself.

I think that sooner or later, may be in a few years, it will be necessary to resort to a treatment consisting of the removal of all traces of rust on the exposure of the reinforcements, to fill the patches, with epoxidic type resins and finally to cover everything up with elastomers of a very high chemical resistance.
