Artikel: The long-term behaviour of viaducts subjected to heavy traffic and situated in an aggressive environment: the viaduct on the Polcevera in Genoa

Autor: Morandi, R.

The Long-Term Behaviour of Viaducts Subjected to Heavy Traffic and Situated in an aggressive Environment. The Viaduct on the Polcevera in Genoa.

R. MORANDI
Professor of Engineering
Rome, Italy

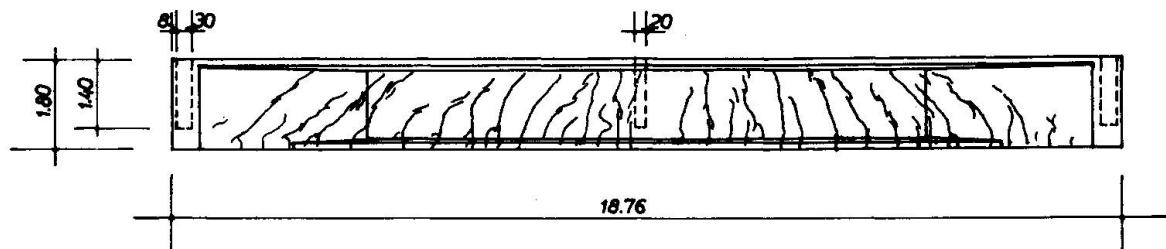
Fig. 2 - Crack pattern on the external rib of bay No. 21

During my visit I found some superficial distress in the paving joints, some excessive crushing of the bearings (although nothing really serious) but, most important of all, that all the parallel beams of the deck showed a diffused pattern of cracks of very similar length, frequency and width on all the bays.

As an example, figure 2 shows the cracks of the external rib of bay No. 21.

As for the crack width, we can briefly conclude that the inclined cracks near the bearings of the deck reached the maximum width of 0.5 mm, while the width of all the others were between the 0.05 and 0.3 mm, with most of them being less than 0.2 mm.

As for the first research (the determination of the causes of such an important cracking phenomenon), we found out after a long series of studies that many factors had occurred accidentally at the same time which could explain the cracking.

- the very small ratio between the beam width and their height,
- the use of a cement which had not been seasoned long enough in silos, with a consequent increase of the shrinkage value.

The faulty performance of the bearings with consequent temperature stress arisen in the structure.

- Very heavy and fast traffic : the structure is located near an important marble production centre,
- the imperfect position of the bent-up bars for shear reinforcement.

Finally, the behaviour of the structures under the dynamic impulses shows a satisfactory level of integrity of the entire assembly. Obviously, after having considered all the above results, we reached the conclusion that it was sufficient to apply coats of various substances (elastomers) on the external surfaces in order to prevent the reinforcements to be reached and damaged by air through the cracks.
