Artikel: Restoration and widening of the Tasman bridge

Autor: Lee, D.J. / Crossley, B.K.G.

Restoration and Widening of the Tasman Bridge

Three out of 22 river spans of the Tasman Bridge were destroyed by ship collision. The paper describes the method of debris survey in the deep water site conditions and the method of restoration determined therefrom. The unusual engineering tasks involved in the work included temporary repairs, demolition, major steel falsework, unusual vertical piling, the incorporation of a long steel span into the prestressed concrete bridge and erection techniques used. The whole bridge was widened concurrently with the restoration.

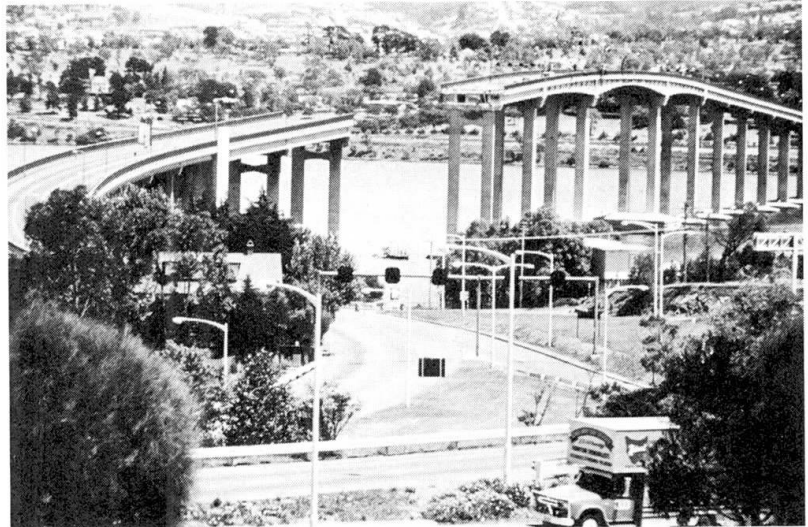
Fig. 1 Tasman Bridge after collapse

In January 1975, the ore carrier S.S. Lake Illawarra, fully laden and displacing 17,000 tonnes, collided with Piers 18 and 19 of the bridge bringing down these piers together with three spans of the eastern main viaduct and leaving a gap of 128 m. The centre one of the three spans fell on the bow of the ship which quickly sank, the tragedy resulting in the loss of twelve lives. The severance of the only road link also caused quite substantial social disruption, as the eastern shore has mainly dormitory suburbs, with the majority of the city's infrastructure being on the western shore.

The consequences of the accident to the remainder of the bridge were relatively minor as it had performed in accordance with design provisions. Span 16-17, the only remaining eastern main viaduct span on the river side of the gap, had remained in position supported by the stay bolts. Pile Cap 20 had suffered severe damage when it was hit by the falling span 19-20, whose trajectory of free fall was intercepted by one end hitting the bow of the ship. The columns on either side of the opening were deflected towards the gap at the top by up to 200 mm and the lower part of the columns was severely cracked. Otherwise the remaining 19 spans of the bridge were undamaged.

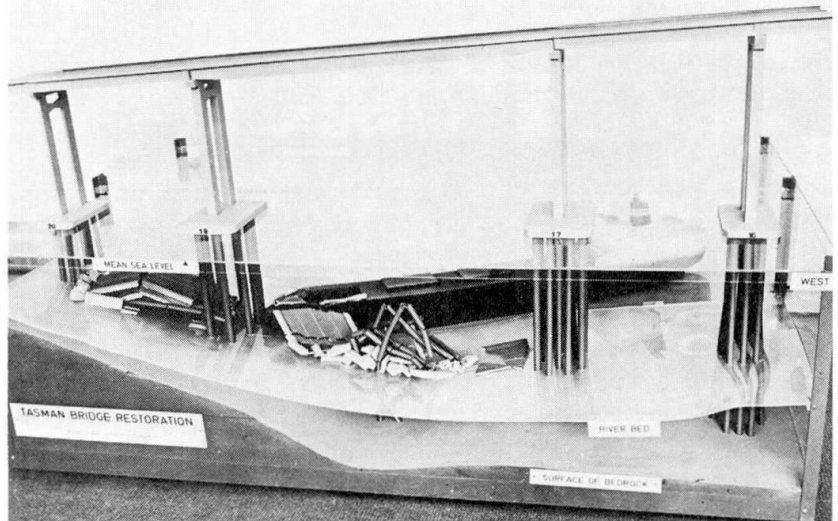
The debris survey took about three months and in the end all the broken bridge pieces were accounted for. A model was built to show the underwater picture (Fig. 3). During the debris survey it is to the credit of the Bridge Commission that pressures to make an early decision on the method of restoration were resisted. Five alternate schemes for reconstruction ranging from a single span scheme to a triple span scheme were examined in some detail. As the underwater scene unfolded the schemes were discarded one by one because debris prevented the placement of new piles, and the selected scheme only became evident at the end of the survey period when a complete picture was available. The only clear space available to establish a new pier was at the site of the original Pier 19 and this involved placement of new vertical piles between the existing broken off raking piles. The decision to delay the selection of a reconstruction method until the survey was completed was vindicated by job performance as no delays occurred due to new piles striking debris.

Fig. 3 Debris model

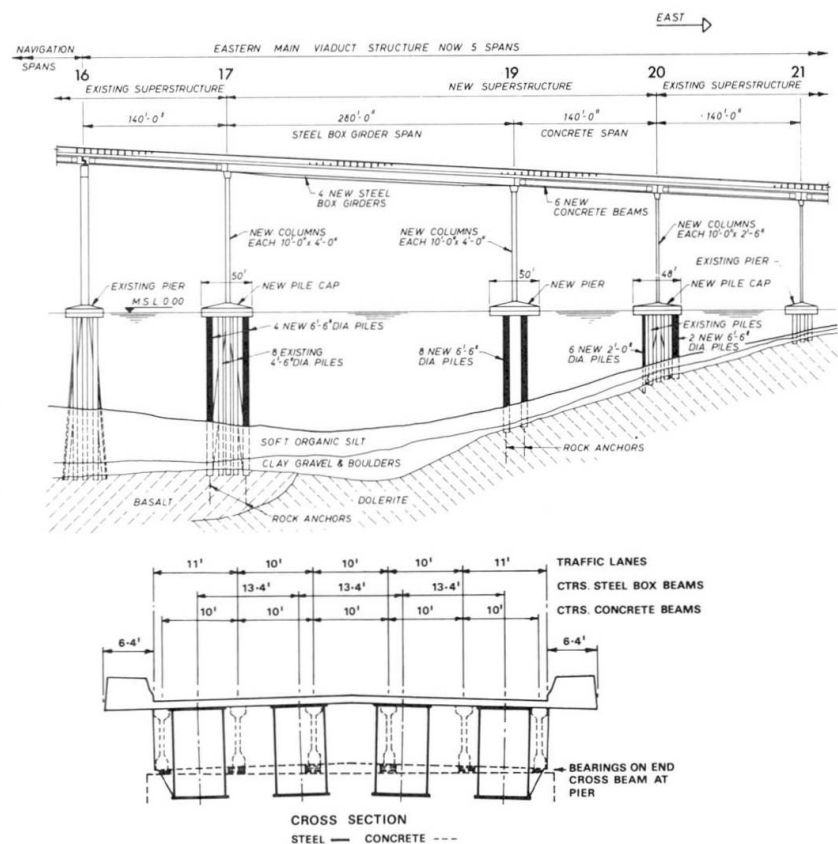
Fig. 4 Details of restoration

The method adopted is shown in Fig. 4 and has been reported on previously by LESLIE [7] and [8]. As the broken 1.4 m diameter piles at Pier 18 (40 m to bed level being the deepest part of the river), rose 15 m above the mud level this pier was omitted and the method involved the replacement of the three fallen spans by two spans; an 85 m steel span 17-19 and 43 m concrete span 19-20. Cross-sections are shown in Figs. 6 and 7. The scheme involved 14 new 2 m diameter vertical piles rock anchored at the base, some of which were to be used both as falsework piles and permanent piles. Foundation conditions were predetermined using one borehole per pile and were good, consisting of almost fresh dolerite at Piers 19 and 20 and partly weathered basalt at Pier 17. At Piers 17 and 20 the existing columns and pile caps had to be demolished and replaced. At Pier 17 additional piles, working in conjunction with the eight existing 1.4 m diameter raking piles, a bigger cap, and heavier columns were required to resist the greater loads from the double span. At Pier 20 there are no additional loads, but it was considered necessary to replace the badly damaged pile cap and columns, and the falsework piles required to achieve this were incorporated into the permanent structure, although not strictly required from a strength viewpoint. As there was a considerable time saving involved, the replacement of the substructure at these two piers was to be undertaken without demolishing the flanking spans (total mass 1,250 tonnes each) supported by them.

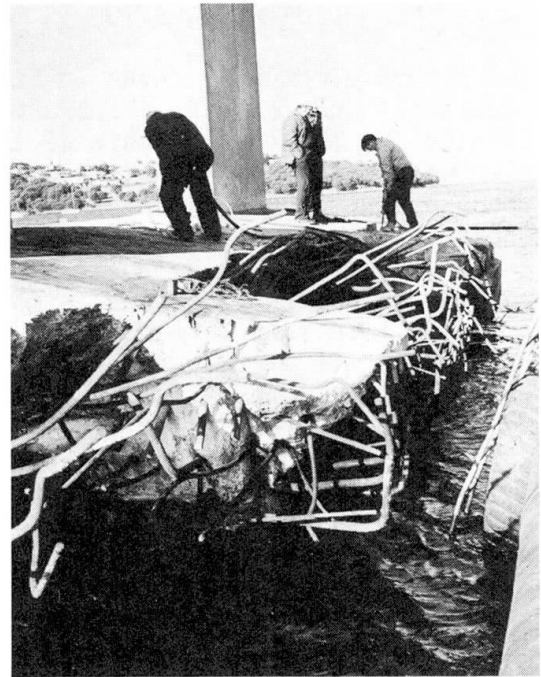
The security of Pile Cap 20 was more difficult as it had lost about one third of its volume (Fig. 5) and the remainder was extensively cracked and in some places crumbled. Its load carrying capacity was unknown and although it had to be replaced later it was decided to do temporary repairs before any major work commenced. These were in two parts:-

Fig. 5 Damage to Pile Cap 20

- Replacement of the concrete which had been removed without attempting to repair or remove and replace the cracked concrete.

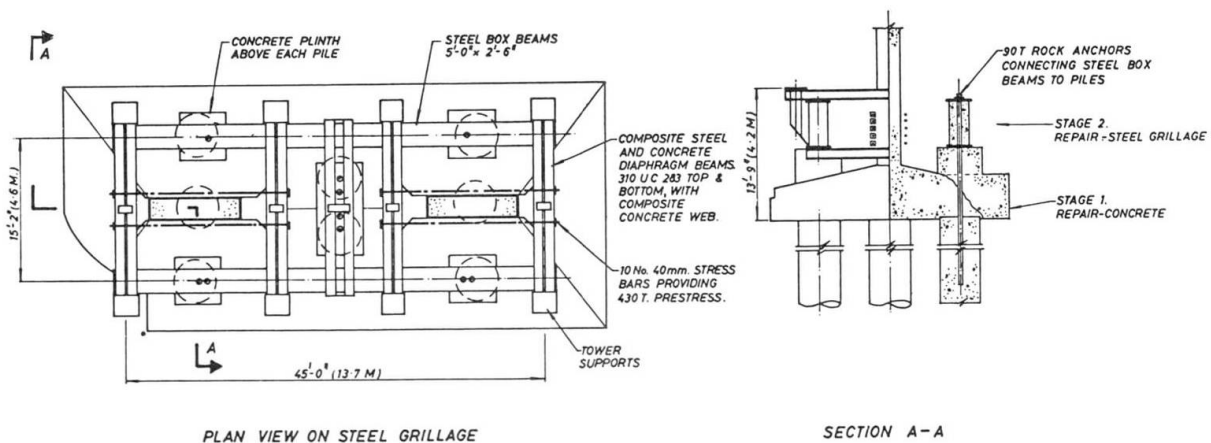
Fig. 6 Pile Cap 20. Temporary steel cap

- Construction of a temporary steel pile cap above the existing cap (Fig. 6). Its purpose was to enable column loads to bypass the existing cap and be transmitted directly into the piles. This action was achieved by stressing the steel cap to the columns and by casting concrete plinths on top of the existing cap, directly above the piles, and stressing the steel cap to the piles by means of rock anchors drilled and grouted into them.

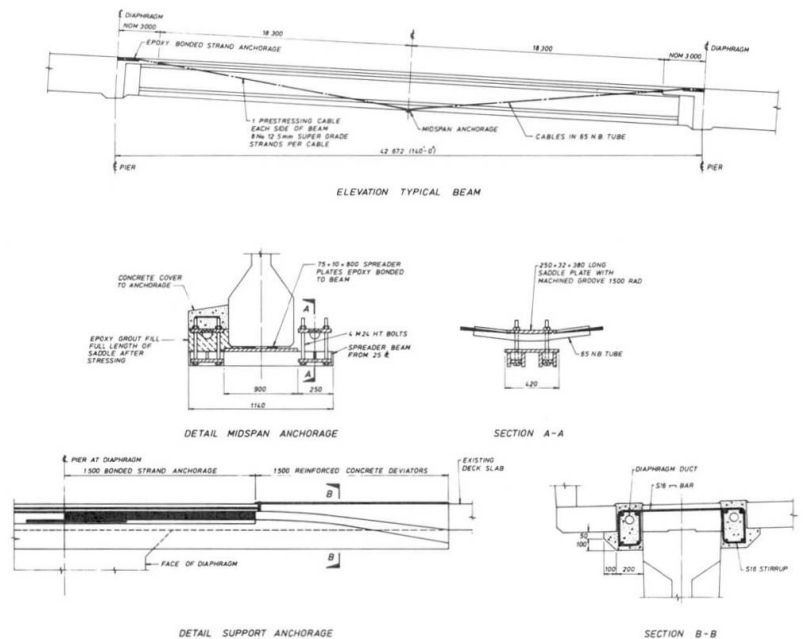
Fig. 13 Beam strengthening details

The 42.7 m span, prestressed concrete beams in the main viaducts were constructed segmentally. Due to the extra load from the widening, the outer beams were in tension at working loads and for serviceability reasons it was decided to

strengthen them by adding external tendons in a "Vee" shape one on each side of the web (Fig. 13). The tendons were 8 x 12.5 mm strands grouted into a 75 mm steel pipe and were stressed by pulling them down at mid span, and anchored by bolting to the mid span saddle to give an uplift force of 38 tonnes.
