**Artikel:** Restoration and widening of the Tasman bridge

**Autor:** Lee, D.J. / Crossley, B.K.G.

## **Restoration and Widening of the Tasman Bridge**

Three out of 22 river spans of the Tasman Bridge were destroyed by ship collision. The paper describes the method of debris survey in the deep water site conditions and the method of restoration determined therefrom. The unusual engineering tasks involved in the work included temporary repairs, demolition, major steel falsework, unusual vertical piling, the incorporation of a long steel span into the prestressed concrete bridge and erection techniques used. The whole bridge was widened concurrently with the restoration.

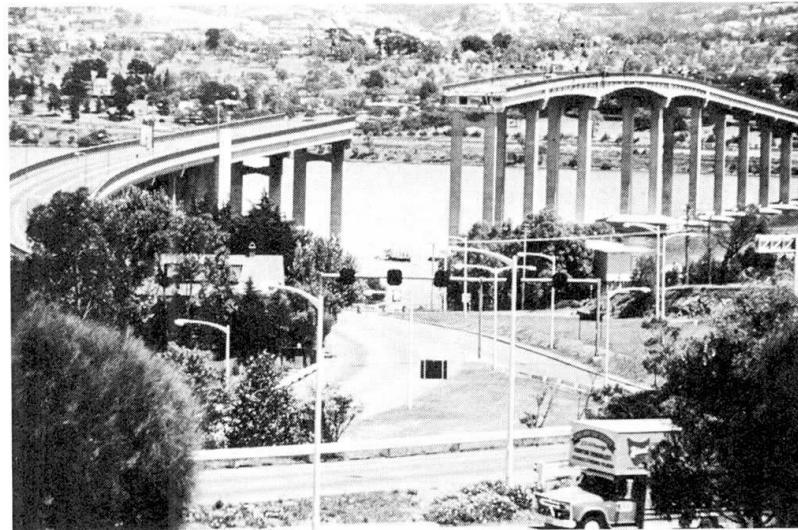
Fig. 1 Tasman Bridge after collapse  
although the

In January 1975, the ore carrier S.S. Lake Illawarra, fully laden and displacing 17,000 tonnes, collided with Piers 18 and 19 of the bridge bringing down these piers together with three spans of the eastern main viaduct and leaving a gap of 128 m. The centre one of the three spans fell on the bow of the ship which quickly sank, the tragedy resulting in the loss of twelve lives. The severance of the only road link also caused quite substantial social disruption, as the eastern shore has mainly dormitory suburbs, with the majority of the city's infrastructure being on the western shore.

The consequences of the accident to the remainder of the bridge were relatively minor as it had performed in accordance with design provisions. Span 16-17, the only remaining eastern main viaduct span on the river side of the gap, had remained in position supported by the stay bolts. Pile Cap 20 had suffered severe damage when it was hit by the falling span 19-20, whose trajectory of free fall was intercepted by one end hitting the bow of the ship. The columns on either side of the opening were deflected towards the gap at the top by up to 200 mm and the lower part of the columns was severely cracked. Otherwise the remaining 19 spans of the bridge were undamaged.

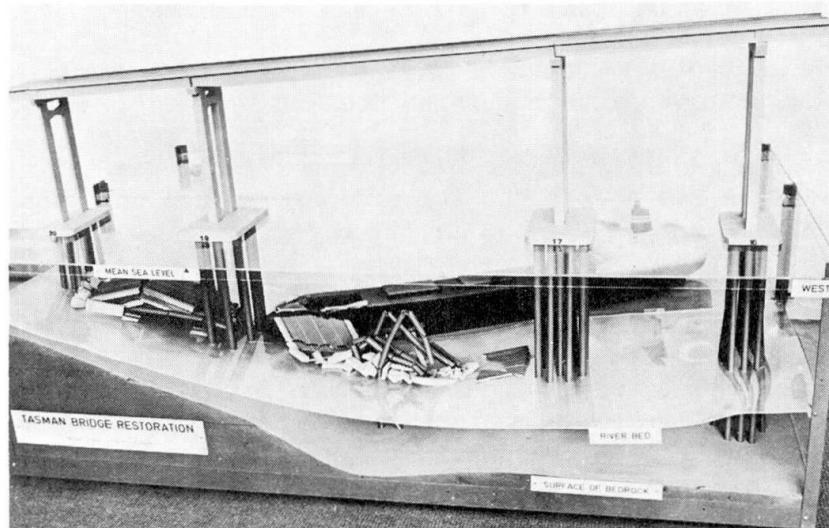
The debris survey took about three months and in the end all the broken bridge pieces were accounted for. A model was built to show the underwater picture (Fig. 3).

Fig. 3 Debris model

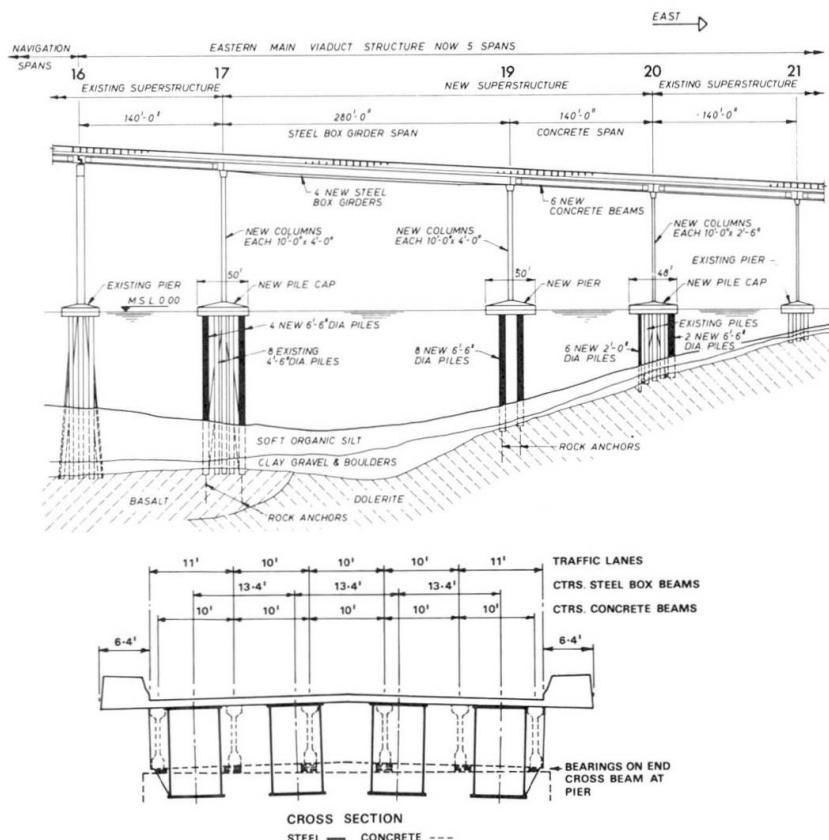
Fig. 4 Details of restoration

The method adopted is shown in Fig. 4 and has been reported on previously by LESLIE [7] and [8]. As the broken 1.4 m diameter piles at Pier 18 (40 m to bed level being the deepest part of the river), rose 15 m above the mud level this pier was omitted and the method involved the replacement of the three fallen spans by two spans; an 85 m steel span 17-19 and 43 m concrete span 19-20. Cross-sections are shown in Figs. 6 and 7. The scheme involved 14 new 2 m diameter vertical piles rock anchored at the base, some of which were to be used both as falsework piles and permanent piles. Foundation conditions were predetermined using one borehole per pile and were good, consisting of almost fresh dolerite at Piers 19 and 20 and partly weathered basalt at Pier 17. At Piers 17 and 20 the existing columns and pile caps had to be demolished and replaced. At Pier 17 additional piles, working in conjunction with the eight existing 1.4 m diameter raking piles, a bigger cap, and heavier columns were required to resist the greater loads from the double span. At Pier 20 there are no additional loads, but it was considered necessary to replace the badly damaged pile cap and columns, and the falsework piles required to achieve this were incorporated into the permanent structure, although not strictly required from a strength viewpoint. As there was a considerable time saving involved, the replacement of the substructure at these two piers was to be undertaken without demolishing the flanking spans (total mass 1,250 tonnes each) supported by them.

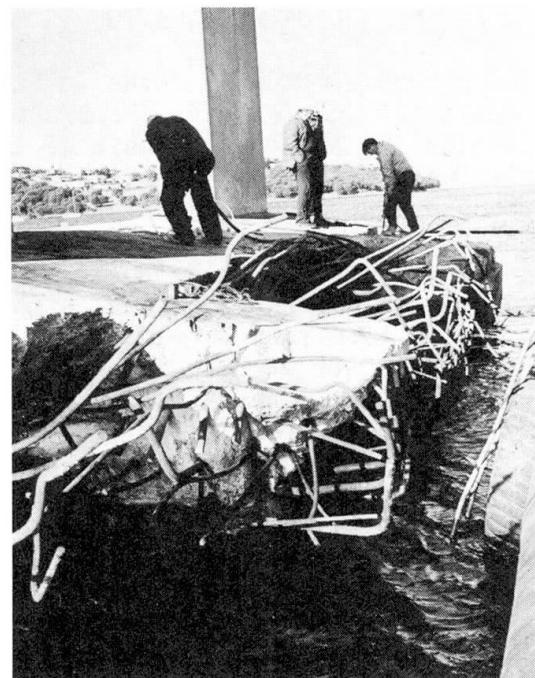
The security of Pile Cap 20 was more difficult as it had lost about one third of its volume (Fig. 5) and the remainder was extensively cracked and in some places crumbled. Its load carrying capacity was unknown and although it had to be replaced later it was decided to do temporary repairs before any major work commenced. These were in two parts:-

Fig. 5 Damage to Pile Cap 20

- Replacement of the concrete which had been removed without attempting to repair or remove and replace the cracked concrete.

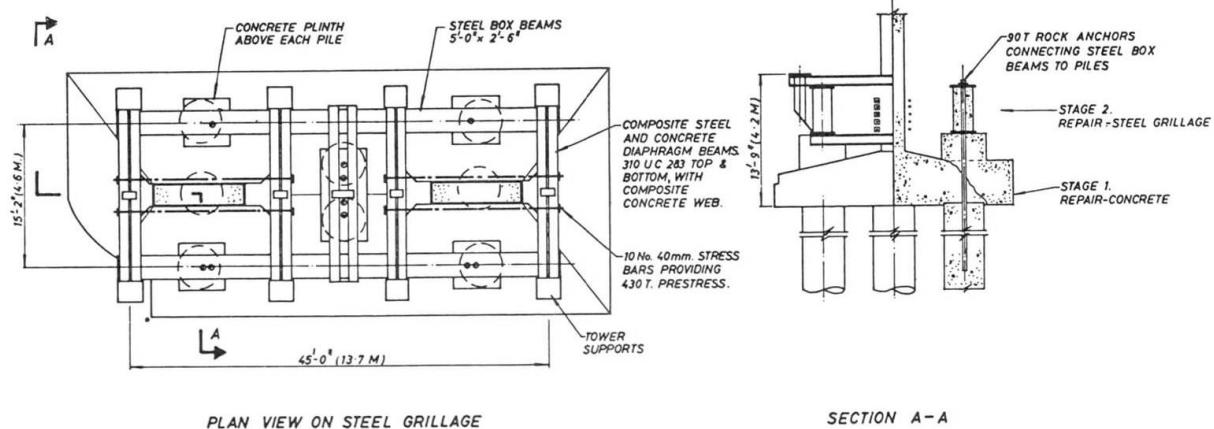
Fig. 6 Pile Cap 20. Temporary steel cap

- Construction of a temporary steel pile cap above the existing cap (Fig. 6). Its purpose was to enable column loads to bypass the existing cap and be transmitted directly into the piles. This action was achieved by stressing the steel cap to the columns and by casting concrete plinths on top of the existing cap, directly above the piles, and stressing the steel cap to the piles by means of rock anchors drilled and grouted into them.

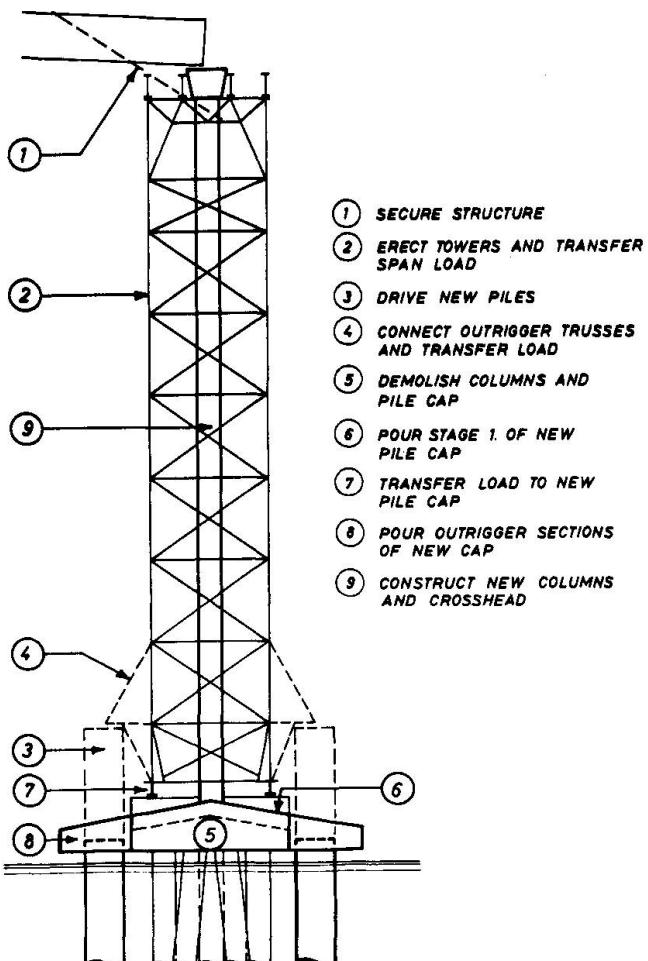
Fig. 8 Pier 17 construction sequence

The steel towers fulfilled many functions, including support of existing spans during column demolition, bracing for new concrete columns during construction, supports for the erection derricks and landing points for the new beams. The construction sequence involved in the use of the tower at Pier 17 is shown in Fig. 8.

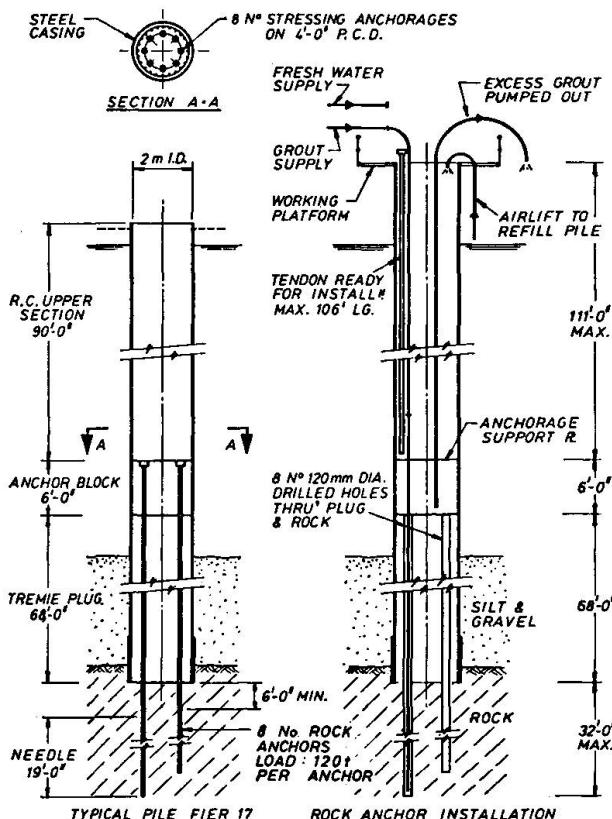
Fig. 7 Pile details

Details of the new vertical piling are shown in Fig. 7. 2 m diameter was selected as being the largest size which could be

At Pier 17 due to frequent rock joints the anchor holes could not be sealed and the installation method was modified to enable anchors to be grouted in a flooded pile (Fig. 7). Individual holes were kept grout filled while the grout leaking into adjacent holes was flushed out. A reservoir at the top of the plug enabled the grout quality to be monitored by underwater TV camera while visibility was maintained by downward circulation of fresh water.

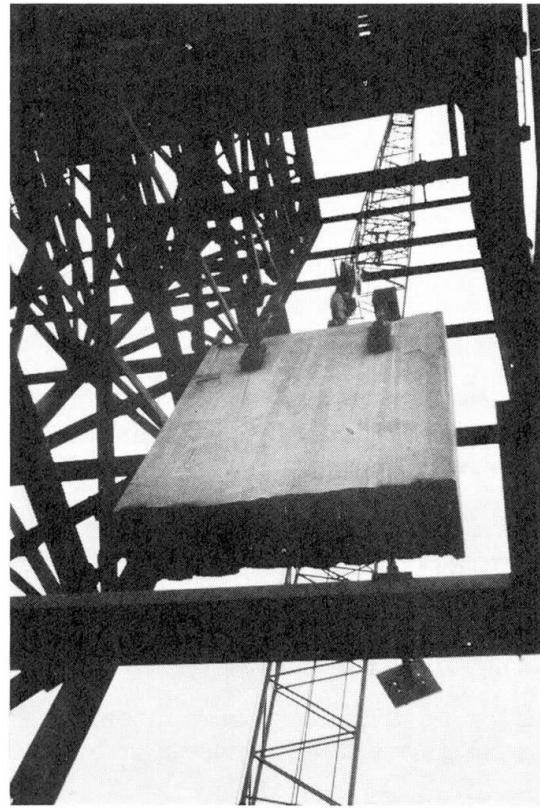
Fig. 9 Column demolition

The original columns were made up of precast concrete blocks, vertically stressed together with Macalloy bars. They had a cross-section of 3 m x 0.75 m and were cut horizontally using a thermic lance and hydraulic wedge splitters. The 25 tonne pieces were lifted out through the top of the falsework tower (Fig. 9). Twelve working days were required to remove the two legs of the Pier 20 column.

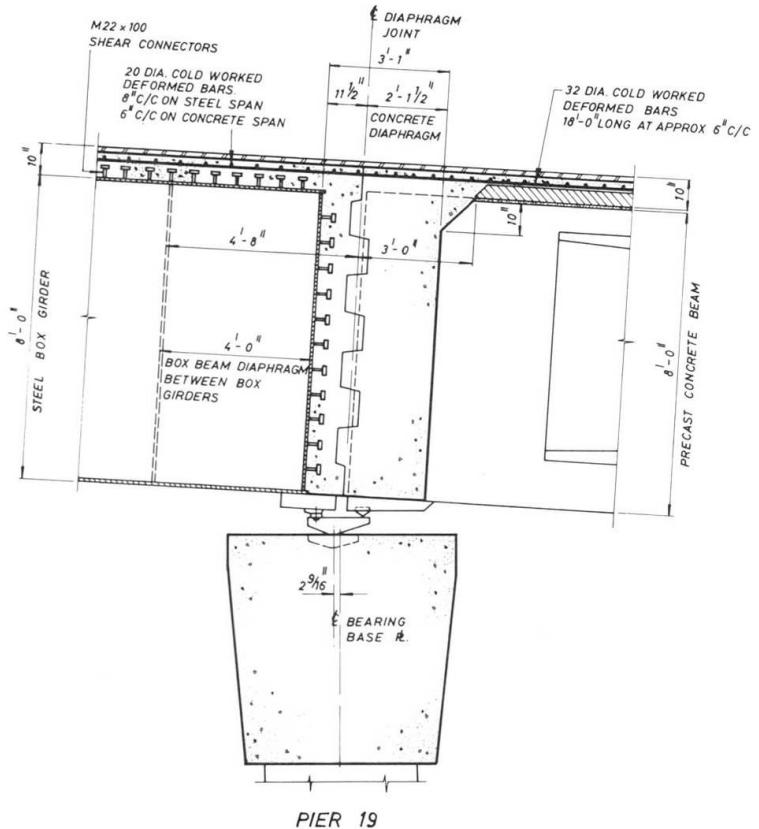
Fig. 10 Continuity connection steel/concrete spans

the finite element analyses of the end crossbeams. The continuity detail between the steel and concrete spans over the piers (Fig. 10) was similar to that used in the original design.

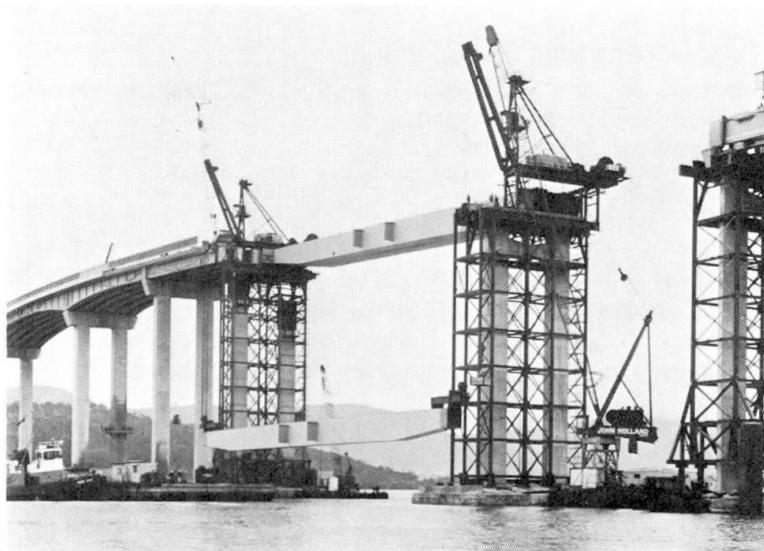
Fig. 11 Box girder erection

The adopted scheme used luffing 'A' frame lifting derricks specifically designed by the Contractor for the purpose (Fig. 11). By using temporary cantilever extensions at the ends of the boxes, they were lifted outboard of the towers as a single unit and positioned on top of the towers. The boxes were towed to site on a barge and then lifted. The operation from mooring of the barge to lifting the girders 40 m, and positioning them on temporary bearings on the falsework towers took about 20 minutes.

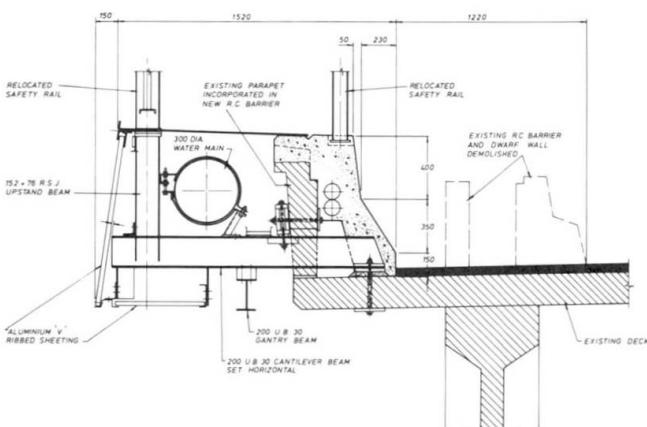
Fig. 12 Bridge widening details

While the bridge was out of service the opportunity was taken to widen it from four to five lanes over its full length. This permitted the operation of a rather more comfortable 3:2 tidal flow system rather than 3:1 as previously. The widening was achieved by cantilevering new footways and using the existing concrete deck for the five lanes (Fig. 12).

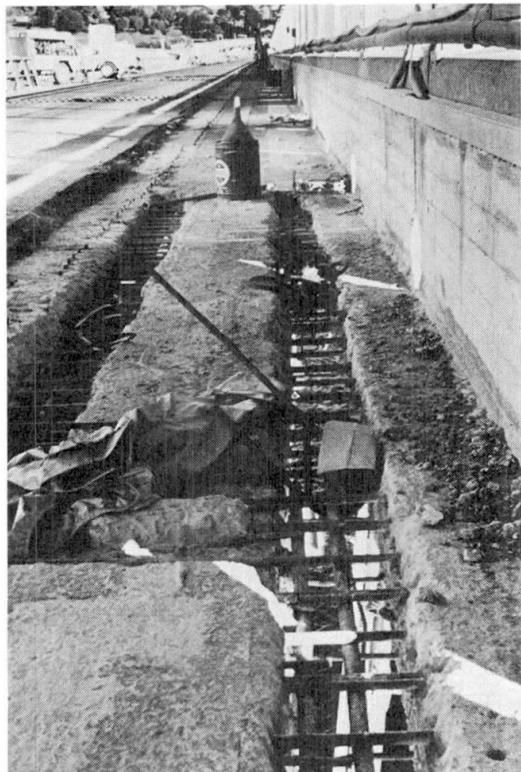
Fig. 14 Slots

It was originally intended to anchor the tendons in the deck by breaking out an area of concrete and casting a traditional anchor block. To reduce the required demolition and avoid cutting the main transverse deck reinforcement, the Contractor, Pearson Bridge (Tas.) Pty. Ltd. proposed cutting a slot 3 m x 200 mm (Fig. 14) into which the bare strands were anchored using an epoxy with fillers. The method worked very well.

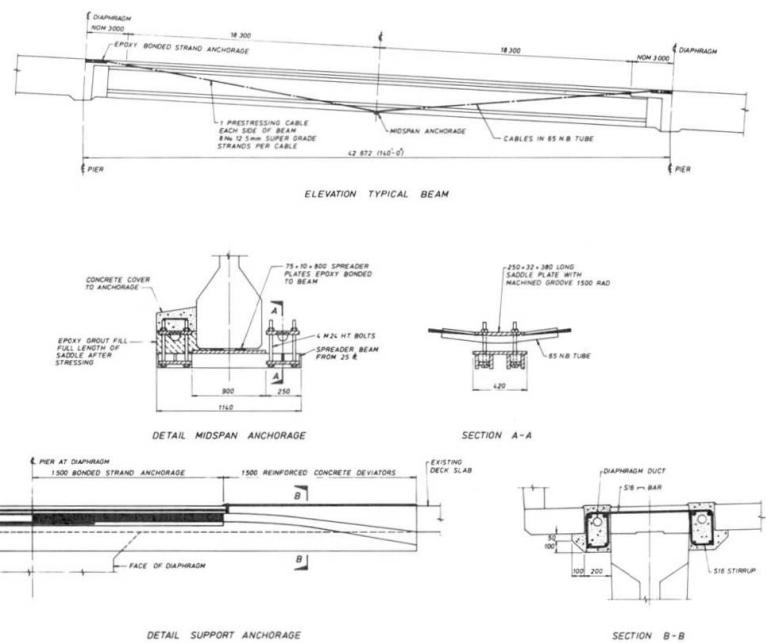
The 42.7 m span, prestressed concrete beams in the main viaducts were constructed segmentally. Due to the extra load from the widening, the outer beams were in tension at working loads and for serviceability reasons it was decided to

Fig. 13 Beam strengthening details

strengthen them by adding external tendons in a "Vee" shape one on each side of the web (Fig. 13). The tendons were 8 x 12.5 mm strands grouted into a 75 mm steel pipe and were stressed by pulling them down at mid span, and anchored by bolting to the mid span saddle to give an uplift force of 38 tonnes.
