Artikel: Restoration and widening of the Tasman bridge

Autor: Lee, D.J. / Crossley, B.K.G.

Restoration and Widening of the Tasman Bridge

Three out of 22 river spans of the Tasman Bridge were destroyed by ship collision. The paper describes the method of debris survey in the deep water site conditions and the method of restoration determined therefrom. The unusual engineering tasks involved in the work included temporary repairs, demolition, major steel falsework, unusual vertical piling, the incorporation of a long steel span into the prestressed concrete bridge and erection techniques used. The whole bridge was widened concurrently with the restoration.

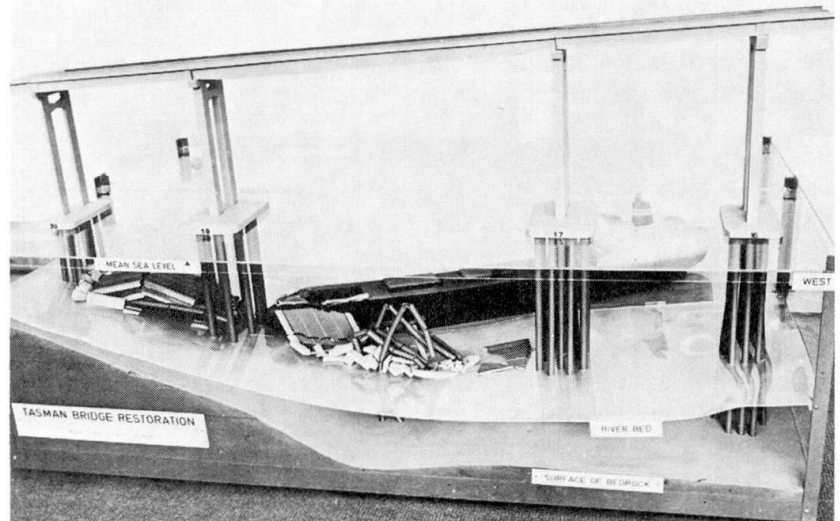
The debris survey took about three months and in the end all the broken bridge pieces were accounted for. A model was built to show the underwater picture (Fig. 3). During the debris survey it is to the credit of the Bridge Commission that pressures to make an early decision on the method of restoration were resisted. Five alternate schemes for reconstruction ranging from a single span scheme to a triple span scheme were examined in some detail. As the underwater scene unfolded the schemes were discarded one by one because debris prevented the placement of new piles, and the selected scheme only became evident at the end of the survey period when a complete picture was available. The only clear space available to establish a new pier was at the site of the original Pier 19 and this involved placement of new vertical piles between the existing broken off raking piles. The decision to delay the selection of a reconstruction method until the survey was completed was vindicated by job performance as no delays occurred due to new piles striking debris.

Fig. 3 Debris model

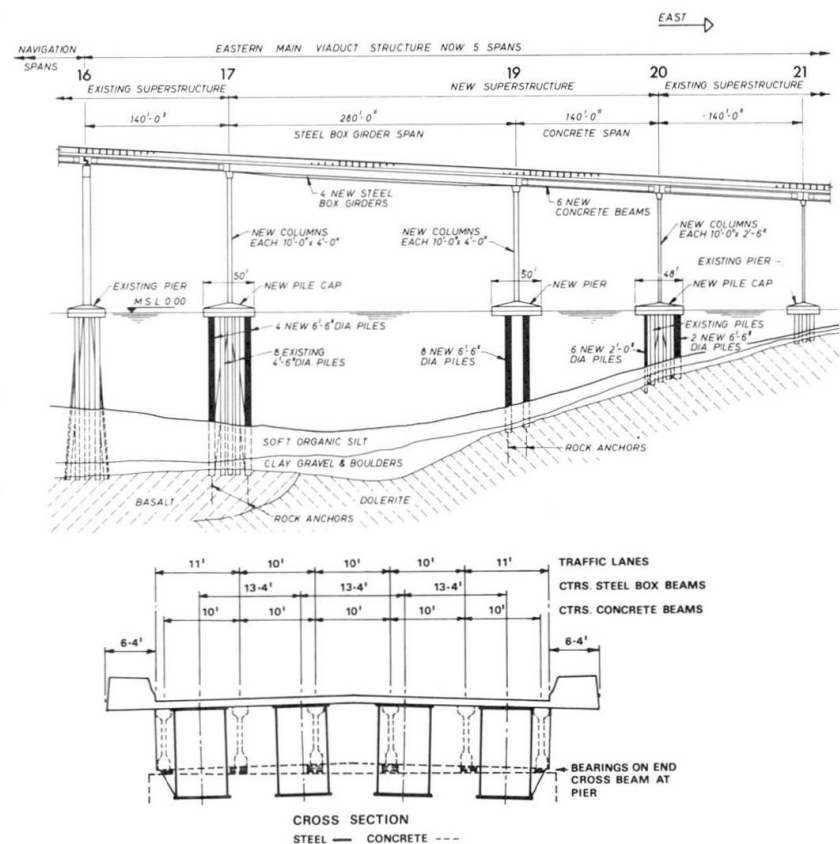
Fig. 4 Details of restoration

The method adopted is shown in Fig. 4 and has been reported on previously by LESLIE [7] and [8]. As the broken 1.4 m diameter piles at Pier 18 (40 m to bed level being the deepest part of the river), rose 15 m above the mud level this pier was omitted and the method involved the replacement of the three fallen spans by two spans; an 85 m steel span 17-19 and 43 m concrete span 19-20. Cross-sections are shown in Figs. 6 and 7. The scheme involved 14 new 2 m diameter vertical piles rock anchored at the base, some of which were to be used both as falsework piles and permanent piles. Foundation conditions were predetermined using one borehole per pile and were good, consisting of almost fresh dolerite at Piers 19 and 20 and partly weathered basalt at Pier 17. At Piers 17 and 20 the existing columns and pile caps had to be demolished and replaced. At Pier 17 additional piles, working in conjunction with the eight existing 1.4 m diameter raking piles, a bigger cap, and heavier columns were required to resist the greater loads from the double span. At Pier 20 there are no additional loads, but it was considered necessary to replace the badly damaged pile cap and columns, and the falsework piles required to achieve this were incorporated into the permanent structure, although not strictly required from a strength viewpoint. As there was a considerable time saving involved, the replacement of the substructure at these two piers was to be undertaken without demolishing the flanking spans (total mass 1,250 tonnes each) supported by them.

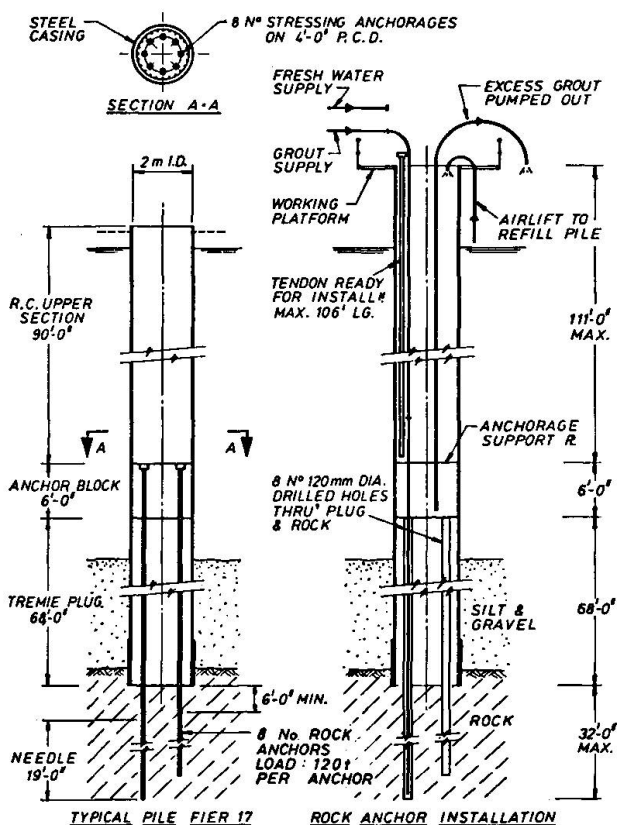
Fig. 7 Pile details

Details of the new vertical piling are shown in Fig. 7. 2 m diameter was selected as being the largest size which could be

reasonably handled. Base fixity to the piles was provided by means of rock anchors. At Pier 19 where all piles are vertical deck deflection under a 45 m/sec. transverse wind is 40 mm being 1 in 1,500 of the deck height above foundation level. The maximum loads per pile at this pier were 10,630 kN and 4,650 kNm.

The principle design features of the piles were; casing designed to be dewatered; reinforced concrete tremie plugs (40 MPa) to give F of S against flotation of 1.1; rock anchors designed for maximum corrosion resistance and each one tested in accordance with FIP recommendations. For safety reasons the test load was 70% UTS and lock off load 54% UTS.

At Pier 17 due to frequent rock joints the anchor holes could not be sealed and the installation method was modified to enable anchors to be grouted in a flooded pile (Fig. 7). Individual holes were kept grout filled while the grout leaking into adjacent holes was flushed out. A reservoir at the top of the plug enabled the grout quality to be monitored by underwater TV camera while visibility was maintained by downward circulation of fresh water.

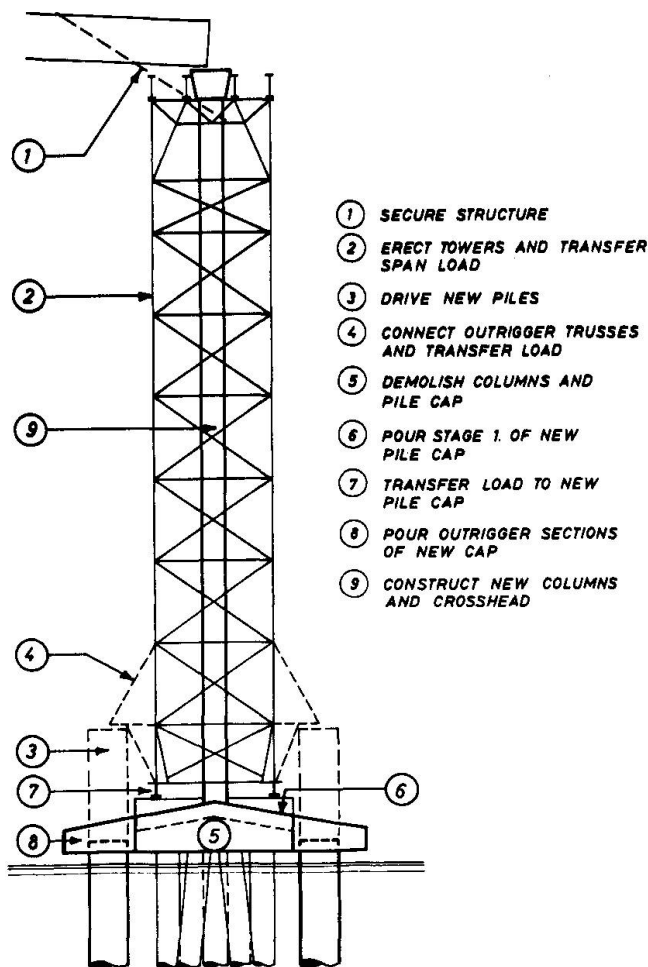
Fig. 8 Pier 17 construction sequence

The steel towers fulfilled many functions, including support of existing spans during column demolition, bracing for new concrete columns during construction, supports for the erection derricks and landing points for the new beams. The construction sequence involved in the use of the tower at Pier 17 is shown in Fig. 8.

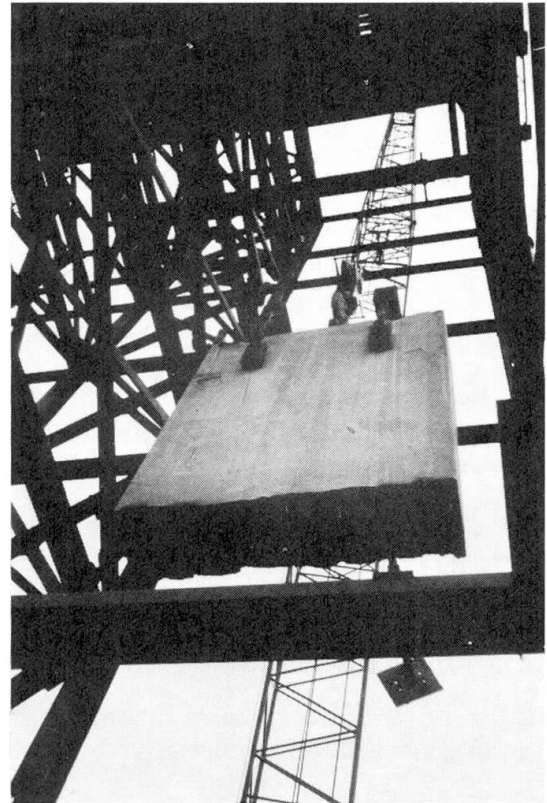
Fig. 9 Column demolition

The original columns were made up of precast concrete blocks, vertically stressed together with Macalloy bars. They had a cross-section of 3 m x 0.75 m and were cut horizontally using a thermic lance and hydraulic wedge splitters. The 25 tonne pieces were lifted out through the top of the falsework tower (Fig. 9). Twelve working days were required to remove the two legs of the Pier 20 column.

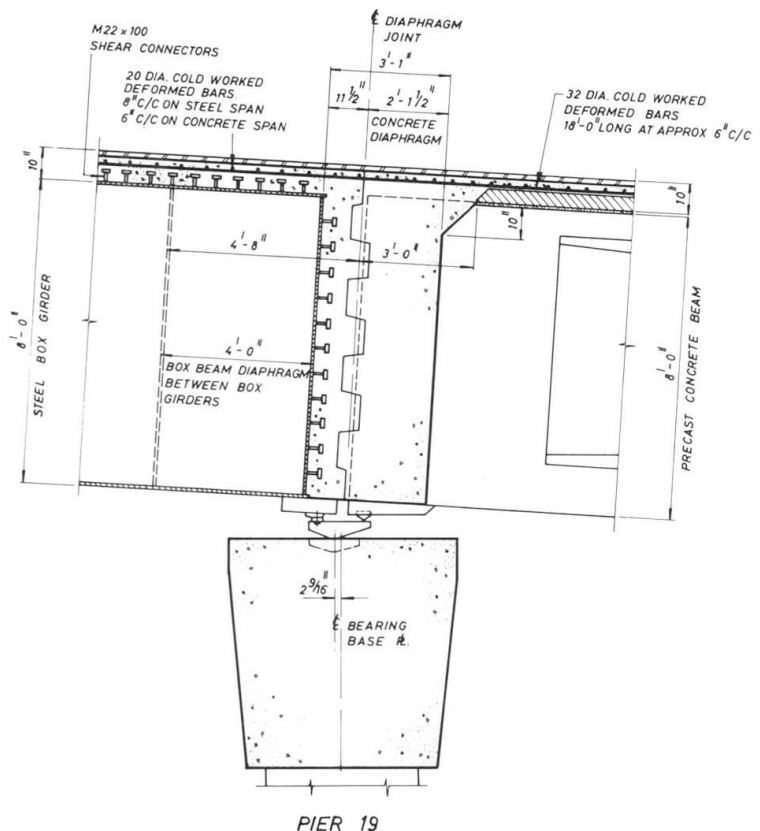
Fig. 10 Continuity connection steel/ concrete spans

the finite element analyses of the end crossbeams. The continuity detail between the steel and concrete spans over the piers (Fig. 10) was similar to that used in the original design.
