Restoration and Widening of the Tasman Bridge

D.J. LEE

B.K.G. CROSSLEY

SUMMARY

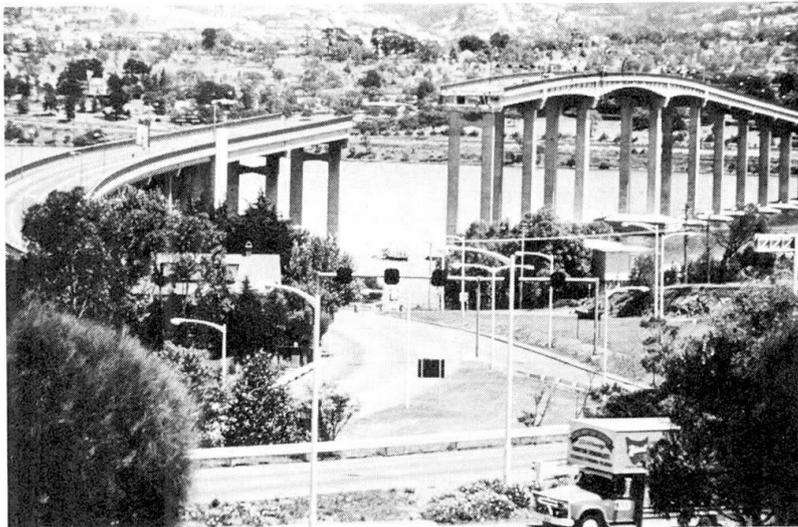
Fig. 1 Tasman Bridge after collapse

In January 1975, the ore carrier S.S. Lake Illawarra, fully laden and displacing 17,000 tonnes, collided with Piers 18 and 19 of the bridge bringing down these piers together with three spans of the eastern main viaduct and leaving a gap of 128 m. The centre one of the three spans fell on the bow of the ship which quickly sank, the tragedy resulting in the loss of twelve lives. The severence of the only road link also caused quite substantial social disruption, as the eastern shore has mainly dormitory suburbs, with the majority of the city's infrastructure being on the western shore.

The consequences of the accident to the remainder of the bridge were relatively minor as it had performed in accordance with design provisions. Span 16-17, the only remaining eastern main viaduct span on the river side of the gap, had remained in position supported by the stay bolts. Pile Cap 20 had suffered severe damage when it was hit by the falling span 19-20, whose trajectory of free fall was intercepted by one end hitting the bow of the ship. The columns on either side of the opening were deflected towards the gap at the top by up to 200 mm and the lower part of the columns was severely cracked. Otherwise the remaining 19 spans of the bridge were undamaged.

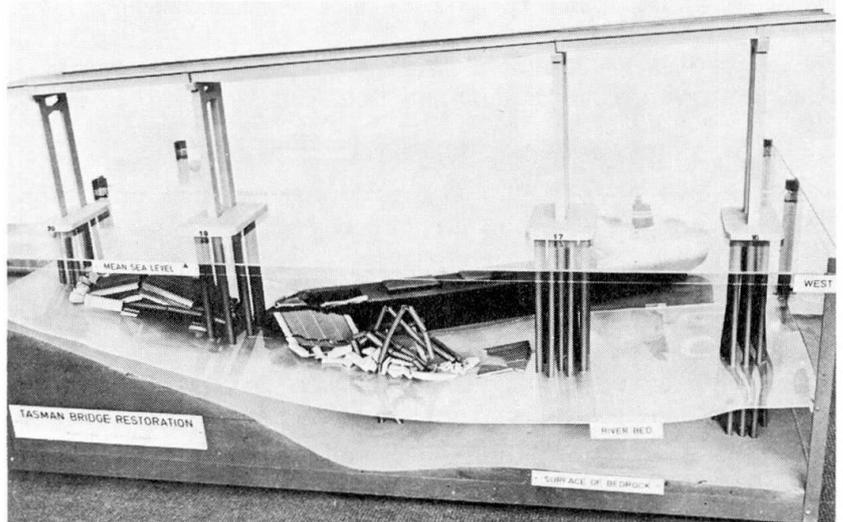
Fig. 3 Debris model

The debris survey took about three months and in the end all the broken bridge pieces were accounted for. A model was built to show the underwater picture (Fig. 3). During the debris survey it is to the credit of the Bridge Commission that pressures to make an early decision on the method of restoration were resisted. Five alternate schemes for reconstruction ranging from a single span scheme to a triple span scheme were examined in some detail. As the underwater scene unfolded the schemes were discarded one by one because debris prevented the placement of new piles, and the selected scheme only became evident at the end of the survey period when a complete picture was available. The only clear space available to establish a new pier was at the site of the original Pier 19 and this involved placement of new vertical piles between the existing broken off raking piles. The decision to delay the selection of a reconstruction method until the survey was completed was vindicated by job performance as no delays occurred due to new piles striking debris.

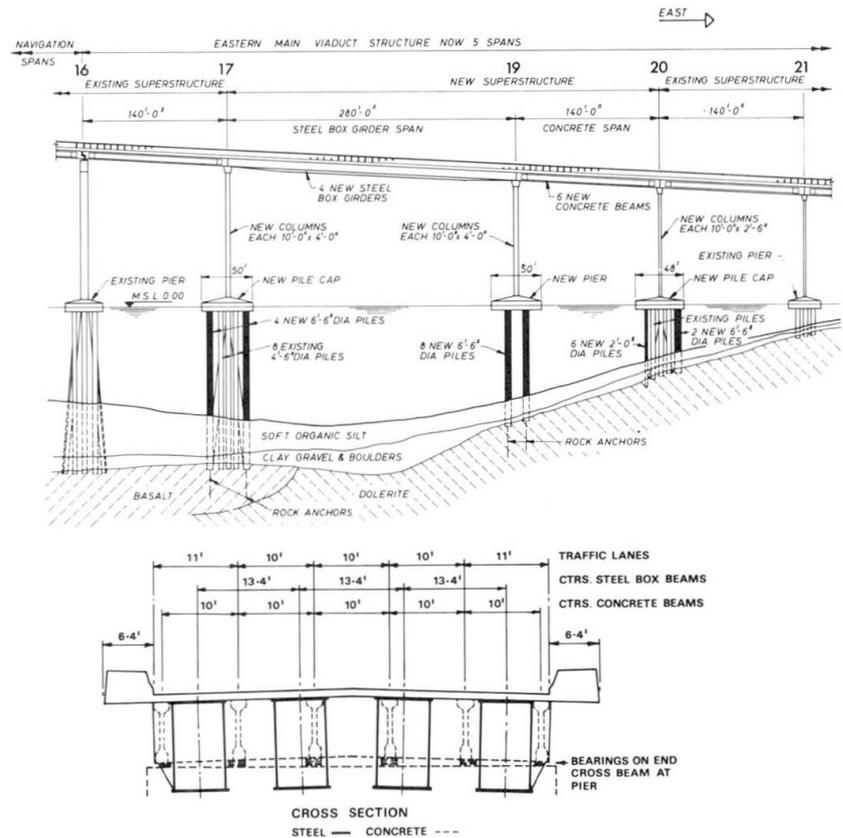
Fig. 4 Details of restoration

The method adopted is shown in Fig. 4 and has been reported on previously by LESLIE [7] and [8]. As the broken 1.4 m diameter piles at Pier 18 (40 m to bed level being the deepest part of the river), rose 15 m above the mud level this pier was omitted and the method involved the replacement of the three fallen spans by two spans; an 85 m steel span 17-19 and 43 m concrete span 19-20. Cross-sections are shown in Figs. 6 and 7. The scheme involved 14 new 2 m diameter vertical piles rock anchored at the base, some of which were to be used both as falsework piles and permanent piles. Foundation conditions were predetermined using one borehole per pile and were good, consisting of almost fresh dolerite at Piers 19 and 20 and partly weathered basalt at Pier 17. At Piers 17 and 20 the existing columns and pile caps had to be demolished and replaced. At Pier 17 additional piles, working in conjunction with the eight existing 1.4 m diameter raking piles, a bigger cap, and heavier columns were required to resist the greater loads from the double span. At Pier 20 there are no additional loads, but it was considered necessary to replace the badly damaged pile cap and columns, and the falsework piles required to achieve this were incorporated into the permanent structure, although not strictly required from a strength viewpoint. As there was a considerable time saving involved, the replacement of the substructure at these two piers was to be undertaken without demolishing the flanking spans (total mass 1,250 tonnes each) supported by them.

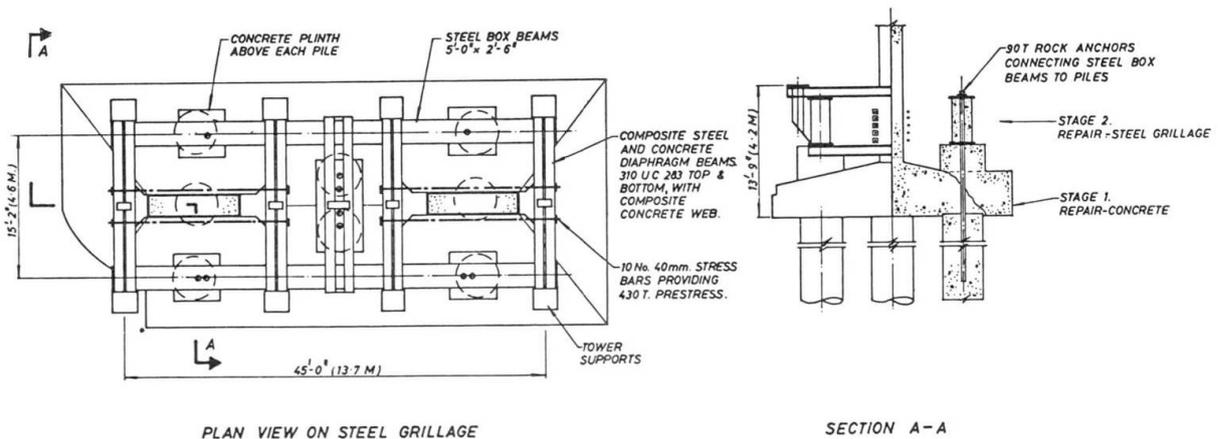
Fig. 6 Pile Cap 20. Temporary steel cap

- Construction of a temporary steel pile cap above the existing cap (Fig. 6). Its purpose was to enable column loads to bypass the existing cap and be transmitted directly into the piles. This action was achieved by stressing the steel cap to the columns and by casting concrete plinths on top of the existing cap, directly above the piles, and stressing the steel cap to the piles by means of rock anchors drilled and grouted into them.

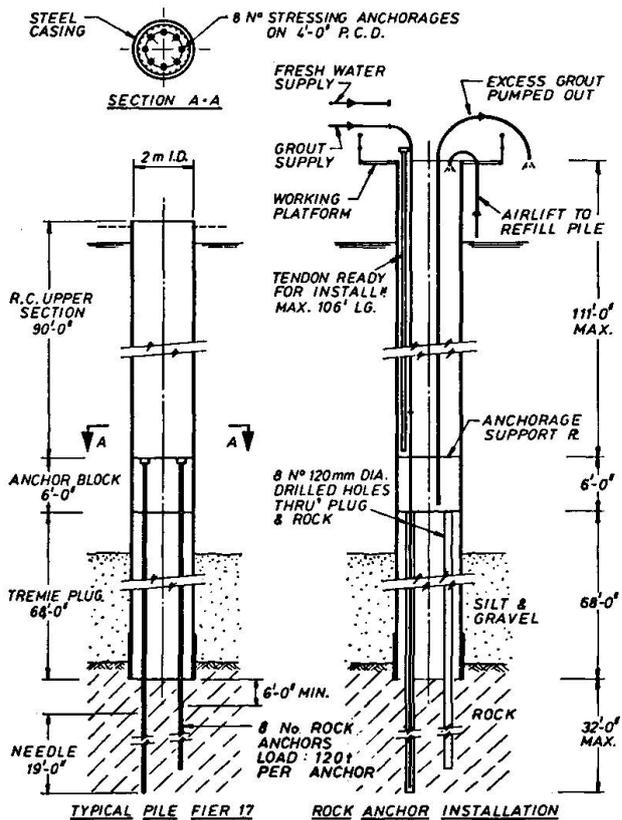
Fig. 7 Pile details

Details of the new vertical piling are shown in Fig. 7. 2 m diameter was selected as being the largest size which could be

reasonably handled. Base fixity to the piles was provided by means of rock anchors. At Pier 19 where all piles are vertical deck deflection under a 45 m/sec. transverse wind is 40 mm being 1 in 1,500 of the deck height above foundation level. The maximum loads per pile at this pier were 10,630 kN and 4,650 kNm.

The principle design features of the piles were; casing designed to be dewatered; reinforced concrete tremie plugs (40 MPa) to give F of S against flotation of 1.1; rock anchors designed for maximum corrosion resistance and each one tested in accordance with FIP recommendations. For safety reasons the test load was 70% UTS and lock off load 54% UTS.

At Pier 17 due to frequent rock joints the anchor holes could not be sealed and the installation method was modified to enable anchors to be grouted in a flooded pile (Fig. 7). Individual holes were kept grout filled while the grout leaking into adjacent holes was flushed out. A reservoir at the top of the plug enabled the grout quality to be monitored by underwater TV camera while visibility was maintained by downward circulation of fresh water.

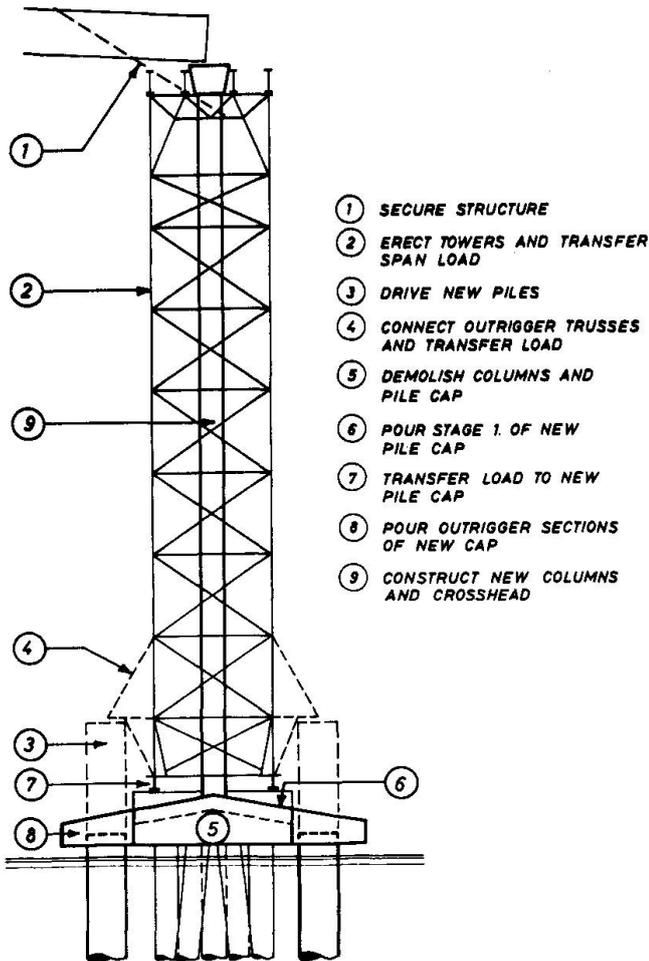
Fig. 8 Pier 17 construction sequence

The steel towers fulfilled many functions, including support of existing spans during column demolition, bracing for new concrete columns during construction, supports for the erection derricks and landing points for the new beams. The construction sequence involved in the use of the tower at Pier 17 is shown in Fig. 8.

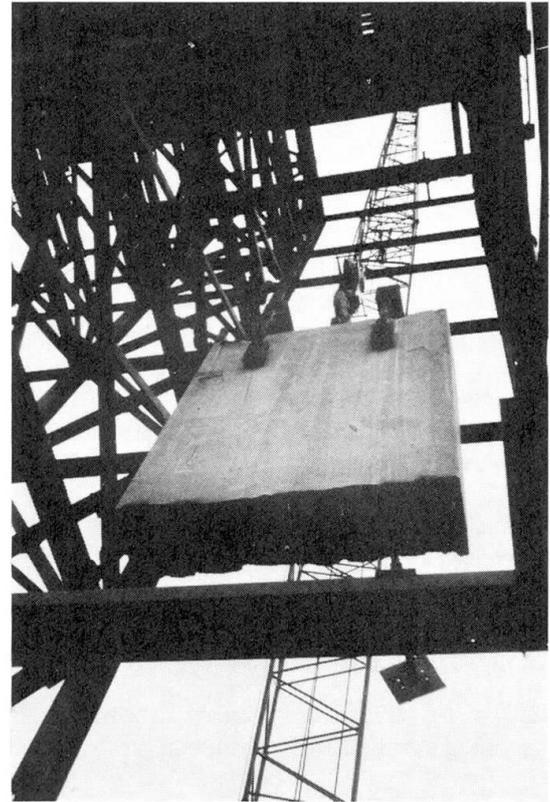
Fig. 9 Column demolition

The original columns were made up of precast concrete blocks, vertically stressed together with Macalloy bars. They had a cross-section of 3 m x 0.75 m and were cut horizontally using a thermic lance and hydraulic wedge splitters. The 25 tonne pieces were lifted out through the top of the falsework tower (Fig. 9). Twelve working days were required to remove the two legs of the Pier 20 column.

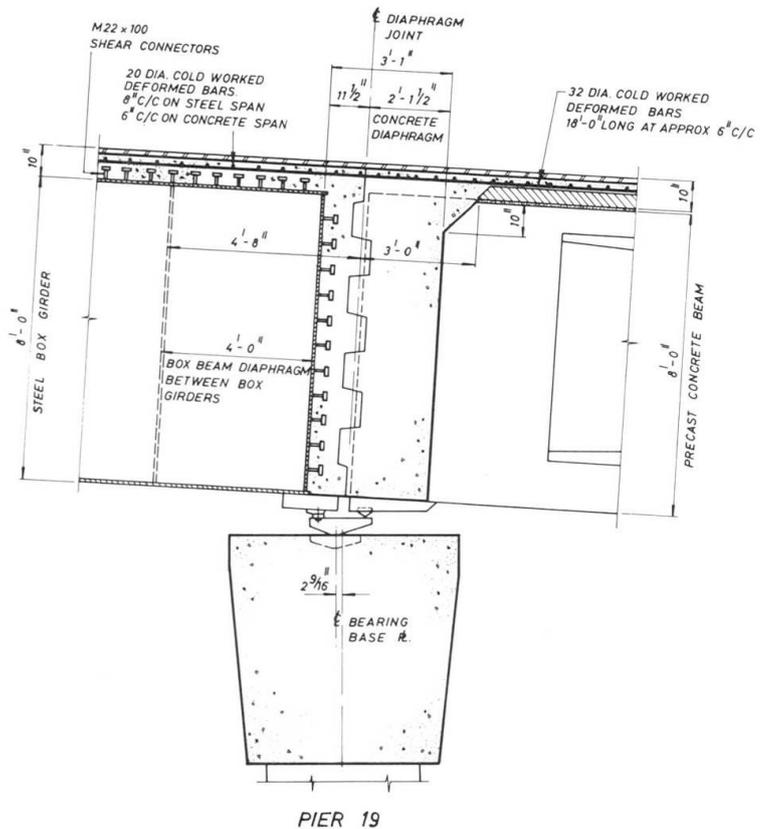
Fig. 10 Continuity connection steel/ concrete spans

the finite element analyses of the end crossbeams. The continuity detail between the steel and concrete spans over the piers (Fig. 10) was similar to that used in the original design.

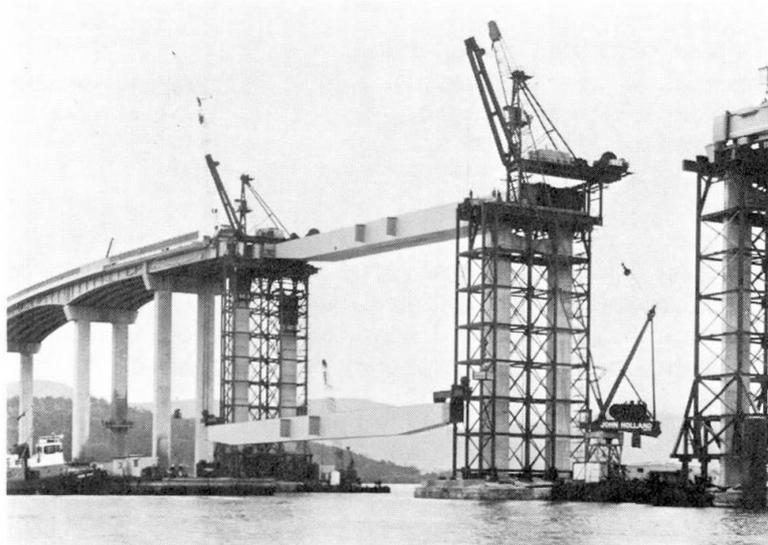
Fig. 11 Box girder erection

The adopted scheme used luffing 'A' frame lifting derricks specifically designed by the Contractor for the purpose (Fig. 11). By using temporary cantilever extensions at the ends of the boxes, they were lifted outboard of the towers as a single unit and positioned on top of the towers. The boxes were towed to site on a barge and then lifted. The operation from mooring of the barge to lifting the girders 40 m, and positioning them on temporary bearings on the falsework towers took about 20 minutes.

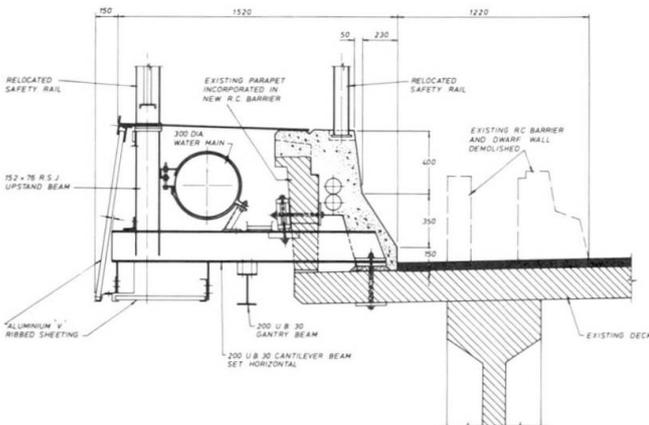
Fig. 12 Bridge widening details

While the bridge was out of service the opportunity was taken to widen it from four to five lanes over its full length. This permitted the operation of a rather more comfortable 3:2 tidal flow system rather than 3:1 as previously. The widening was achieved by cantilevering new footways and using the existing concrete deck for the five lanes (Fig. 12).

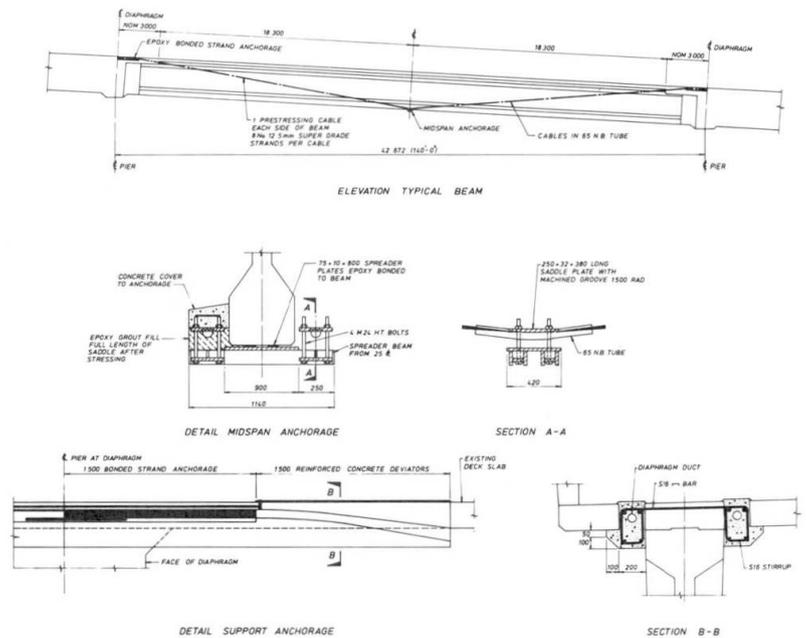
The 42.7 m span, prestressed concrete beams in the main viaducts were constructed segmentally. Due to the extra load from the widening, the outer beams were in tension at working loads and for serviceability reasons it was decided to

Fig. 13 Beam strengthening details

strengthen them by adding external tendons in a "Vee" shape one on each side of the web (Fig. 13). The tendons were 8 x 12.5 mm strands grouted into a 75 mm steel pipe and were stressed by pulling them down at mid span, and anchored by bolting to the mid span saddle to give an uplift force of 38 tonnes.

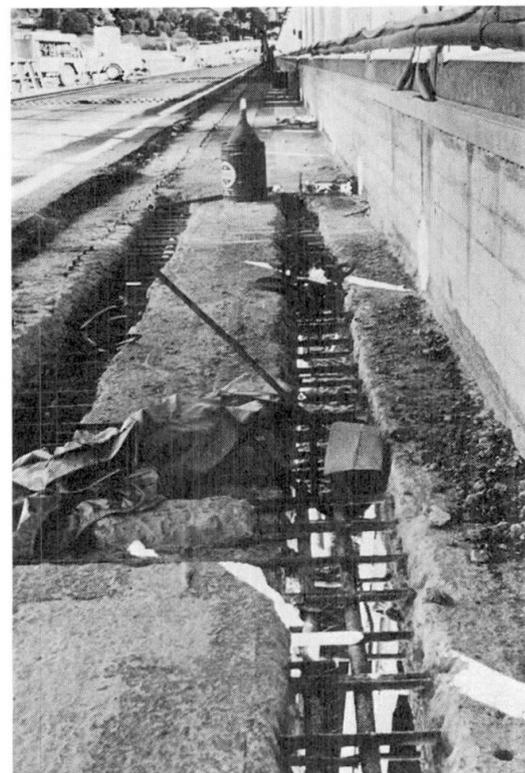
Fig. 14 Slots

It was originally intended to anchor the tendons in the deck by breaking out an area of concrete and casting a traditional anchor block. To reduce the required demolition and avoid cutting the main transverse deck reinforcement, the Contractor, Pearson Bridge (Tas.) Pty. Ltd. proposed cutting a slot 3 m x 200 mm (Fig. 14) into which the bare strands were anchored using an epoxy with fillers. The method worked very well.
