The long-term behaviour of viaducts subjected to heavy traffic and situated in an aggressive environment: the viaduct on the Polcevera in Genoa

The Long-Term Behaviour of Viaducts Subjected to Heavy Traffic and Situated in an aggressive Environment. The Viaduct on the Polcevera in Genoa.

R. MORANDI

THE VIADUCT ON THE POLCEVERA, FOR THE GENOA-SAVONA SPEEDWAY.

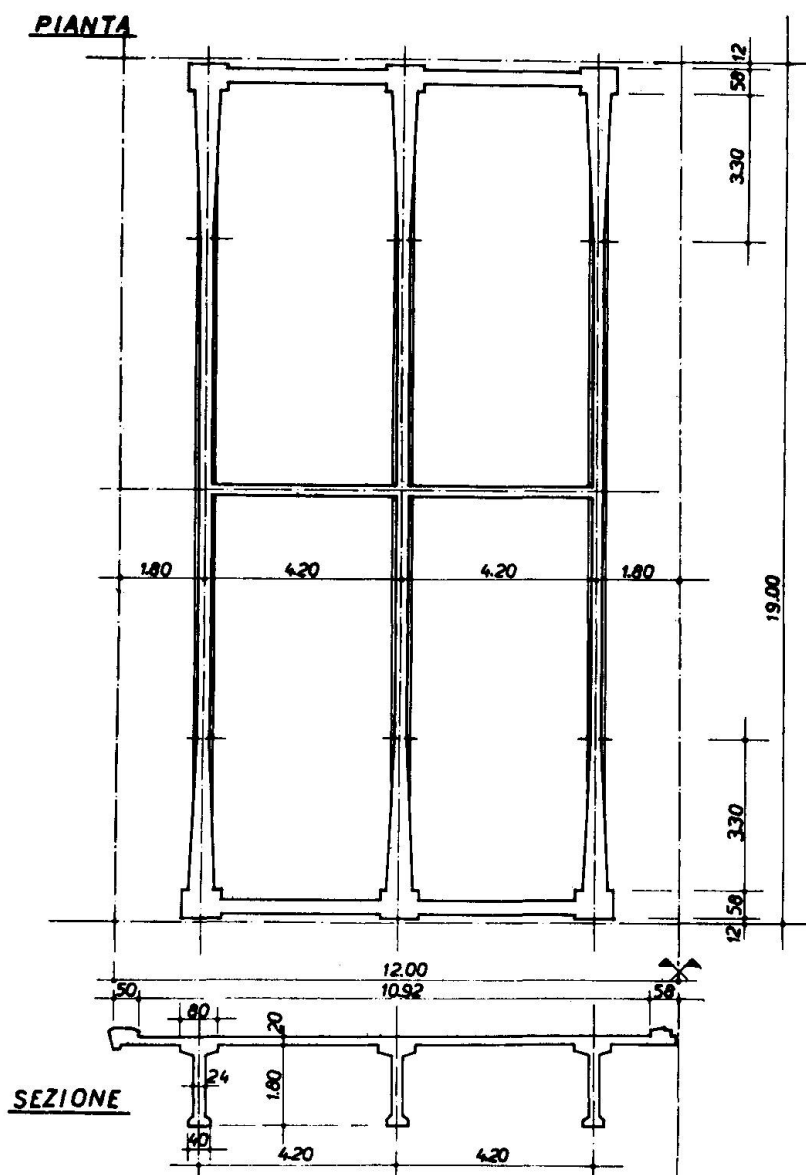
Fig. 1 - Geometry of the standard bay.

During my visit I found some superficial distress in the paving joints, some excessive crushing of the bearings (although nothing really serious) but, most important of all, that all the parallel beams of the deck showed a diffused pattern of cracks of very similar length, frequency and width on all the bays.
