Artikel: Application of photon tomography to weld inspection
Autor: Frank, Karl H. / Kohutek, Terry L.
DOI: <https://doi.org/10.5169/seals-28935>

Application of Photon Tomography to Weld Inspection

Weld cores from the Silver Memorial Bridge located at Point Pleasant, West Virginia, U.S.A., were scanned as part of a study to determine the significance of the cracks found in a field inspection of the bridge. The details of the study are given in Ref. 2. The results of two weld cores are detailed below.

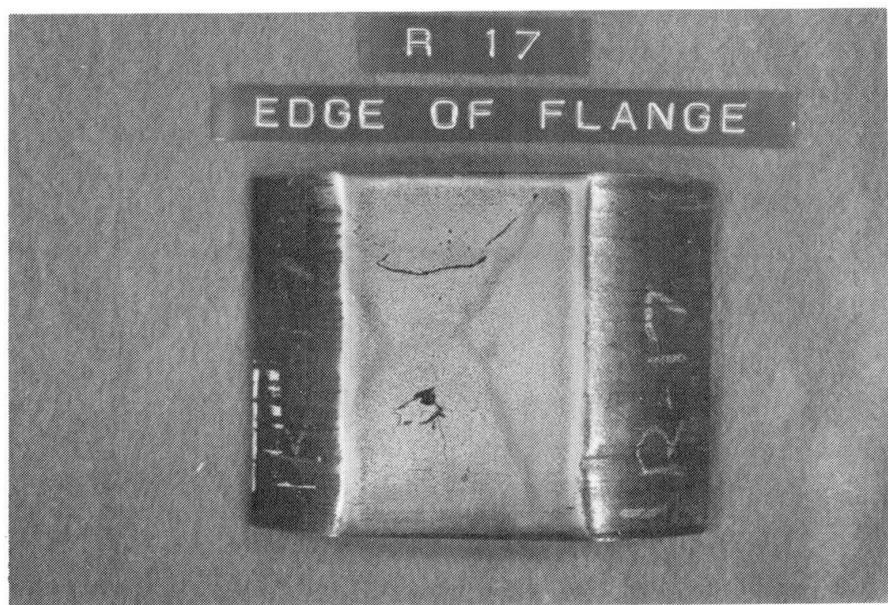
Many of the cores from the bridge had visible cracks at the edge of the weld. These welds were butt welds used to join the plates comprising the flanges of the "H" shapes used for the members of the truss. A typical example is shown in Fig. 3. The edge of the weld, at the flange tip, contains two large defects. Standard radiography of the cores, at 1% sensitivity, did not image these large cracks. A tomogram was taken of the core perpendicular to the face shown in Fig. 3. The results are shown in Fig. 4. Both defects are imaged. The curved shape and depth of the upper defect was confirmed by destructive examination.

Fig. 3 Edge of Core Showing Two Defects

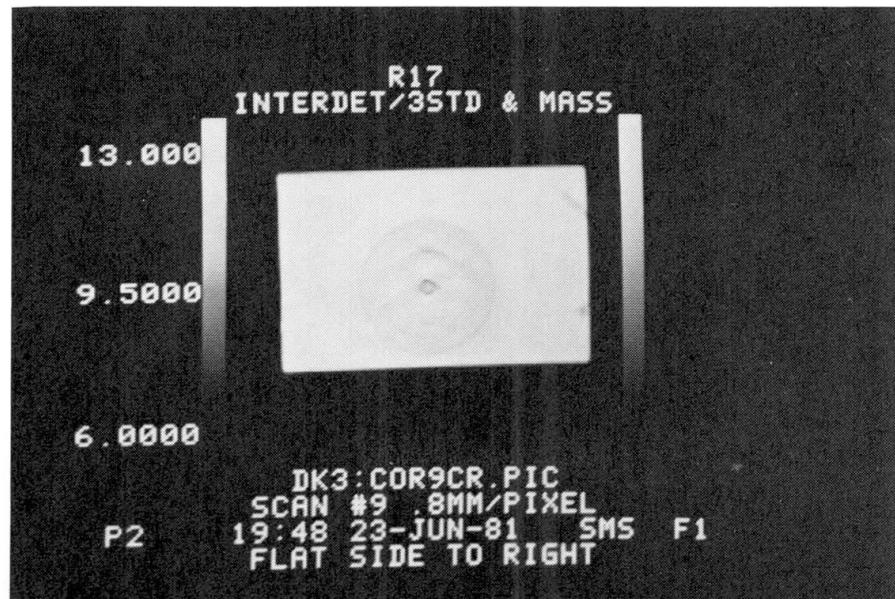
Fig. 4 Tomogram Through Edge Defects

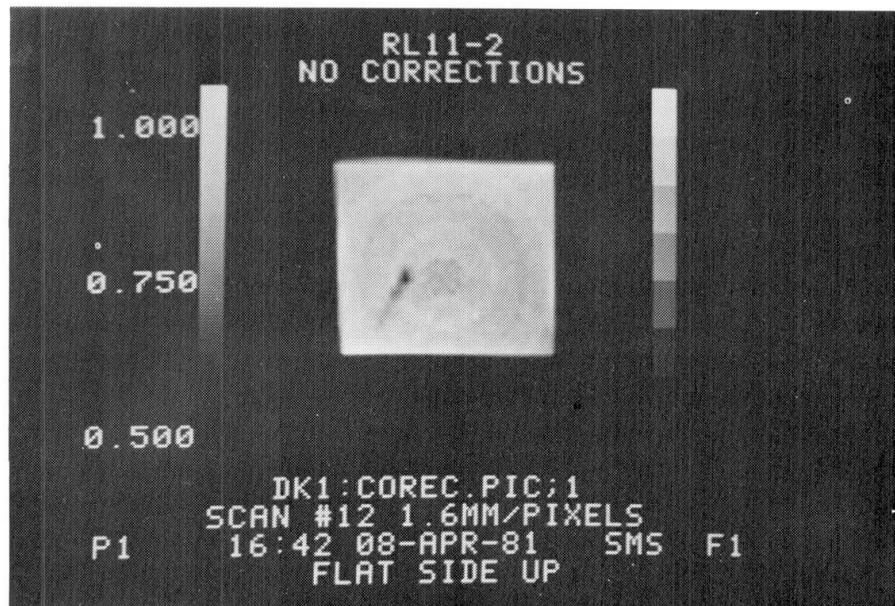
In another core, a defect was found by radiography. An internal defect was interpreted as porosity by the radiographer. A tomogram across the weld at the defect produced the results shown in Fig. 5. Figure 6 shows a cross section of the weld at the location of the tomogram slice plane. The defect imaged in the tomogram agrees with the results of the destructive examination. The defect is not porosity but a fusion line defect.

Fig. 5 Tomogram of Embedded Defect

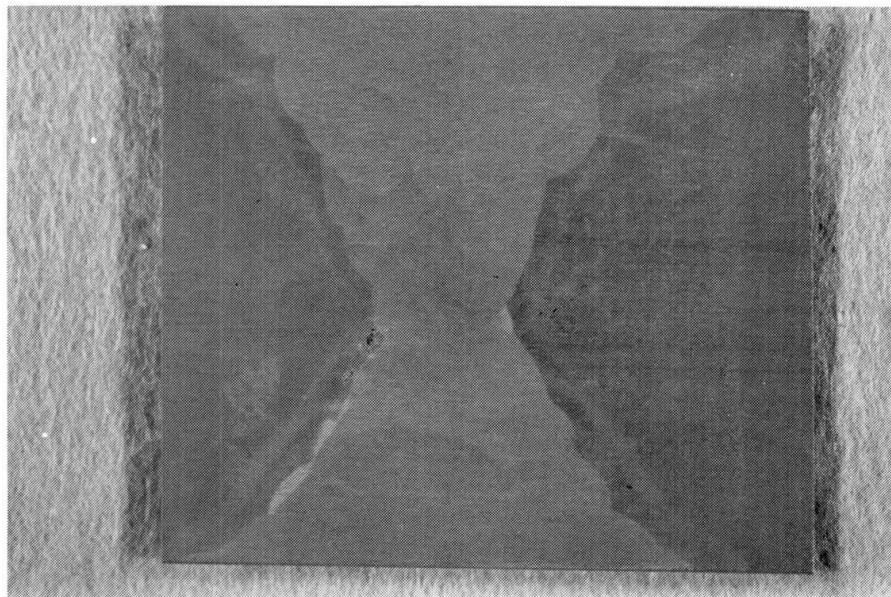
Fig. 6 Cross Section of Weld at Embedded Defect
