Application of Photon Tomography to Weld Inspection

KARL H. FRANK

TERRY L. KOHUTEK

The results of a study of the application of photon tomography to weld inspection are presented. The evaluation of two weld cores containing defects is presented and compared with standard radiography. The results indicate that tomography may be an extremely useful method of weld inspection.

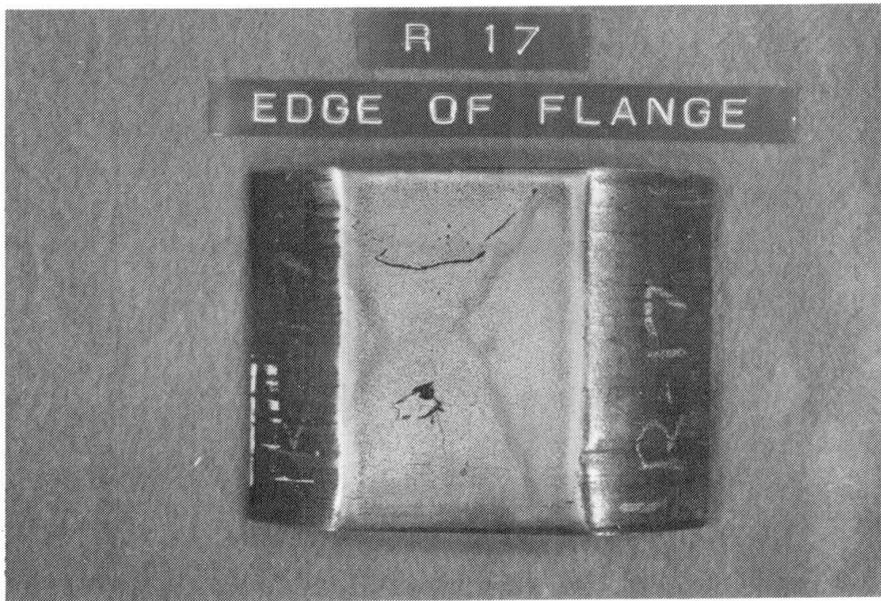
Fig. 3 Edge of Core Showing Two Defects

Many of the cores from the bridge had visible cracks at the edge of the weld. These welds were butt welds used to join the plates comprising the flanges of the "H" shapes used for the members of the truss. A typical example is shown in Fig. 3. The edge of the weld, at the flange tip, contains two large defects. Standard radiography of the cores, at 1% sensitivity, did not image these large cracks. A tomogram was taken of the core perpendicular to the face shown in Fig. 3. The results are shown in Fig. 4. Both defects are imaged. The curved shape and depth of the upper defect was confirmed by destructive examination.

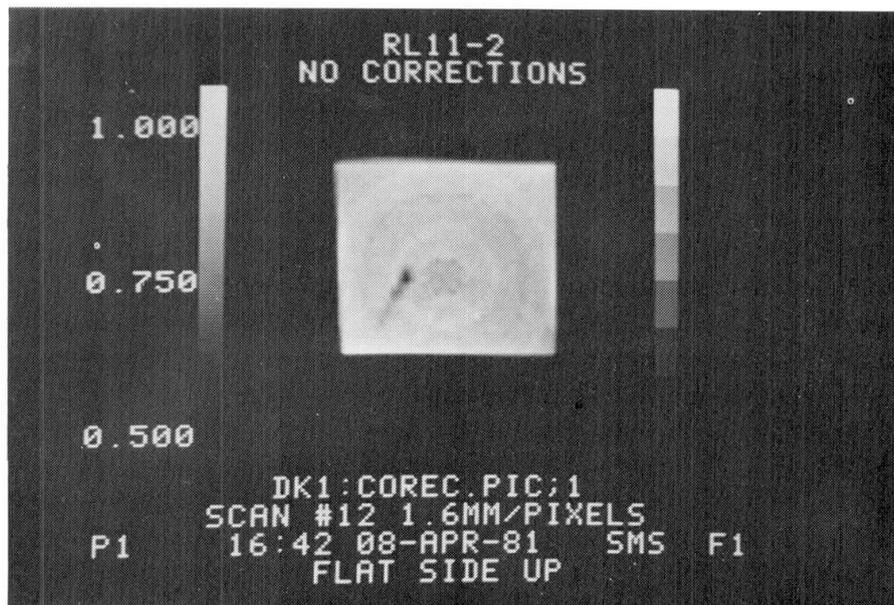
Fig. 5 Tomogram of Embedded Defect

In another core, a defect was found by radiography. An internal defect was interpreted as porosity by the radiographer. A tomogram across the weld at the defect produced the results shown in Fig. 5. Figure 6 shows a cross section of the weld at the location of the tomogram slice plane. The defect imaged in the tomogram agrees with the results of the destructive examination. The defect is not porosity but a fusion line defect.
