**Artikel:** Application of photon tomography to weld inspection  
**Autor:** Frank, Karl H. / Kohutek, Terry L.  
**DOI:** <https://doi.org/10.5169/seals-28935>

## **Application of Photon Tomography to Weld Inspection**

### **KARL H. FRANK**

### **TERRY L. KOHUTEK**

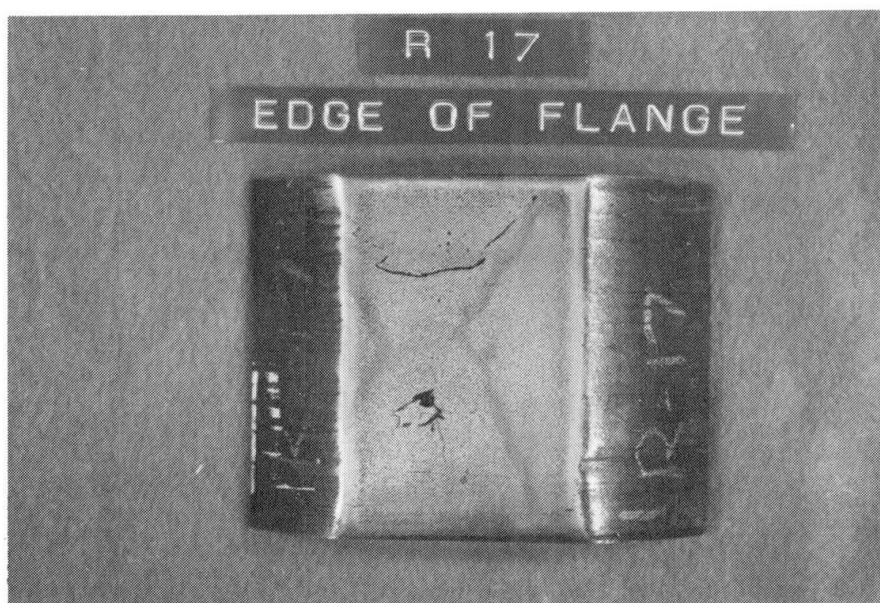
Fig. 3 Edge of Core Showing Two Defects

Many of the cores from the bridge had visible cracks at the edge of the weld. These welds were butt welds used to join the plates comprising the flanges of the "H" shapes used for the members of the truss. A typical example is shown in Fig. 3. The edge of the weld, at the flange tip, contains two large defects. Standard radiography of the cores, at 1% sensitivity, did not image these large cracks. A tomogram was taken of the core perpendicular to the face shown in Fig. 3. The results are shown in Fig. 4. Both defects are imaged. The curved shape and depth of the upper defect was confirmed by destructive examination.

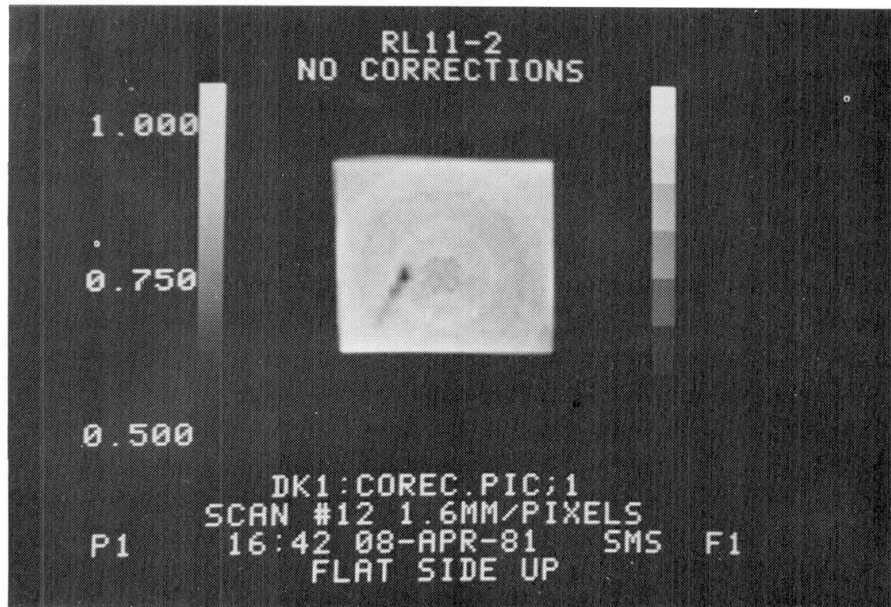
Fig. 5 Tomogram of Embedded Defect

In another core, a defect was found by radiography. An internal defect was interpreted as porosity by the radiographer. A tomogram across the weld at the defect produced the results shown in Fig. 5. Figure 6 shows a cross section of the weld at the location of the tomogram slice plane. The defect imaged in the tomogram agrees with the results of the destructive examination. The defect is not porosity but a fusion line defect.
