Zeitschrift: **IABSE reports = Rapports AIPC = IVBH Berichte**

Band (Jahr): **37 (1982)**

## **Fatigue Failures of Steel Railway Bridges in China**

### **SHI YONGJI**

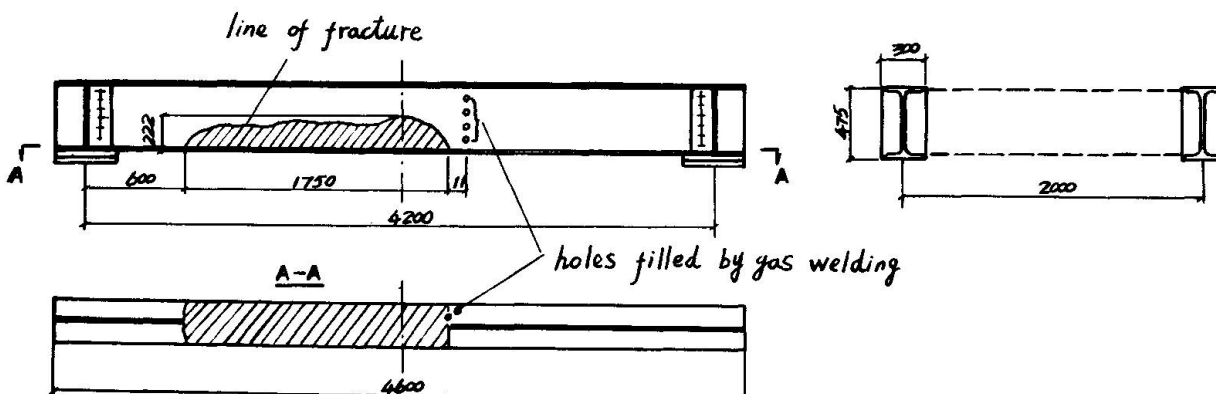
Bridge No. 248 on the Beijing-Baotou Railway Line was a rolled I-beam bridge which was manufactured in Britain in 1898 and erected in 1903. Its original length was 7 M and was cut down to 4.6 M in 1947 to be used as a simple span. There were four drilled holes of  $\phi 19$  on the webs and two on the bottom flanges. These holes were filled later by gas welding when it was cut. It so happened that at about 11 o'clock in the morning of November 30, 1967, after a heavy snow fall, a large piece of flange metal broke off together with a portion of the web. Fig 1 is a sketch of the girder and the failure location. Photo 1 is the fallen off piece. From the fracture surface, we could find that the weld quality was very poor. Under repeated action of train load through a long period of time, fatigue crack was initiated at the notch (Photo 2).

Fig 1 Sketch of the girder bridge No. 248 and its failure location

Samples were taken from the girder for chemical analysis and mechanical test. The steel strength was equivalent to that of the carbon steel but was high in S, P and N content which made it difficult for welding. The ductility of the material at low temperature was rather poor and the ageing effect tendency was quite strong. U-notch impact test showed that the brittleness transition temperature was about  $+15^{\circ}\text{C} - 0^{\circ}\text{C}$ .

This accident once more teaches that direct repair welding on steel girders must be strictly forbidden. Otherwise it would be very much likely that weld defects or weld cracks should appear and deterioration, a decrease in ductility in particular of the weld metal and the heat affected zone would happen. And these would certainly give rise for the formation of fatigue crack and brittle fracture. This is an important problem we must pay attention to in the reconstruction and maintenance of bridge in the future.

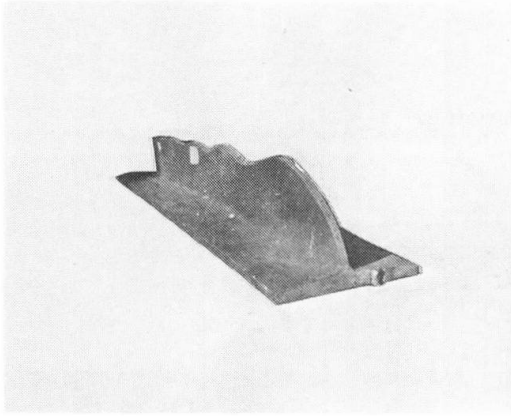
Photo 1 The fallen off metal of bridge No. 248

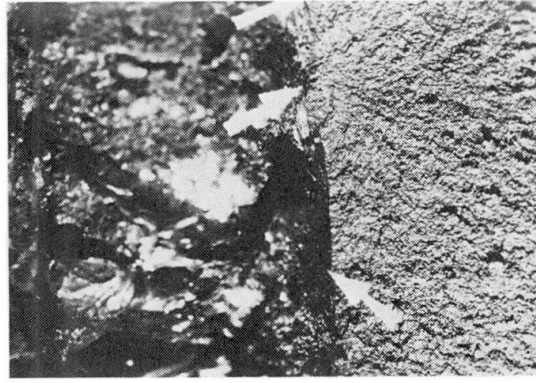
Photo 2 Fatigue crack at the notch of bridge No. 248

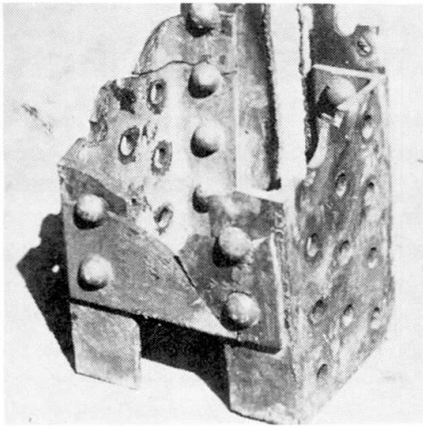
On March 23, 1973, the fracture occurred at the upper panel point of the first diagonal of the 16th truss built in 1930, with a span length of 33.54 M.

Photo 3 The form of the fracture member of Taizi River Bridge

Field investigation revealed that fatigue crack took place at an early stage in one of the diagonal channels. The other channel was pulled to break with obvious appearance of a bottleneck. The causes of the formation of the fatigue cracks are as follows:

At the time of design 50 years ago, the fatigue behaviour of the riveted joints was not clearly understood. The present train load and train load and train density (about 80 trains per day) on the bridge were much greater than those when the

bridge was first constructed. The lateral bracings were too weak, so the passing trains caused the truss to produce great vibration in the horizontal direction.

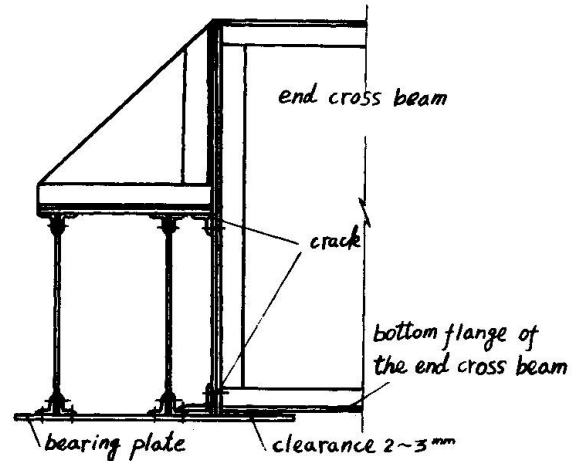
In Fig 2 is indicated the fatigue cracks occurring at the angles connecting the end cross beam and the main truss. In the original design, the bottom flange of the end cross beam was placed directly against the bearing plate so that the reaction force might be partly transmitted through the plate. However, after many years of operation, a gap of 2-3 MM was formed between the bottom flange of the cross beam and the top of the bearing plate, which had deformed and worn out. As a result, the line of transmission of the reaction force was so

altered that the stresses in the connecting angles were greatly increased. This was the major cause of the fatigue cracks.

Fig 2 Fatigue cracks occurring at the connecting angles

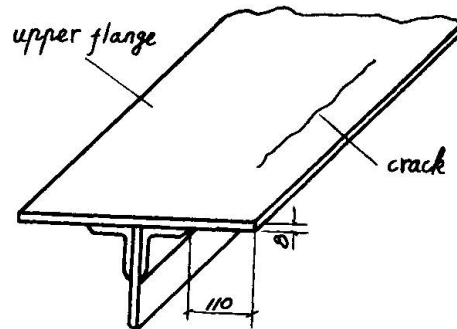
In some old-type riveted girders, both the upper and lower flange cover plates were provided in conformity to the moment diagram. Some of them often stopped at a distance from the bridge support. The flange plate between the support and stopped point was rather thin (8 MM only), but it cantilevered out as many as 110 MM (Fig 3). This was why longitudinal fatigue cracks often took place at this location. The two major causes of the formation of this longitudinal fatigue cracks are: (1) high impact forces under the direct train wheel load. (2) Transverse deflection of the upper flange induced by the vertical deformation of sleeper under train load. The beam action of sleepers on D.P.G. Bridges arose from a difference that existed between the center to center distance of the main girders which was 2 M and the gauge distance of the rails which was 1.435 M.

Fig 3 Crack on the upper flange

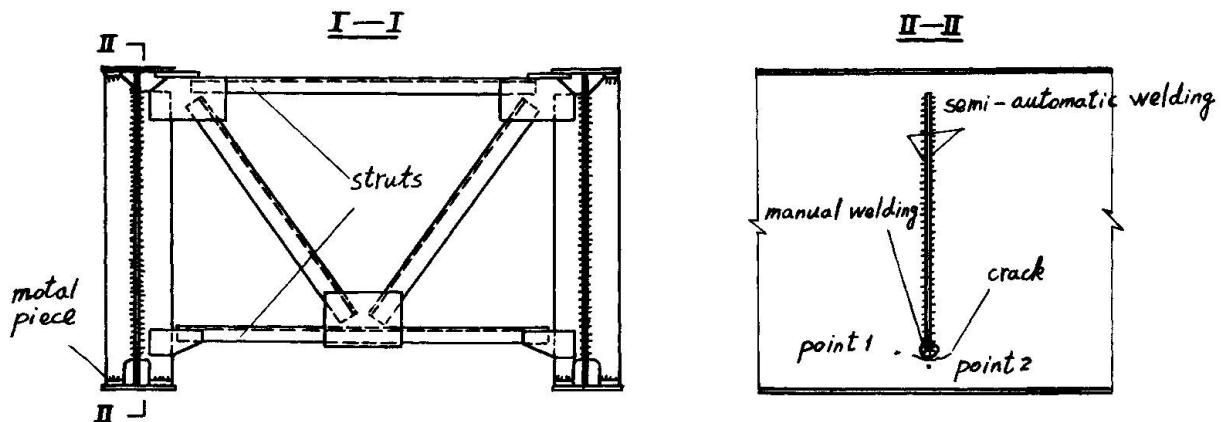
Langjiang Bridge on the Changsha - Liuzhou Railway Line, which was completed and opened to traffic on November 28, 1964, was the first bolt-weld railway through truss bridge using 16 Mn steel, with a span length of 61.44 M. One hundred days later, a horizontal crack was observed right beneath the manual weld, which connected the semi-automatic welds on both sides of stiffener, at the end of the center stiffener of stringers on March 8, 1965 (Fig 4).

Fig 4 Crack at the end of the center stiffener

After the crack was revealed, the stringer was subjected to a test. Test result showed that, under the long-term action of train load, the metal pieces, which

were inserted in the gaps between the stiffener ends and flange, could hardly keep bearing tight against the flanges. It was obvious that this type of structural detail would not meet the design requirements. In such a case, the vibration frequency measured on point 1 and 2, near the lower end of the center stiffener, was about 30 HZ, this location produced great vibration as the train passed. The maximum alternate stress at point 1 was observed to be +45.6 and -31.0  $N/mm^2$ . However, when the bottom flange of the stringer and the bottom lateral bracing of the truss were held rigidly together, the vibration frequencies at point 1 and 2 were measured to be 40-50 HZ and the alternate stress reduced to less than  $\pm 4.9 N/mm^2$ .

Furthermore, out-of-plane deformation and angle of rotation are produced in the stringer under the action of train load. The additional flexural stresses were induced at the lower end of the vertical stiffener.

In addition to the above considerations, the welding technologies used for the vertical stiffeners of the stringers were unfit. Employing manual welding to connect the semi-automatic welds on both sides of the stiffener was apt to produce welding defects instead of any favourable effect. It may be concluded that the horizontal crack or under cut (even it was very fine) at the lower end of the vertical stiffener welds would propagate very fast under the action of the above-mentioned additional stresses.

Since the Langjiang Bridge accident, the constructional detail of the stiffener and the strut has been modified. The lower strut of cross brace, instead of being connected to the lower end of the vertical stiffener, was made to connect to the bottom flange of the stringer through gusset plate. Furthermore, 16Mn low alloy steel was used to make the stringers, the height of which was thus reduced from 1,450 to 1,290 MM. After these modifications, no fatigue problem has been encountered at this location.

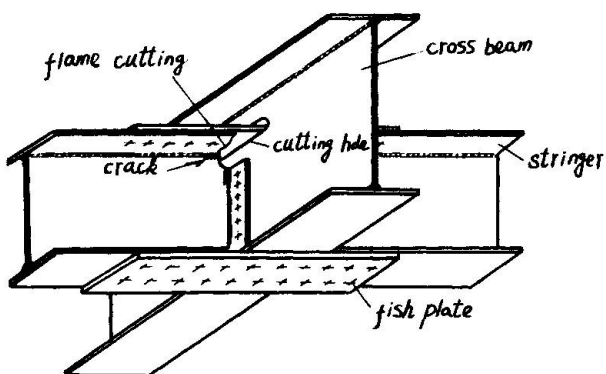
The Puyanjiang Bridge on the Hangzhou-Nanchang Railway Line is a half-through girder bridge with a total length of 166.9 M. The third span is 34.75 M in length. The girder was made in September, 1975 and opened to traffic in 1976. In July, 1979, the first crack was found at the toe of fillet weld of a stringer. Eleven cracks at similar locations of the bridge were found in latter inspection.

Fig 5 Cracks at the toe of filled welds of stringer flange and connecting plate between cross beam and stringer.

The most serious one appeared at the fillet weld near the end of the upper flange of the stringer in the 8th panel. The crack ran 25 MM along the toe line and then turned an angle of  $30^\circ$  into the web 17 MM (See Fig 5).

During manufacture, flame cutting of the flanges and the web was done in one operation. The cut face was not machined nor ground with disk sander. Its zigzagged outlook showed that the cutting quality was very poor and did not meet the need of design. Considering the location of the crack, its tendency and course of propagation, and the length of service time, it is quite possible that crack(1) owes its origin from the toe crack which developed under the effect of thermal

stress during flame cutting accompanied by a complicated state of residual stresses induced around the crack. As a result, under the train load, first of

all developed into the web plate, and then extended along the direction normal to the principal stress in the web.

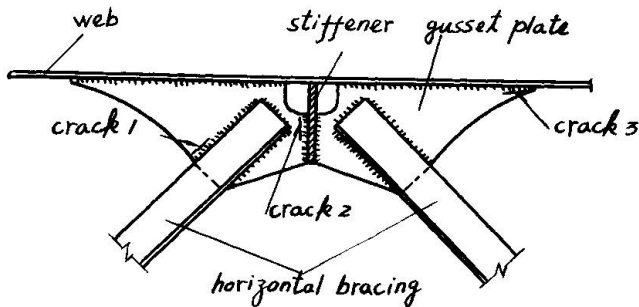
Fig 6 Cracks at the toes of fillet welds of the gusset plate of horizontal bracing

Fig 6 shows the cracks found at the welds of the gusset plates of the horizontal bracing on the deck girder bridges of 22.0 M span in the Shenyang Railway Administration. These bridges were erected after being fabricated in 1974-1975. Very soon thereafter, the cracks were generally found. During an overall inspection in April, 1976, cracks of this kind were found at as many as 29 places on five of the 22.0 M span girders on the No.3 Anshanhe Bridge on the Changchun-Dalian Railway Line. It was more

than four years from the cracks found up to now, they did not propagate. These cracks, in the main, were essentially welding cracks at the toe of weld.

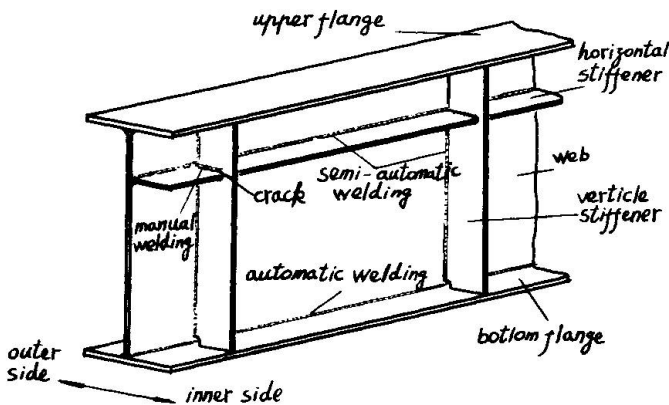
Fig 7 Cracks in the welds connecting horizontal and vertical stiffeners

Fig 7 shows the crack found at the toe of weld connecting the horizontal and vertical stiffeners on welded girder bridges. To avoid this kind of welding cracks, aside from that it is essential to select the right type of welding rod, to strictly control the baking temperature of the rod so as to reduce its hydrogen content, to reduce the assembly tolerance as much as possible, and to clear the steel plates of rust, it is also advisable to modify the structural details and to rearrange the welding sequence. The horizontal stiffener can be made with a whole piece of the same length as the web passing through the notches of the vertical stiffeners,

and weld up the stiffeners after assembling before other welds are done. An alternative is to leave the horizontal and vertical stiffeners unwelded as arranged in the above-mentioned manner.
