Zeitschrift: IABSE reports = Rapports AIPC = IVBH Berichte
Band: 37 (1982)

Artikel: Fatigue failures of steel railway bridges in China
Autor: Yongji, Shi / Zegan, Chen / Yenman, Yang
DOI: <https://doi.org/10.5169/seals-28950>

Fatigue Failures of Steel Railway Bridges in China

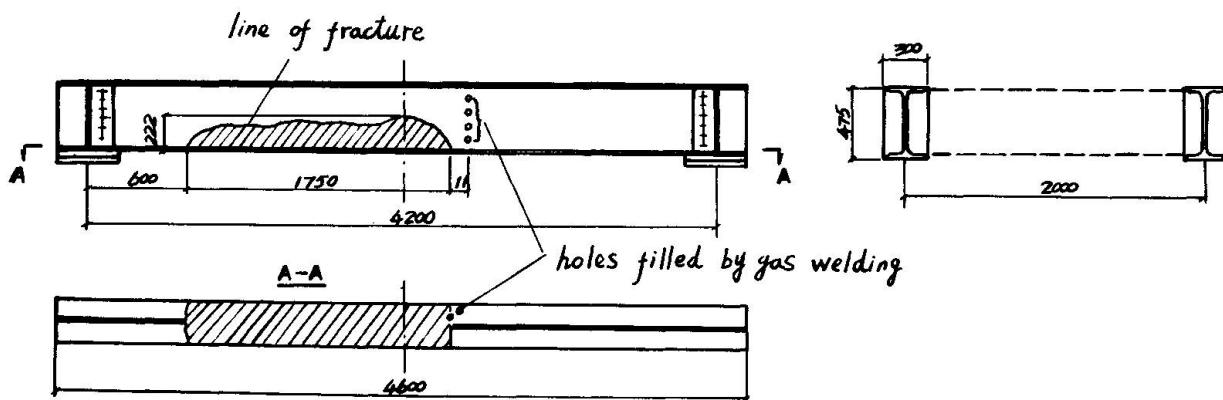
Fig 1 Sketch of the girder bridge No. 248 and its failure location

Bridge No. 248 on the Beijing-Baotou Railway Line was a rolled I-beam bridge which was manufactured in Britain in 1898 and erected in 1903. Its original length was 7 M and was cut down to 4.6 M in 1947 to be used as a simple span. There were four drilled holes of #19 on the webs and two on the bottom flanges. These holes were filled later by gas welding when it was cut. It so happened that at about 11 o'clock in the morning of November 30, 1967, after a heavy snow fall, a large piece of flange metal broke off together with a portion of the web. Fig 1 is a sketch of the girder and the failure location. Photo 1 is the fallen off piece. From the fracture surface, we could find that the weld quality was very poor. Under repeated action of train load through a long period of time, fatigue crack was initiated at the notch (Photo 2).

This accident once more teaches that direct repair welding on steel girders must be strictly forbidden. Otherwise it would be very much likely that weld defects or weld cracks should appear and deterioration, a decrease inductility in particular of the weld metal and the heat affected zone would happen. And these would certainly give rise for the formation of fatigue crack and brittle fracture. This is an important problem we must pay attention to in the reconstruction and maintenance of bridge in the future.

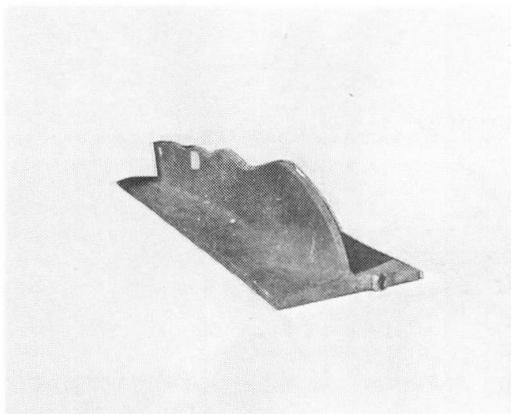
Photo 1 The fallen off metal of bridge No. 248

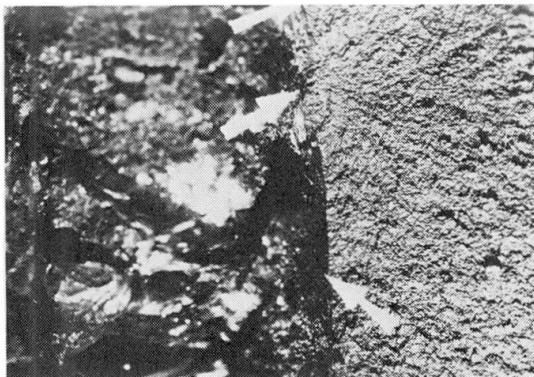
Photo 2 Fatigue crack at the notch of bridge No. 248

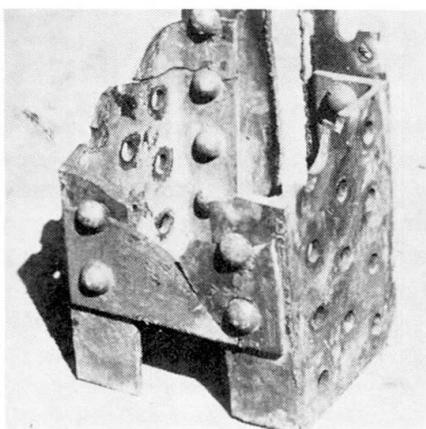
On March 23, 1973, the fracture occurred at the upper panel point of the first diagonal of the 16th truss built in 1930, with a span length of 33.54 M.

Photo 3 show the location of the fracture.

Photo 3 The form of the fracture member of Taizi River Bridge

Field investigation revealed that fatigue crack took place at an early stage in one of the diagonal channels. The other channel was pulled to break with obvious appearance of a bottleneck. The causes of the formation of the fatigue cracks are as follows:

At the time of design 50 years ago, the fatigue behaviour of the riveted joints was not clearly understood. The present train load and train load and train density (about 80 trains per day) on the bridge were much greater than those when the

bridge was first constructed. The lateral bracings were too weak, so the passing trains caused the truss to produce great vibration in the horizontal direction.

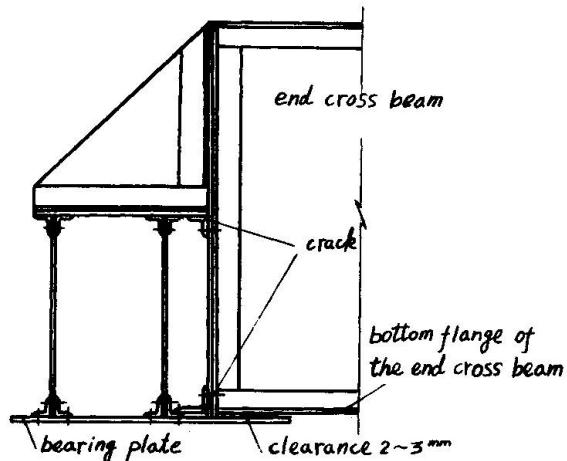
In Fig 2 is indicated the fatigue cracks occurring at the angles connecting the end cross beam and the main truss. In the original design, the bottom flange of the end cross beam was placed directly against the bearing plate so that the reaction force might be partly transmitted through the plate. However, after many years of operation, a gap of 2-3 MM was formed between the bottom flange of the cross beam and the top of the bearing plate, which had deformed and worn out. As a result, the line of transmission of the reaction force was so

altered that the stresses in the connecting angles were greatly increased. This was the major cause of the fatigue cracks.

Fig 2 Fatigue cracks occurring at the connecting angles

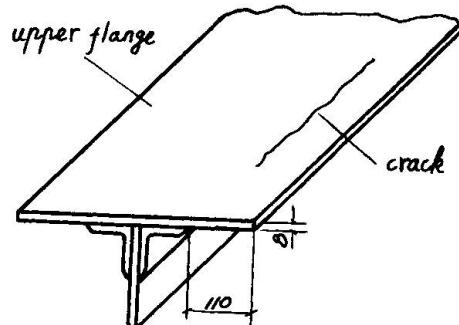
In some old-type riveted girders, both the upper and lower flange cover plates were provided in conformity to the moment diagram. Some of them often stopped at a distance from the bridge support. The flange plate between the support and stopped point was rather thin (8 MM only), but it cantilevered out as many as 110 MM (Fig 3). This was why longitudinal fatigue cracks often took place at this location. The two major causes of the formation of this longitudinal fatigue cracks are: (1) high impact forces under the direct train wheel load. (2) Transverse deflection of the upper flange induced by the vertical deforation of sleeper under train load. The beam action of sleepers on D.P.G. Bridges arose from a difference that existed between the center to center distance of the main girders which was 2 M and the gauge distance of the rails which was 1.435 M.

Fig 3 Crack on the upper flange

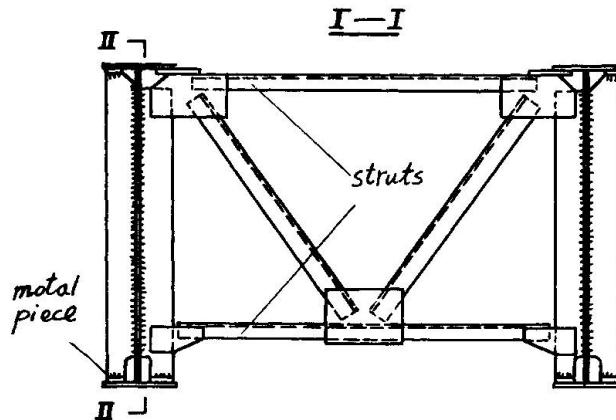
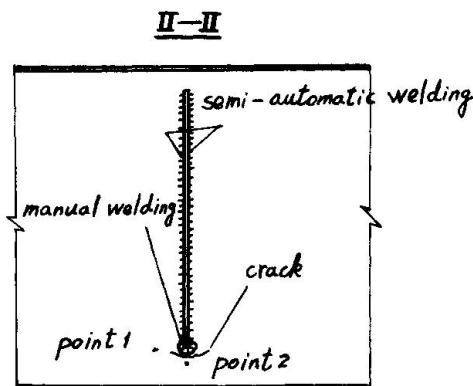
Liuzhou Railway Line, which was completed and opened to traffic on November 28, 1964, was the first bolt-weld railway through truss bridge using 16 Mn steel, with a span length of 61.44 M. One hundred days later, a horizontal crack was observed right beneath the manual weld, which connected the semi-automatic welds on both sides of stiffener, at the end of the center stiffener of stringers on March 8, 1965 (Fig 4).

Fig 4 Crack at the end of the center stiffener

After the crack was revealed, the stringer was subjected to a test. Test result showed that, under the long-term action of train load, the metal pieces, which

were inserted in the gaps between the stiffener ends and flange, could hardly keep bearing tight against the flanges. It was obvious that this type of structural detail would not meet the design requirements. In such a case, the vibration frequency measured on point 1 and 2, near the lower end of the center stiffener, was about 30 HZ, this location produced great vibration as the train passed. The maximum alternate stress at point 1 was observed to be ± 45.6 and -31.0 N/mm². However, when the bottom flange of the stringer and the bottom lateral bracing of the truss were held rigidly together, the vibration frequencies at point 1 and 2 were measured to be 40-50 HZ and the alternate stress reduced to less than ± 4.9 N/mm².

Furthermore, out-of-plane deformation and angle of rotation are produced in the stringer under the action of train load. The additional flexural stresses were induced at the lower end of the vertical stiffener.

In addition to the above considerations, the welding technologies used for the vertical stiffeners of the stringers were unfit. Employing manual welding to connect the semi-automatic welds on both sides of the stiffener was apt to produce welding defects instead of any favourable effect. It may be concluded that the horizontal crack or under cut (even it was very fine) at the lower end of the vertical stiffener welds would propagate very fast under the action of the above-mentioned additional stresses.

Since the Langjiang Bridge accident, the constructional detail of the stiffener and the strut has been modified. The lower strut of cross brace, instead of being connected to the lower end of the vertical stiffener, was made to connect to the bottom flange of the stringer through gusset plate. Furthermore, 16Mn low alloy steel was used to make the stringers, the height of which was thus reduced from 1,450 to 1,290 MM. After these modifications, no fatigue problem has been encountered at this location.

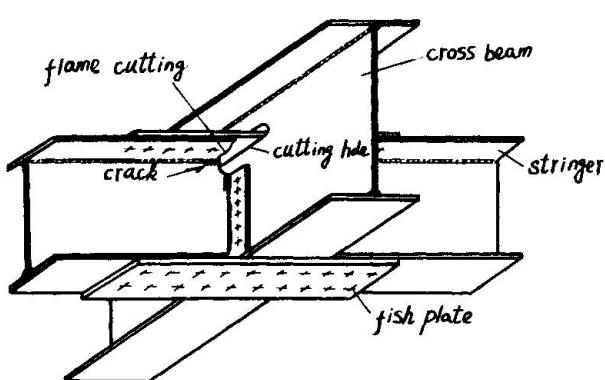
The most serious one appeared at the fillet weld near the end of the upper flange of the stringer in the 8th panel. The crack ran 25 MM along the toe line and then turned an angle of 30° into the web 17 MM (See Fig 5).

Fig 5 Cracks at the toe of filled welds of stringer flange and connecting plate between cross beam and stringer.

During manufacture, flame cutting of the flanges and the web was done in one operation. The cut face was not machined nor ground with disk sander. Its zigzagged outlook showed that the cutting quality was very poor and did not meet the need of design. Considering the location of the crack, its tendency and course of propagation, and the length of service time, it is quite possible that crack(1) owes its origin from the toe crack which developed under the effect of thermal

stress during flame cutting accompanied by a complicated state of residual stresses induced around the crack. As a result, under the train load, first of

all developed into the web plate, and then extended along the direction normal to the principal stress in the web.

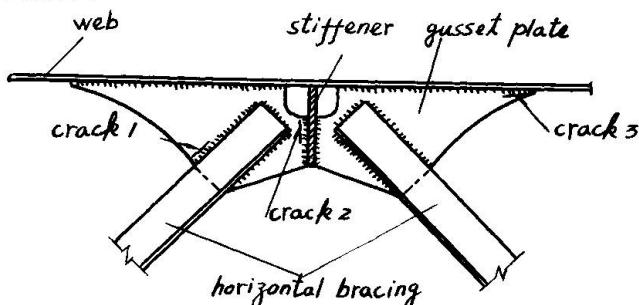
Fig 6 Cracks at the toes of fillet welds of the gusset plate of horizontal bracing

than four years from the cracks found up to now, they did not propagate. These cracks, in the main, were essentially welding cracks at the toe of weld.

Fig 6 shows the cracks found at the welds of the gusset plates of the horizontal bracing on the deck girder bridges of 22.0 M span in the Shenyang Railway Administration. These bridges were erected after being fabricated in 1974-1975. Very soon thereafter, the cracks were generally found. During an overall inspection in April, 1976, cracks of this kind were found at as many as 29 places on five of the 22.0 M span girders on the No.3 Anshanhe Bridge on the Changchun-Dalian Railway Line. It was more

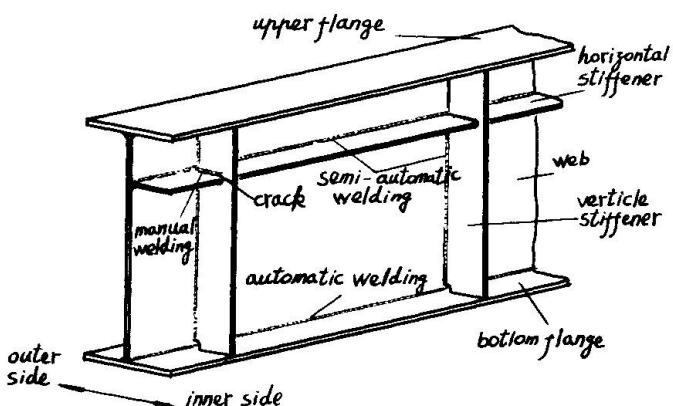
Fig 7 Cracks in the welds connecting horizontal and vertical stiffeners

Fig 7 shows the crack found at the toe of weld connecting the horizontal and vertical stiffeners on welded deck girder bridges. To avoid this kind of welding cracks, aside from that it is essential to select the right type of welding rod, to strictly control the baking temperature of the rod so as to reduce its hydrogen content, to reduce the assembly tolerance as much as possible, and to clear the steel plates of rust, it is also advisable to modify the structural details and to rearrange the welding sequence. The horizontal stiffener can be made with a whole piece of the same length as the web passing through the notches of the vertical stiffeners,

and weld up the stiffeners after assembling before other welds are done. An alternative is to leave the horizontal and vertical stiffeners unwelded as arranged in the above-mentioned manner.
