Artikel: Fatigue failures of steel railway bridges in China

Fatigue Failures of Steel Railway Bridges in China

SHI YONGJI

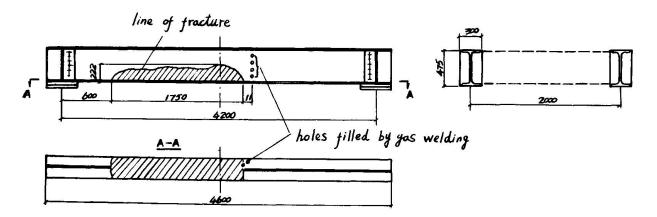
Fig 1 Sketch of the girder bridge No. 248 and its failure location

Bridge No. 248 on the Beijing-Baotou Railway Line was a rolled I-beam bridge which was manufactured in Britain in 1898 and erected in 1903. Its original length was 7 M and was cut down to 4.6 M in 1947 to be used as a simple span. There were four drilled holes of \$19 on the webs and two on the bottom flanges. These holes were filled later by gas welding when it was cut. It so happened that at about 11 o'clock in the mroning of November 30, 1967, after a heavy snow fall, a large piece of flange metal broke off together with a portion of the web. Fig 1 is a sketch of the girder and the failure location. Photo 1 is the fallen off piece. From the fracture surface, we could find that the weld quality was very poor. Under repeated action of train load through a long period of time, fatique crack was initiated at the notch (Photo 2).

Samples were taken from the girder for chemical analysis and mechanical test. The steel strength was equivalent to that of the carbon steel but was high in S, P and N content which made it difficult for welding. The ductility of the material at low temperature was rather poor and the ageing effect tendency was quite strong. U-notch impact test showed that the brittleness transition temperature was about $+15^{\circ}\text{C} - 0^{\circ}\text{C}$.

This accident once more teaches that direct repair welding on steel girders must be strictly forbidden. Otherwise it would be very much likely that weld defects or weld cracks should appear and deterioration, a decrease in ductility in particular of the weld metal and the heat affected zone would happen. And these would certainly give rise for the formation of fatigue crack and brittle fracture. This is an important problem we must pay attention to in the reconstruction and maintenance of bridge in the future.

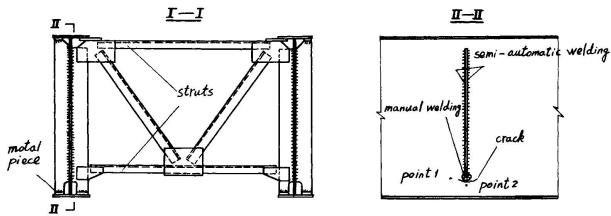
Fig 4 Crack at the end of the center stiffener

Liuzhou Railway Line, which was completed and opened to traffic on November 28, 1964, was the first bolt-weld railway through truss bridge using 16 Mn steel, with a span length of 61.44 M. One hundred days later, a horizontal crack was observed right beneath the manual weld, which connected the semi-automatic welds on both sides of stiffener, at the end of the center stiffener of stringers on March 8, 1965 (Fig 4).

After the crack was revealed, the stringer was subjected to a test. showed that, under the long-term action of train load, the metal pieces, which

were inserted in the gaps between the stiffener ends and flange, could hardly keep bearing tight against the flanges. It was obvious that this type of structural detail would not meet the design requirements. In such a case, the vibration frequency measured on point 1 and 2, near the lower end of the center stiffener, was about 30 Hz, this location produced great vibration as the train passed. The maximum alternate stress at point 1 was observed to be +45.6 and -31.0 N/mm². However, when the bottom flange of the stringer and the bottom lateral bracing of the truss were held rigidly togather, the vibration frequencies at point 1 and 2 were measured to be 40-50 Hz and the alternate stress reduced to less than ±4.9 N/mm².

Furthermore, out-of-plane deformation and angle of rotation are produced in the stringer under the action of train load. The additional flexural stresses were induced at the lower end of the vertical stiffener.

In addition to the above considerations, the welding technologies used for the vertical stiffeners of the stringers were unfit. Employing manual welding to connect the semi-automatic welds on both sides of the stiffener was apt to produce welding defects instead of any favourable effect. It may be concluded that the horizontal crack or under cut (even it was very fine) at the lower end of the vertical stiffener welds would propagate very fast under the action of the above-mentioned additional stresses.

Since the Langjiang Bridge accident, the constructional detail of the stiffener and the strut hastbeen modified. The lower strut of cross brace, instead of being connected to the lower end of the vertical stiffener, was made to connect to the bottom flange of the stringer through gussest plate. Furthermore, 16Mn low alloy steel was used to make the stringers, the height of which was thus reduced from 1,450 to 1,290 MM. After these modifications, no fatigue problem has been encountered at this location.
