Artikel: Fatigue failures of steel railway bridges in China
Autor: Yongji, Shi / Zegan, Chen / Yenman, Yang
DOI: <https://doi.org/10.5169/seals-28950>

Fatigue Failures of Steel Railway Bridges in China

SHI YONGJI

This paper briefly describes the basic conditions of steel bridges on Chinese railway lines including their date of construction and the materials, technology and specifications used. Fatigue cracks are classified according to the age of the bridge at the time of their detection and then their causes analysed. Finally, examples are given of fatigue failure in bridges from every period of construction.

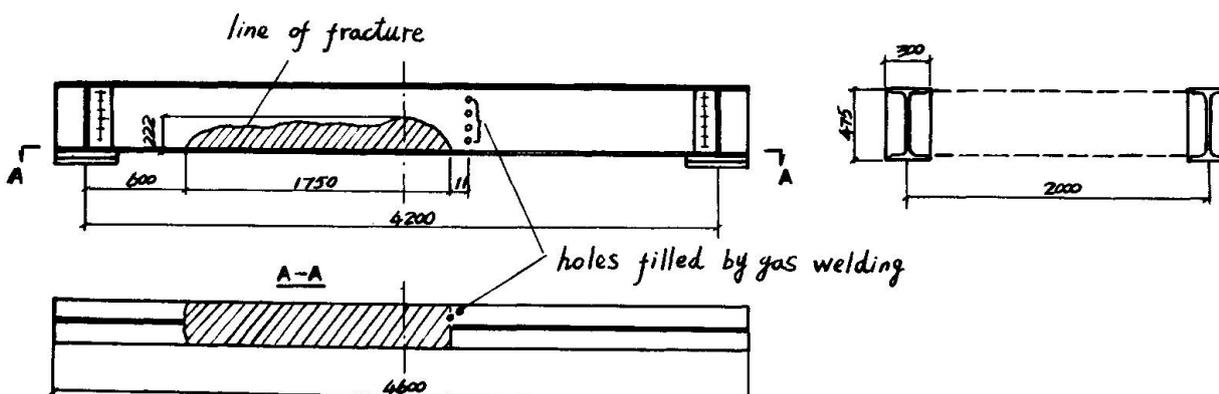
Bridge No. 248 on the Beijing-Baotou Railway Line was a rolled I-beam bridge which was manufactured in Britain in 1898 and erected in 1903. Its original length was 7 M and was cut down to 4.6 M in 1947 to be used as a simple span. There were four drilled holes of $\phi 19$ on the webs and two on the bottom flanges. These holes were filled later by gas welding when it was cut. It so happened that at about 11 o'clock in the morning of November 30, 1967, after a heavy snow fall, a large piece of flange metal broke off together with a portion of the web. Fig 1 is a sketch of the girder and the failure location. Photo 1 is the fallen off piece. From the fracture surface, we could find that the weld quality was very poor. Under repeated action of train load through a long period of time, fatigue crack was initiated at the notch (Photo 2).

Fig 1 Sketch of the girder bridge No. 248 and its failure location

Samples were taken from the girder for chemical analysis and mechanical test. The steel strength was equivalent to that of the carbon steel but was high in S, P and N content which made it difficult for welding. The ductility of the material at low temperature was rather poor and the ageing effect tendency was quite strong. U-notch impact test showed that the brittleness transition temperature was about $+15^{\circ}\text{C} - 0^{\circ}\text{C}$.

This accident once more teaches that direct repair welding on steel girders must be strictly forbidden. Otherwise it would be very much likely that weld defects or weld cracks should appear and deterioration, a decrease in ductility in particular of the weld metal and the heat affected zone would happen. And these would certainly give rise for the formation of fatigue crack and brittle fracture. This is an important problem we must pay attention to in the reconstruction and maintenance of bridge in the future.

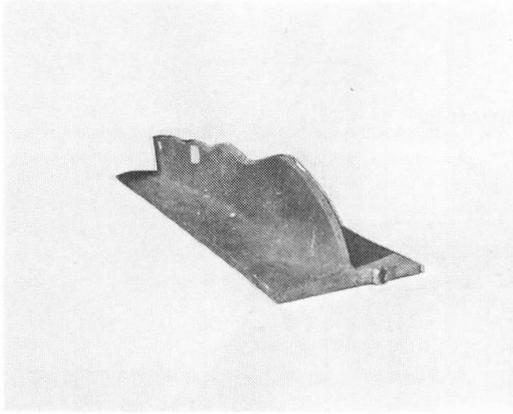
Photo 1 The fallen off metal of bridge No. 248

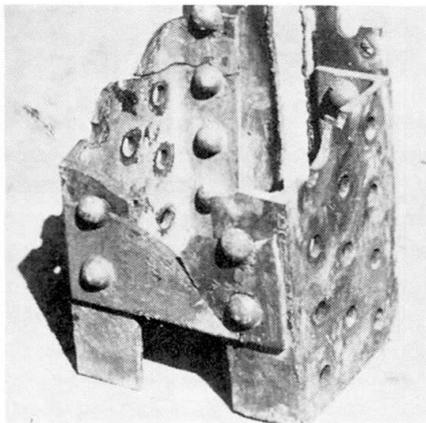
On March 23, 1973, the fracture occurred at the upper panel point of the first diagonal of the 16th truss built in 1930, with a span length of 33.54 M.

Photo 3 The form of the fracture member of Taizi River Bridge

Field investigation revealed that fatigue crack took place at an early stage in one of the diagonal channels. The other channel was pulled to break with obvious appearance of a bottleneck. The causes of the formation of the fatigue cracks are as follows:

At the time of design 50 years ago, the fatigue behaviour of the riveted joints was not clearly understood. The present train load and train load and train density (about 80 trains per day) on the bridge were much greater than those when the

bridge was first constructed. The lateral bracings were too weak, so the passing trains caused the truss to produce great vibration in the horizontal direction.

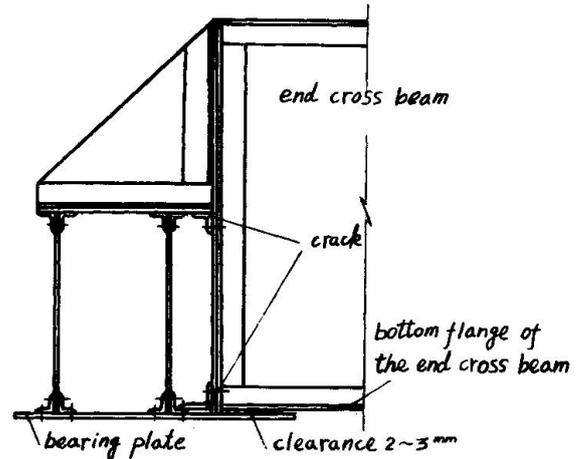
In Fig 2 is indicated the fatigue cracks occurring at the angles connecting the end cross beam and the main truss. In the original design, the bottom flange of the end cross beam was placed directly against the bearing plate so that the reaction force might be partly transmitted through the plate. However, after many years of operation, a gap of 2-3 MM was formed between the bottom flange of the cross beam and the top of the bearing plate, which had deformed and worn out. As a result, the line of transmission of the reaction force was so

altered that the stresses in the connecting angles were greatly increased. This was the major cause of the fatigue cracks.

Fig 2 Fatigue cracks occurring at the connecting angles

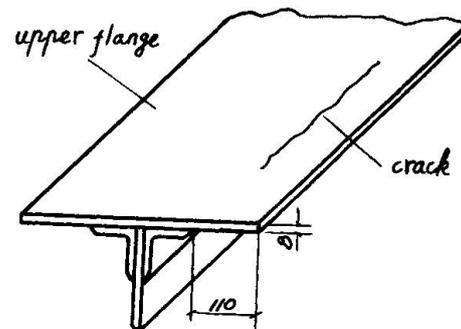
In some old-type riveted girders, both the upper and lower flange cover plates were provided in conformity to the moment diagram. Some of them often stopped at a distance from the bridge support. The flange plate between the support and stopped point was rather thin (8 MM only), but it cantilevered out as many as 110 MM (Fig 3). This was why longitudinal fatigue cracks often took place at this location. The two major causes of the formation of this longitudinal fatigue cracks are: (1) high impact forces under the direct train wheel load. (2) Transverse deflection of the upper flange induced by the vertical deformation of sleeper under train load. The beam action of sleepers on D.P.G. Bridges arose from a difference that existed between the center to center distance of the main girders which was 2 M and the gauge distance of the rails which was 1.435 M.

Fig 3 Crack on the upper flange

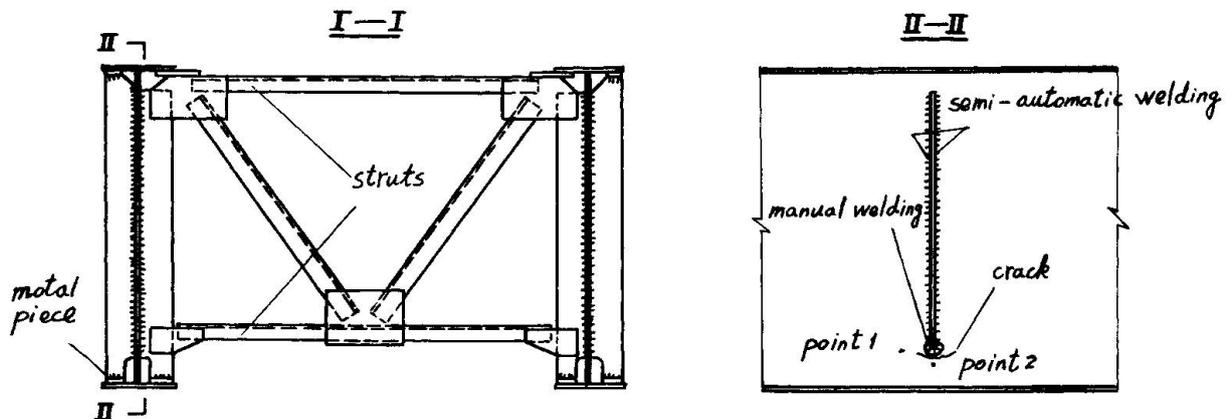
Langjiang Bridge on the Changsha - Liuzhou Railway Line, which was completed and opened to traffic on November 28, 1964, was the first bolt-weld railway through truss bridge using 16 Mn steel, with a span length of 61.44 M. One hundred days later, a horizontal crack was observed right beneath the manual weld, which connected the semi-automatic welds on both sides of stiffener, at the end of the center stiffener of stringers on March 8, 1965 (Fig 4).

Fig 4 Crack at the end of the center stiffener

were inserted in the gaps between the stiffener ends and flange, could hardly keep bearing tight against the flanges. It was obvious that this type of structural detail would not meet the design requirements. In such a case, the vibration frequency measured on point 1 and 2, near the lower end of the center stiffener, was about 30 HZ, this location produced great vibration as the train passed. The maximum alternate stress at point 1 was observed to be +45.6 and -31.0 N/mm^2 . However, when the bottom flange of the stringer and the bottom lateral bracing of the truss were held rigidly together, the vibration frequencies at point 1 and 2 were measured to be 40-50 HZ and the alternate stress reduced to less than $\pm 4.9 N/mm^2$.

Furthermore, out-of-plane deformation and angle of rotation are produced in the stringer under the action of train load. The additional flexural stresses were induced at the lower end of the vertical stiffener.

In addition to the above considerations, the welding technologies used for the vertical stiffeners of the stringers were unfit. Employing manual welding to connect the semi-automatic welds on both sides of the stiffener was apt to produce welding defects instead of any favourable effect. It may be concluded that the horizontal crack or under cut (even it was very fine) at the lower end of the vertical stiffener welds would propagate very fast under the action of the above-mentioned additional stresses.

Since the Langjiang Bridge accident, the constructional detail of the stiffener and the strut has been modified. The lower strut of cross brace, instead of being connected to the lower end of the vertical stiffener, was made to connect to the bottom flange of the stringer through gusset plate. Furthermore, 16Mn low alloy steel was used to make the stringers, the height of which was thus reduced from 1,450 to 1,290 MM. After these modifications, no fatigue problem has been encountered at this location.

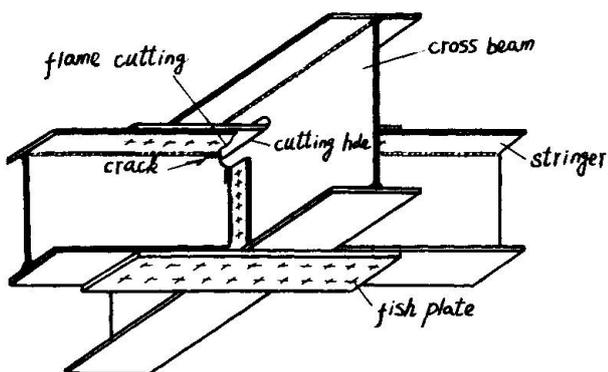
Fig 5 Cracks at the toe of filled welds of stringer flange and connecting plate between cross beam and stringer.

The most serious one appeared at the fillet weld near the end of the upper flange of the stringer in the 8th panel. The crack ran 25 MM along the toe line and then turned an angle of 30° into the web 17 MM (See Fig 5).

During manufacture, flame cutting of the flanges and the web was done in one operation. The cut face was not machined nor ground with disk sander. Its zigzagged outlook showed that the cutting quality was very poor and did not meet the need of design. Considering the location of the crack, its tendency and course of propagation, and the length of service time, it is quite possible that crack(1) owes its origin from the toe crack which developed under the effect of thermal

stress during flame cutting accompanied by a complicated state of residual stresses induced around the crack. As a result, under the train load, first of

all developed into the web plate, and then extended along the direction normal to the principal stress in the web.

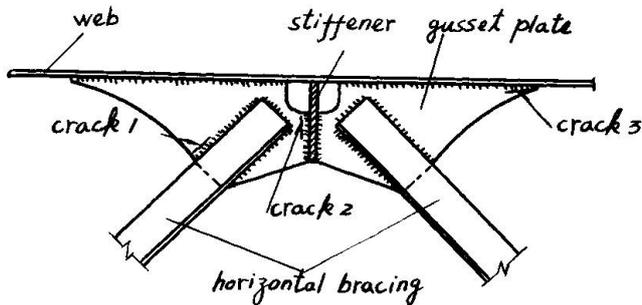
Fig 6 Cracks at the toes of fillet welds of the gusset plate of horizontal bracing

Fig 6 shows the cracks found at the welds of the gusset plates of the horizontal bracing on the deck girder bridges of 22.0 M span in the Shenyang Railway Administration. These bridges were erected after being fabricated in 1974-1975. Very soon thereafter, the cracks were generally found. During an overall inspection in April, 1976, cracks of this kind were found at as many as 29 places on five of the 22.0 M span girders on the No.3 Anshanhe Bridge on the Changchun-Dalian Railway Line. It was more

than four years from the cracks found up to now, they did not propagate. These cracks, in the main, were essentially welding cracks at the toe of weld.

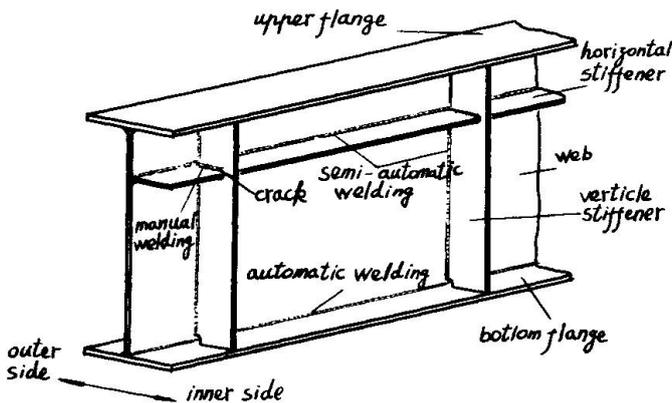
Fig 7 Cracks in the welds connecting horizontal and vertical stiffeners

Fig 7 shows the crack found at the toe of weld connecting the horizontal and vertical stiffeners on welded girder bridges. To avoid this kind of welding cracks, aside from that it is essential to select the right type of welding rod, to strictly control the baking temperature of the rod so as to reduce its hydrogen content, to reduce the assembly tolerance as much as possible, and to clear the steel plates of rust, it is also advisable to modify the structural details and to rearrange the welding sequence. The horizontal stiffener can be made with a whole piece of the same length as the web passing through the notches of the vertical stiffeners,

and weld up the stiffeners after assembling before other welds are done. An alternative is to leave the horizontal and vertical stiffeners unwelded as arranged in the above-mentioned manner.
