Zeitschrift: IABSE reports = Rapports AIPC = IVBH Berichte
Band: 37 (1982)

Artikel: Fatigue failures of steel railway bridges in China
Autor: Yongji, Shi / Zegan, Chen / Yenman, Yang
DOI: <https://doi.org/10.5169/seals-28950>

Fatigue Failures of Steel Railway Bridges in China

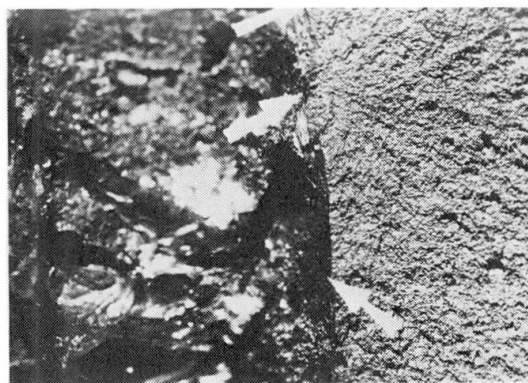
Photo 2 Fatigue crack at the notch of bridge No. 248

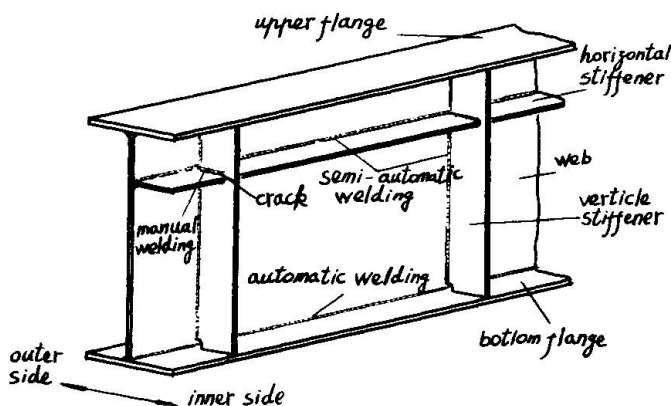
Fig 7 Cracks in the welds connecting horizontal and vertical stiffeners

Fig 7 shows the crack found at the toe of weld connecting the horizontal and vertical stiffeners on welded deck girder bridges. To avoid this kind of welding cracks, aside from that it is essential to select the right type of welding rod, to strictly control the baking temperature of the rod so as to reduce its hydrogen content, to reduce the assembly tolerance as much as possible, and to clear the steel plates of rust, it is also advisable to modify the structural details and to rearrange the welding sequence. The horizontal stiffener can be made with a whole piece of the same length as the web passing through the notches of the vertical stiffeners,

and weld up the stiffeners after assembling before other welds are done. An alternative is to leave the horizontal and vertical stiffeners unwelded as arranged in the above-mentioned manner.
