**Artikel:** Fatigue cracking in two steel bridges  
**Autor:** Chatterjee, S. / Dawe, P.H.  
**DOI:** <https://doi.org/10.5169/seals-28951>

## Fatigue Cracking in Two Steel Bridges

### S. CHATTERJEE

### P.H. DAWE

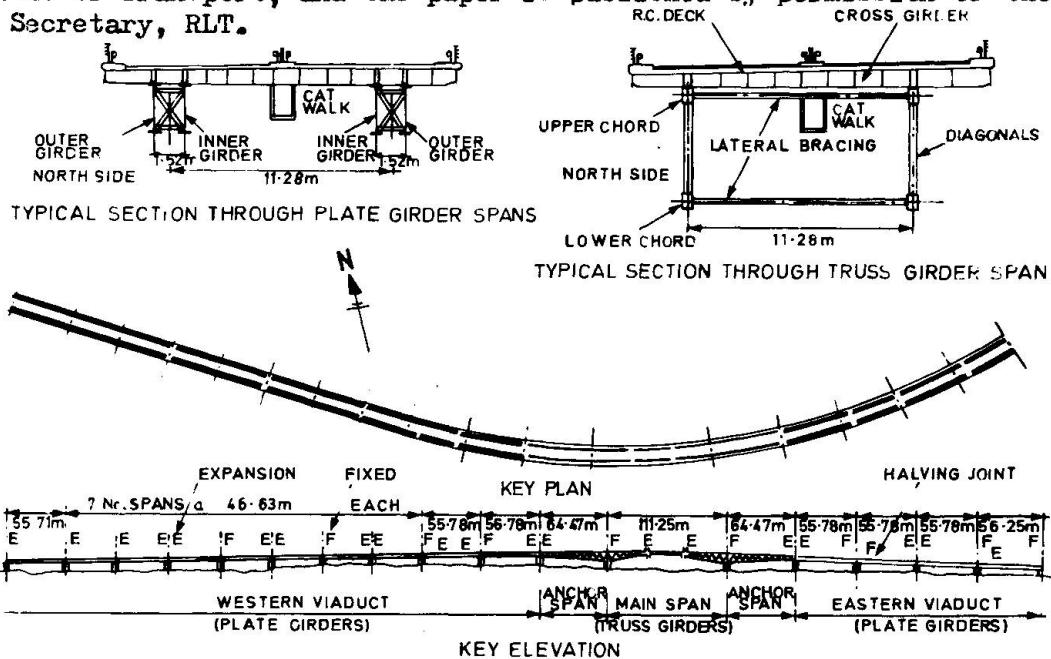
FIG. 1.

An earlier survey had revealed cracks at the top of many of the cross-girder bearing stiffeners at the extremities of the toe of the fillet weld to the top flange. The report on the inspection attributed the cracks to fatigue and noted that their length and number appeared to be increasing and that they were also present at the bottom flange as well. Following this inspection the maintenance authority conducted a visual survey of all the bearing stiffener welds throughout the structure.

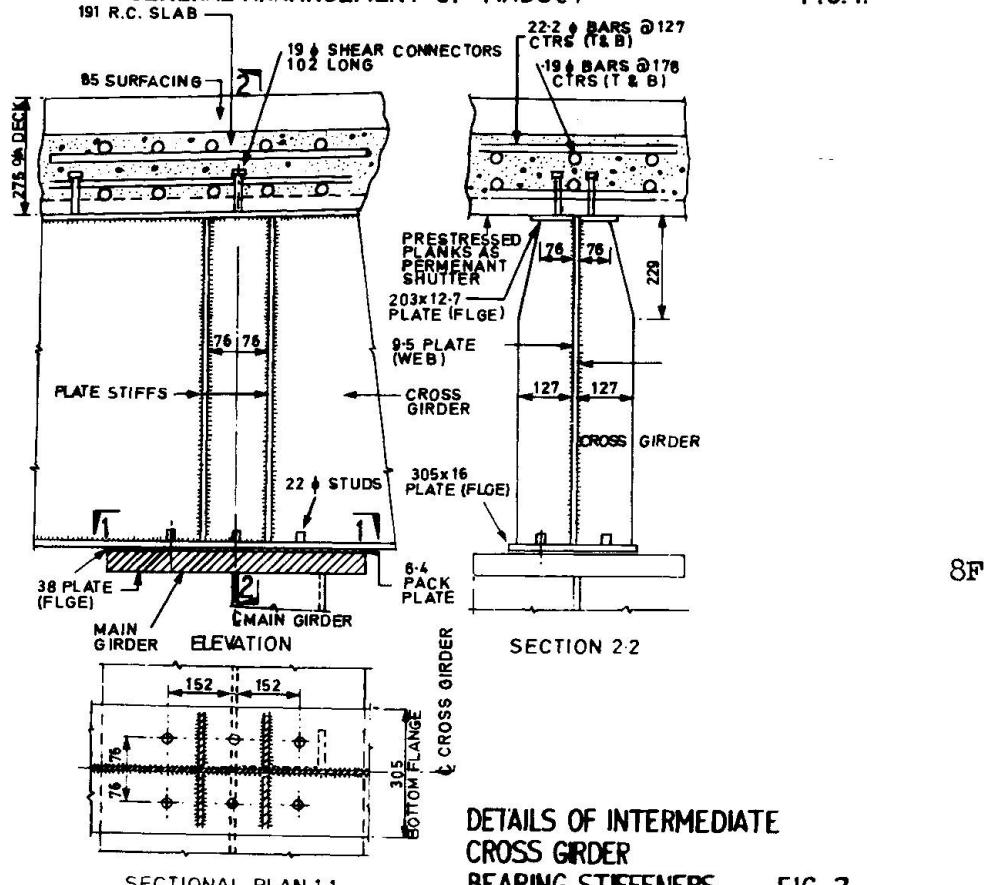
FIG. 2.

DETAILS OF INTERMEDIATE  
CROSS GIRDER  
BEARING STIFFENERS

In the event it was decided to carry out trials on some of the spans using the former approach with the results being monitored. The existing fillet welds were cut out and replaced by full penetration butt welds. It was envisaged that the heavier weld would not only improve the fatigue life of the joint but would distort the flanges of the cross-girders sufficiently to pull the edges away from the concrete deck slab and the main girders and thus remove the load path from the stiffener tips. The repairs have been carried out and the resulting strains and differential movements are being monitored so that the effectiveness of the repairs can be assessed.

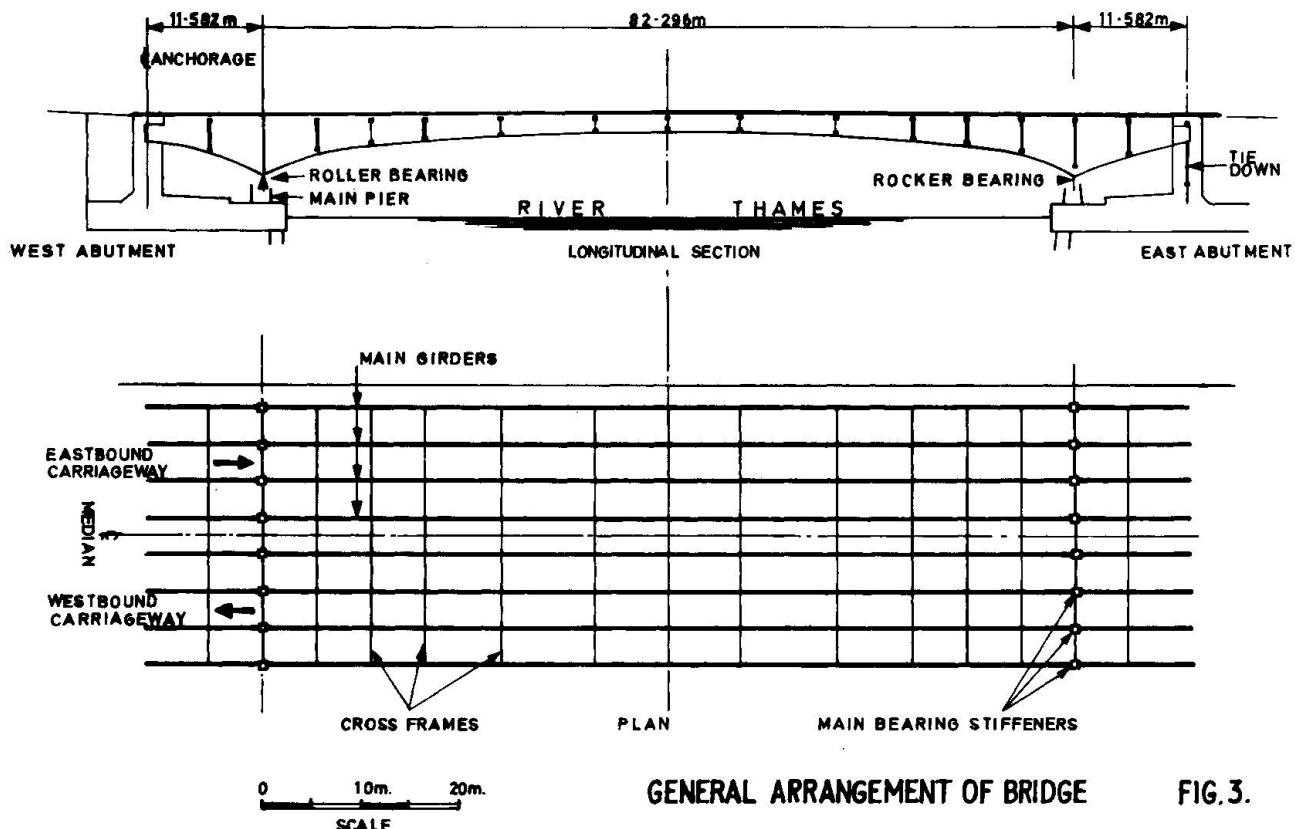
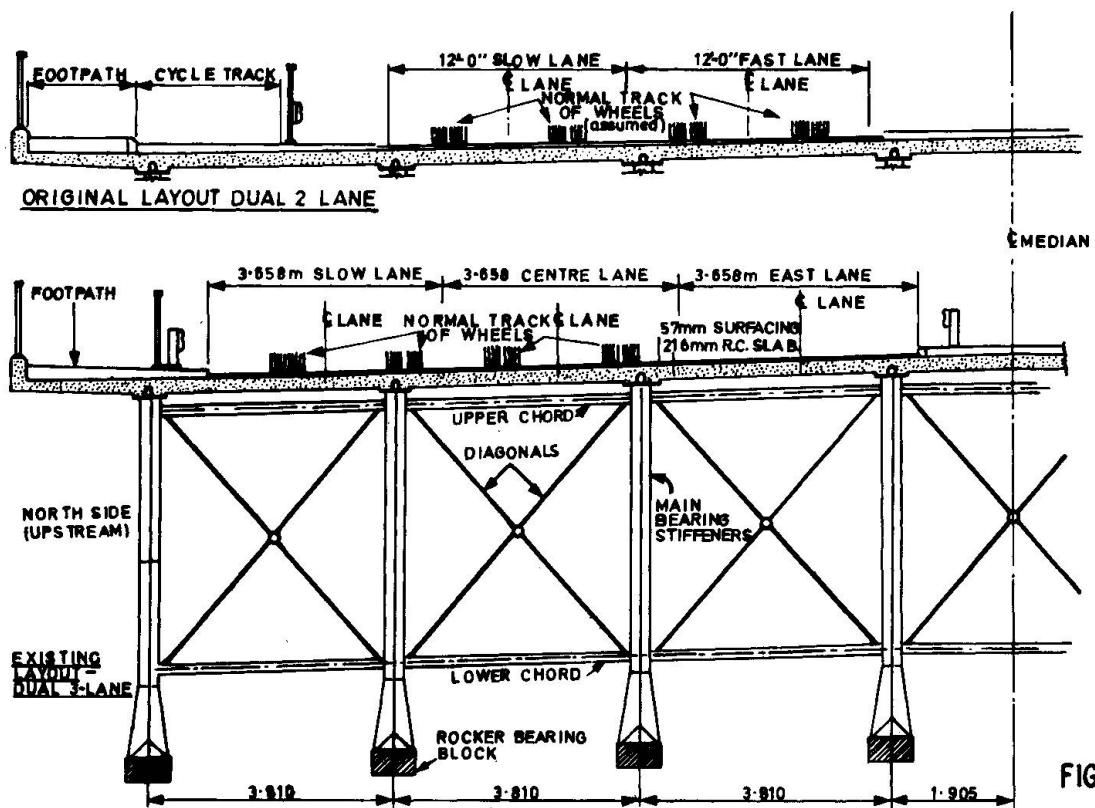
CROSS-SECTION THROUGH SUPERSTRUCTURE AT PIER UNDER EASTBOUND CARRIAGEWAY

The original sample survey covered 8 out of the 16 bearing stiffeners and in 3 cases revealed cracks at the toe of the fillet weld connecting the bearing stiffener to the top main flange. Some cracks were also discovered lower down the stiffeners where temporary erection cleats had been welded to facilitate the erection of the cross-bracing. A subsequent more comprehensive inspection revealed another 4 cases of toe cracks at the top of the bearing stiffeners. A sample was cut from one of the cracked welds and subjected to microscopic examination; the results indicated that the cracking was due to fatigue and it was considered that it was probably due to rotations of the deck slab over each girder under wheel loading.

Although various remedial measures were considered, including repairing the cracks by replacement welds with increased throat thickness, such a method of repair was rejected in favour of some form of deck stiffening aimed at reducing the deck rotations and consequent bearing stiffener weld stresses. The repair method adopted consisted of providing twin lines of universal beams to support the deck on both sides of the pier supports. These UB were fixed to the webs of the main girders by means of bolted cleats. The beams were fixed to the slab at mid-span by means of anchor bolts set in resin which were bolted to plates welded to the top flange of the beams. Additionally a similar connection was made between the top boom of the existing cross-bracing and the underneath of the deck slab (at the line at the pier supports). No repair was done to the cracked welds due to the risks involved in attempting such an operation on a highly stressed tension flange.
