Artikel: Fatigue cracking in two steel bridges
Autor: Chatterjee, S. / Dawe, P.H.
DOI: <https://doi.org/10.5169/seals-28951>

Fatigue Cracking in Two Steel Bridges

S. CHATTERJEE

P.H. DAWE

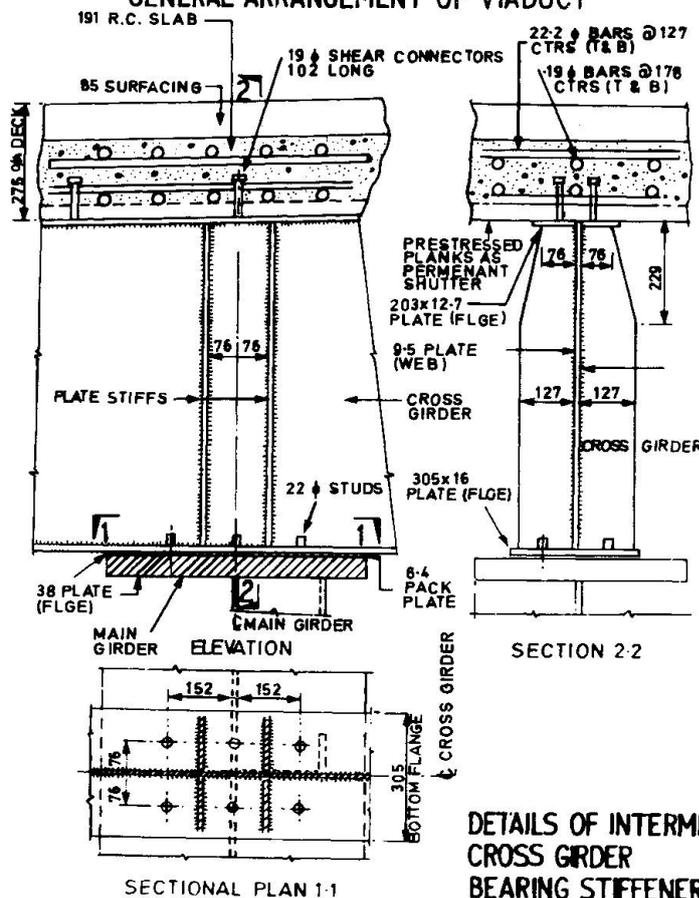
FIG. 2.

An earlier survey had revealed cracks at the top of many of the cross-girder bearing stiffeners at the extremities of the toe of the fillet weld to the top flange. The report on the inspection attributed the cracks to fatigue and noted that their length and number appeared to be increasing and that they were also present at the bottom flange as well. Following this inspection the maintenance authority conducted a visual survey of all the bearing stiffener welds throughout the structure.

DETAILS OF INTERMEDIATE CROSS GIRDER BEARING STIFFENERS

In the event it was decided to carry out trials on some of the spans using the former approach with the results being monitored. The existing fillet welds were cut out and replaced by full penetration butt welds. It was envisaged that the heavier weld would not only improve the fatigue life of the joint but would distort the flanges of the cross-girders sufficiently to pull the edges away from the concrete deck slab and the main girders and thus remove the load path from the stiffener tips. The repairs have been carried out and the resulting strains and differential movements are being monitored so that the effectiveness of the repairs can be assessed.

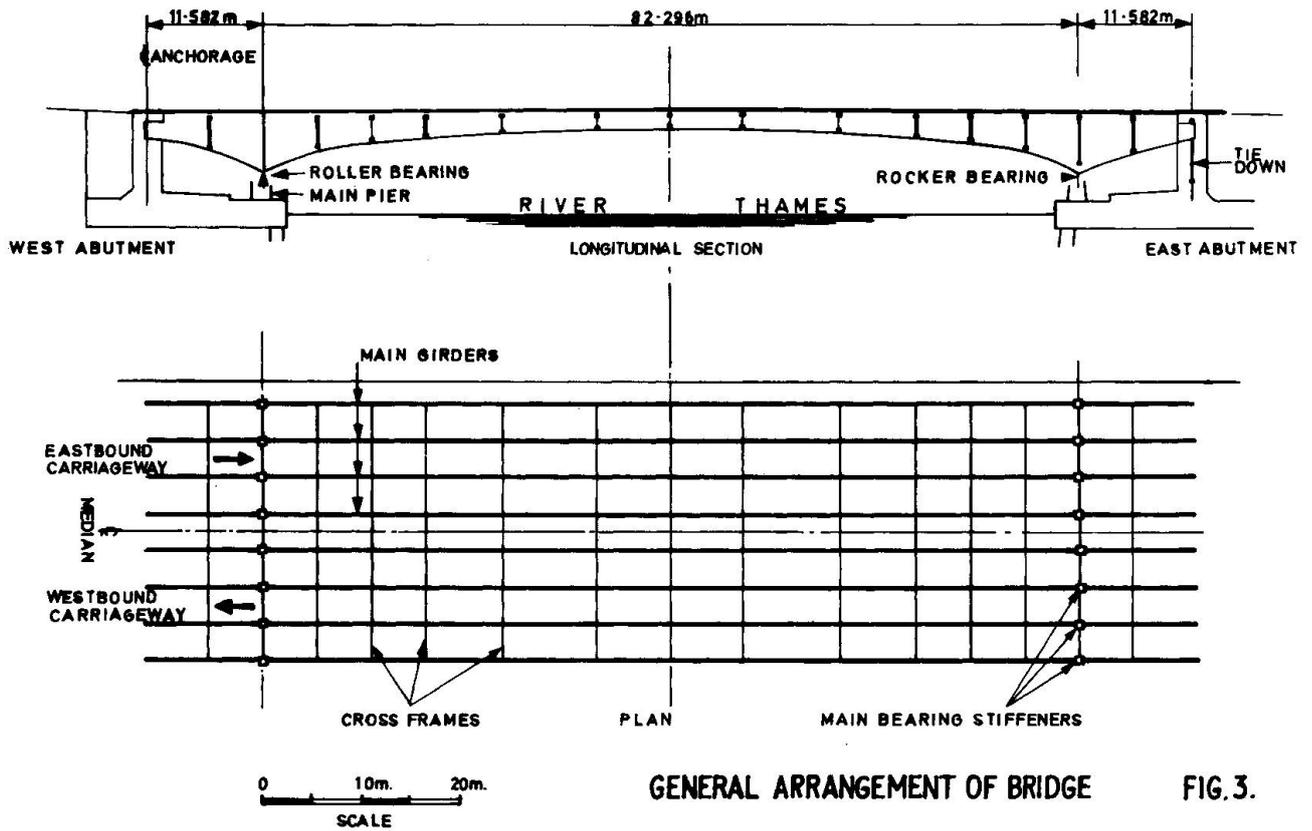
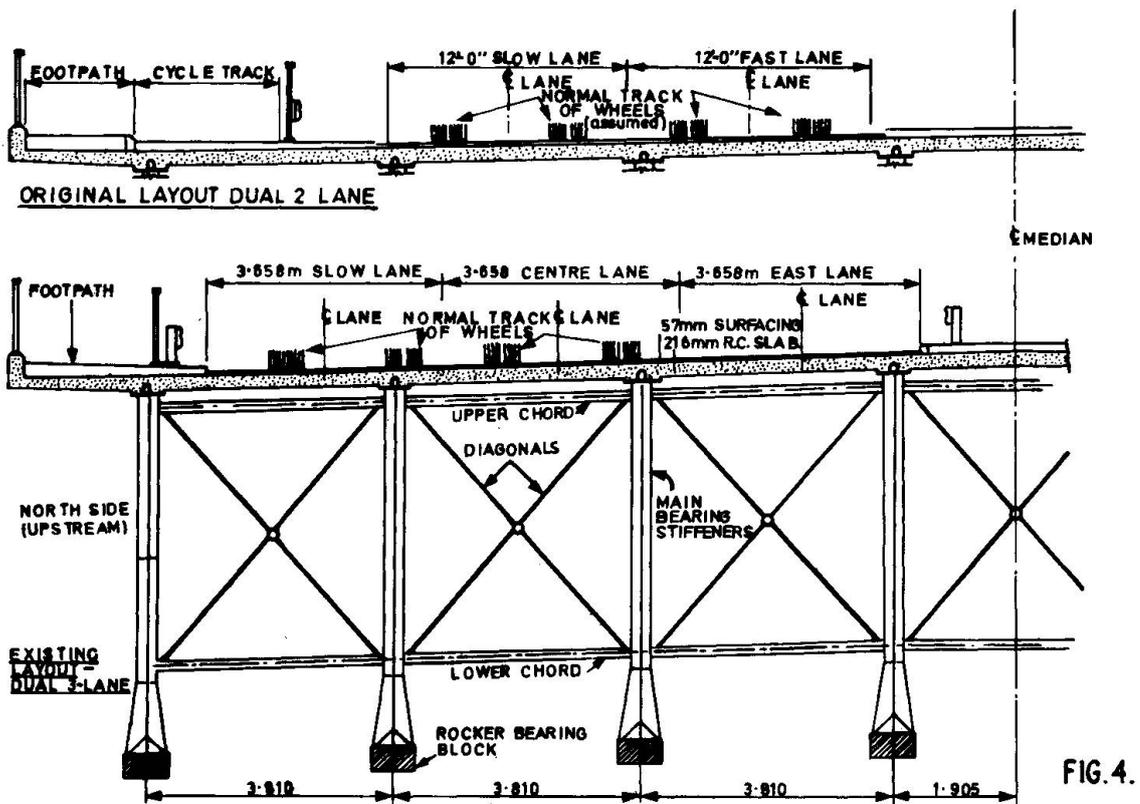
The original sample survey covered 8 out of the 16 bearing stiffeners and in 3 cases revealed cracks at the toe of the fillet weld connecting the bearing stiffener to the top main flange. Some cracks were also discovered lower down the stiffeners where temporary erection cleats had been welded to facilitate the erection of the cross-bracing. A subsequent more comprehensive inspection revealed another 4 cases of toe cracks at the top of the bearing stiffeners. A sample was cut from one of the cracked welds and subjected to microscopic examination; the results indicated that the cracking was due to fatigue and it was considered that it was probably due to rotations of the deck slab over each girder under wheel loading.

CROSS-SECTION THROUGH SUPERSTRUCTURE AT PIER UNDER EASTBOUND CARRIAGEWAY

Although various remedial measures were considered, including repairing the cracks by replacement welds with increased throat thickness, such a method of repair was rejected in favour of some form of deck stiffening aimed at reducing the deck rotations and consequent bearing stiffener weld stresses. The repair method adopted consisted of providing twin lines of universal beams to support the deck on both sides of the pier supports. These UB were fixed to the webs of the main girders by means of bolted cleats. The beams were fixed to the slab at mid-span by means of anchor bolts set in resin which were bolted to plates welded to the top flange of the beams. Additionally a similar connection was made between the top boom of the existing cross-bracing and the underneath of the deck slab (at the line at the pier supports). No repair was done to the cracked welds due to the risks involved in attempting such an operation on a highly stressed tension flange.
