Artikel: Fatigue cracking in two steel bridges
Autor: Chatterjee, S. / Dawe, P.H.
DOI: <https://doi.org/10.5169/seals-28951>

Fatigue Cracking in Two Steel Bridges

S. CHATTERJEE

P.H. DAWE

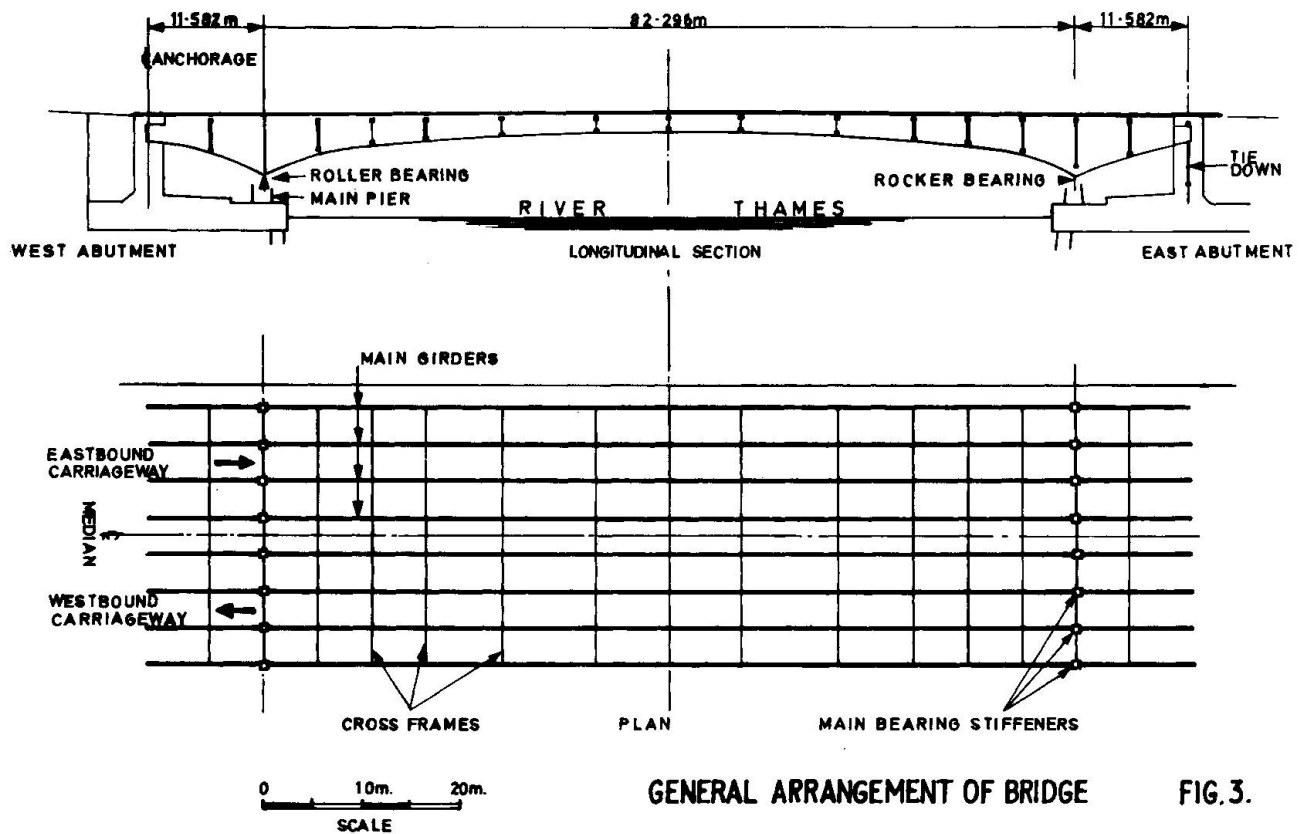
FIG.3.

An earlier survey had revealed cracks at the top of many of the cross-girder bearing stiffeners at the extremities of the toe of the fillet weld to the top flange. The report on the inspection attributed the cracks to fatigue and noted that their length and number appeared to be increasing and that they were also present at the bottom flange as well. Following this inspection the maintenance authority conducted a visual survey of all the bearing stiffener welds throughout the structure.

DETAILS OF INTERMEDIATE CROSS GIRDER BEARING STIFFENERS

In the event it was decided to carry out trials on some of the spans using the former approach with the results being monitored. The existing fillet welds were cut out and replaced by full penetration butt welds. It was envisaged that the heavier weld would not only improve the fatigue life of the joint but would distort the flanges of the cross-girders sufficiently to pull the edges away from the concrete deck slab and the main girders and thus remove the load path from the stiffener tips. The repairs have been carried out and the resulting strains and differential movements are being monitored so that the effectiveness of the repairs can be assessed.

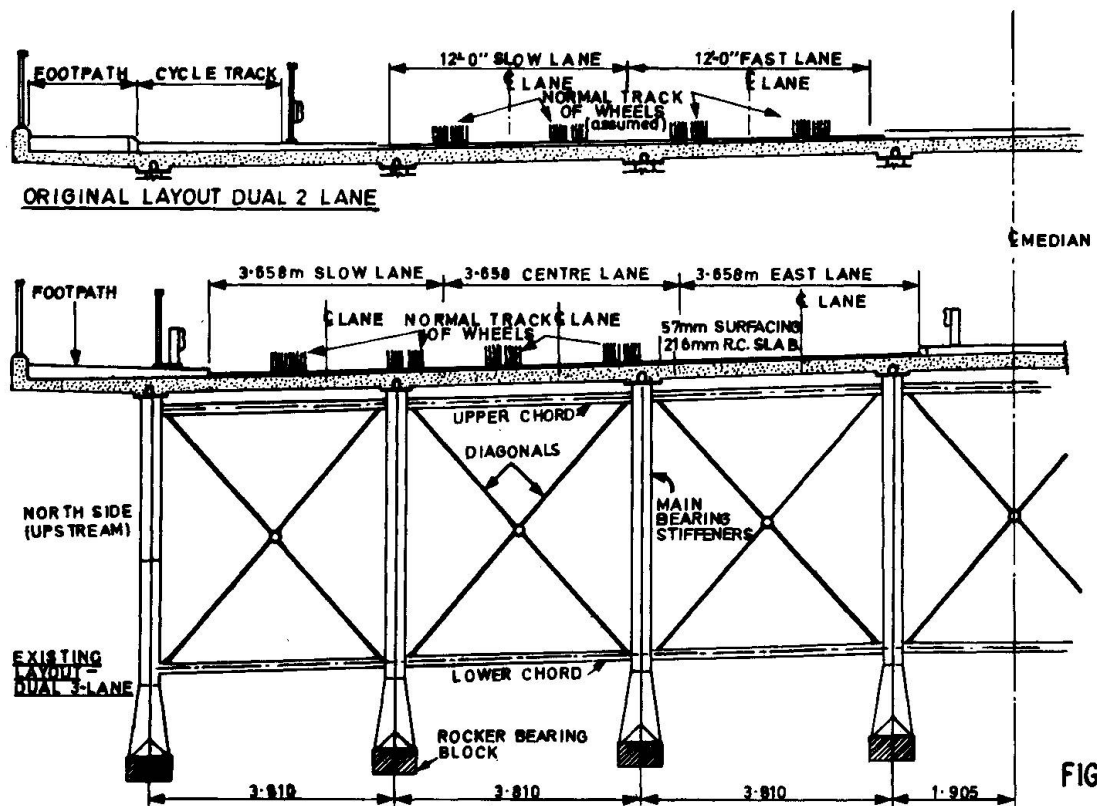
FIG.4.

The deck consists of an in-situ reinforced concrete slab which acts compositely with the main girders through inverted 'U' bars welded to tee-shaped sections which are in turn welded to the top flange of the main girder (Fig 4). The main girders are inter-connected not only by the deck slab but also by a series of transverse cross-frames. The main bearing stiffeners are constructed from rectangular trough section and extend from the main bearing blocks to the top flange and are welded to each side of the main girder webs.

The original sample survey covered 8 out of the 16 bearing stiffeners and in 3 cases revealed cracks at the toe of the fillet weld connecting the bearing stiffener to the top main flange. Some cracks were also discovered lower down the stiffeners where temporary erection cleats had been welded to facilitate the erection of the cross-bracing. A subsequent more comprehensive inspection revealed another 4 cases of toe cracks at the top of the bearing stiffeners. A sample was cut from one of the cracked welds and subjected to microscopic examination; the results indicated that the cracking was due to fatigue and it was considered that it was probably due to rotations of the deck slab over each girder under wheel loading.

Although various remedial measures were considered, including repairing the cracks by replacement welds with increased throat thickness, such a method of repair was rejected in favour of some form of deck stiffening aimed at reducing the deck rotations and consequent bearing stiffener weld stresses. The repair method adopted consisted of providing twin lines of universal beams to support the deck on both sides of the pier supports. These UB were fixed to the webs of the main girders by means of bolted cleats. The beams were fixed to the slab at mid-span by means of anchor bolts set in resin which were bolted to plates welded to the top flange of the beams. Additionally a similar connection was made between the top boom of the existing cross-bracing and the underneath of the deck slab (at the line at the pier supports). No repair was done to the cracked welds due to the risks involved in attempting such an operation on a highly stressed tension flange.
