Artikel: Fatigue cracking in two steel bridges

Fatigue Cracking in Two Steel Bridges

S. CHATTERJEE

Assist. Chief Engineer Department of Transport London, UK P.H. DAWE

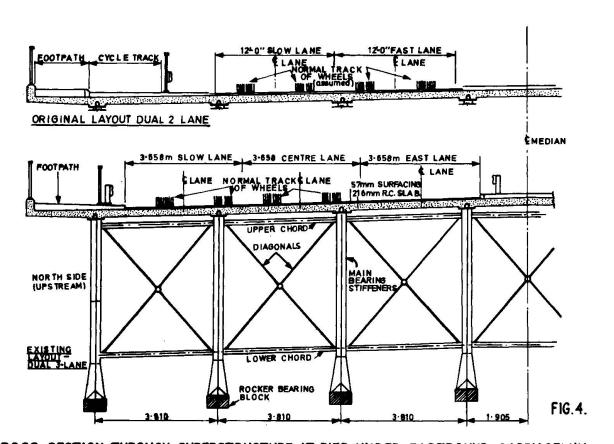
CROSS-SECTION THROUGH SUPERSTRUCTURE AT PIER UNDER EASTBOUND CARRIAGEWAY

The deck consists of an in-situ reinforced concrete slab which acts compositely with the main girders through inverted *U* bars welded to tee-shaped sections which are in turn welded to the top flange of the main girder (Fig 4). The main girders are inter-connected not only by the deck slab but also by a series of transverse cross-frames. The main bearing stiffeners are constructed from rectangular trough section and extend from the main bearing blocks to the top flange and are welded to each side of the main girder webs.

The original sample survey covered 8 out of the 16 bearing stiffeners and in 3 cases revealed cracks at the toe of the fillet weld connecting the bearing stiffener to the top main flange. Some cracks were also discovered lower down the stiffeners where temporary erection cleats had been welded to facilitate the erection of the cross-bracing. A subsequent more comprehensive inspection revealed another 4 cases of toe cracks at the top of the bearing stiffeners. A sample was cut from one of the cracked welds and subjected to microscopic examination; the results indicated that the cracking was due to fatigue and it was considered that it was probably due to rotations of the deck slab over each girder under wheel loading.

Although various remedial measures were considered, including repairing the cracks by replacement welds with increased throat thickness, such a method of repair was rejected in favour of some form of deck stiffening aimed at reducing the deck rotations and consequent bearing stiffener weld stresses. The repair method adopted consisted of providing twin lines of universal beams to support the deck on both sides of the pier supports. These UB were fixed to the webs of the main girders by means of bolted cleats. The beams were fixed to the slab at midspan by means of anchor bolts set in resin which were bolted to plates welded to the top flange of the beams. Additionally a similar connection was made between the top boom of the existing cross-bracing and the underneath of the deck slab (at the line at the pier supports). No repair was done to the cracked welds due to the risks involved in attempting such an operation on a highly stressed tension flange.
