**Zeitschrift:** IABSE reports = Rapports AIPC = IVBH Berichte  
**Band:** 37 (1982)

**Artikel:** Design and retrofit for fatigue damage in web gap  
**Autor:** Fisher, Thomas A. / Fisher, John W. / Kostem, Celal N.  
**DOI:** <https://doi.org/10.5169/seals-28952>

## Design and Retrofit for Fatigue Damage in Web Gap

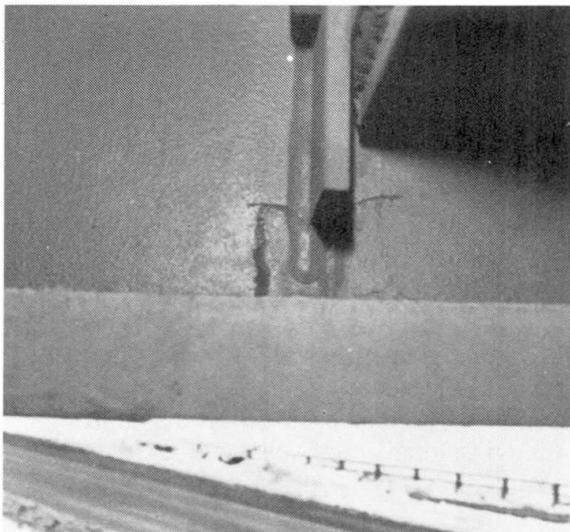
Fig. 1 Cracking at Transverse Diaphragm Web Connection Plate (Skewed Bridge)

Figure 1 shows an example of a detail which developed a fatigue crack. This crack is caused by displacements in the third dimension which occur as a result of interaction between primary (main girders) and secondary members (cross-frames, diaphragms, lateral bracings, etc.). This is the out-of-plane displacement which is not considered in the present design practice [2].

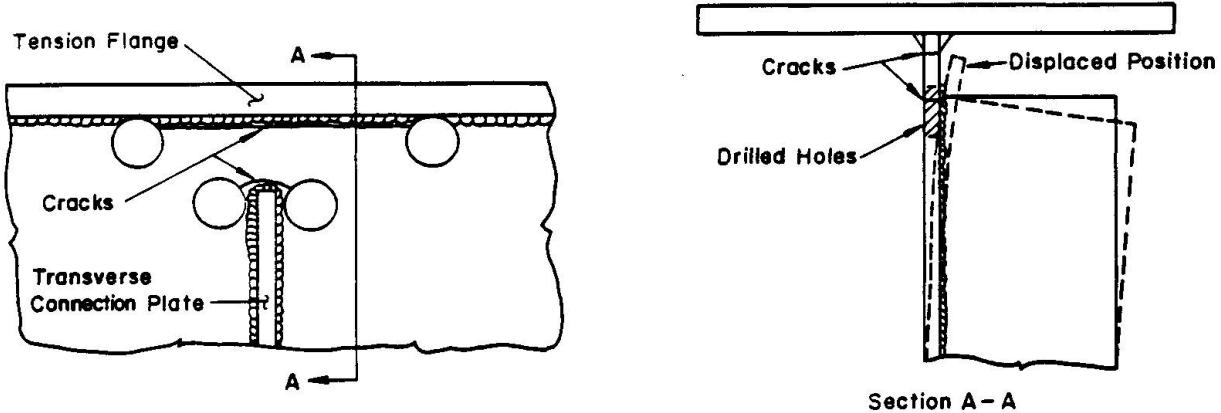
Upon the propagation of a fatigue crack in the short web gap, at the junction of the web and flange, and/or at the end of the transverse (vertical) connection plates, the flexibility of the gap relative to out-of-plane displacement has been increased, as the crack provides a horizontal slot. Therefore, when the displacement-induced stress has been reduced sufficiently due to the lengths of the cracks, drilling holes at the crack tips will often constitute a successful retrofit at diaphragm and floor beam connection plates. Figure 5 shows a schematic of the cracks, retrofit holes and resulting displacement.

Fig. 5 Schematic of Displacement-Induced Cracks

Several bridge structures have been retrofitted by this procedure for at least eight years and have not shown any evidence of further crack propagation [3,8]. Most of these structures are located on high volume arteries and are subjected to one to two million passages of trucks each year.

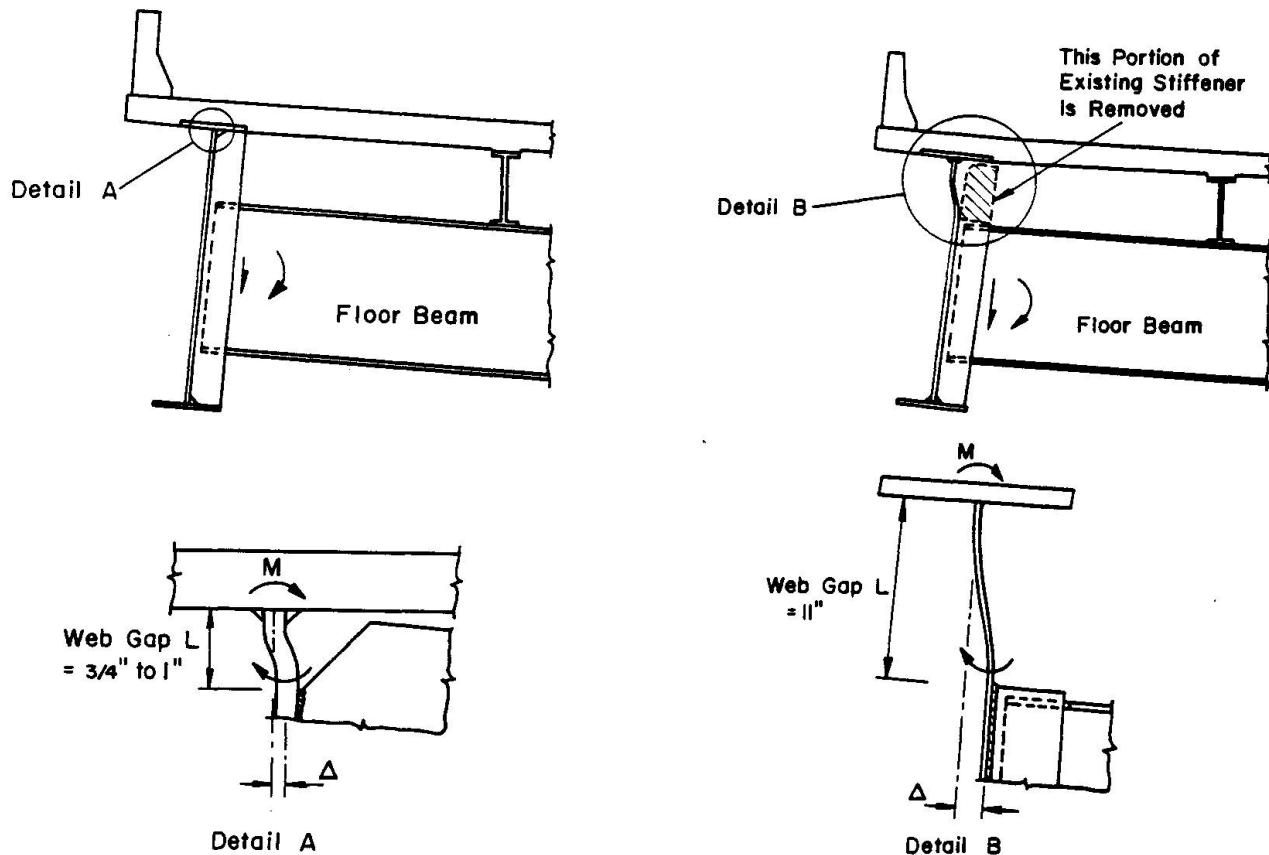
Fig. 6a Distortion of Original Web Gap   Fig. 6b Distortion of Retrofitted Web Gap

A more reliable method to increase the flexibility of the web gap, and thus better accommodate the out-of-plane displacement, as well as prevent the reinitiation of cracks from the drilled holes, involves the removal of a portion of the connection plate (stiffener) adjacent to the web gap, as illustrated in Fig. 6. Through the removal of this stiffening element, the web gap can be lengthened to accommodate the displacement with a significant reduction in out-of-plane bending stress [1]. This decreases the stress range throughout the web gap between the web-flange fillet weld toe and the end of the connection plate, so that cyclic stresses are below the fatigue limit. This insures that cracks do not reinitiate from the holes drilled at the crack tips.

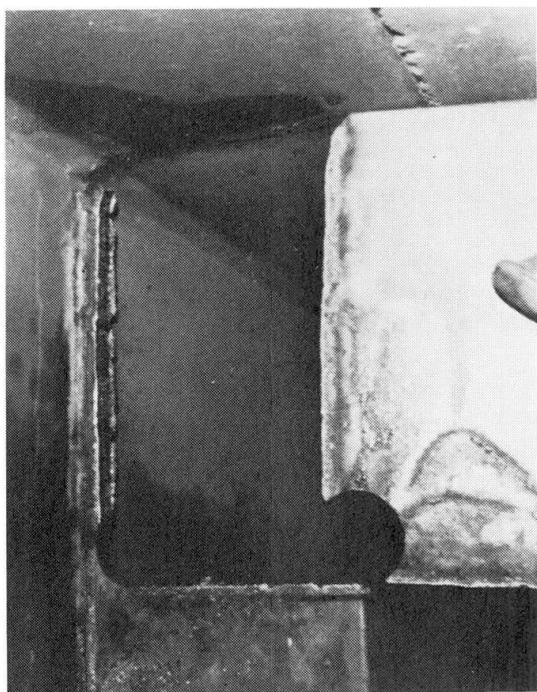
Fig. 7 Removal of a Portion of Connection Plate

In order to remove a portion of the connection plate, 50 mm diameter holes are drilled or cut by hole saw in the connection plate tangent to the girder web, as illustrated in Fig. 7. The hole is placed at the depth the stiffener is to be cut back. The connection plate is then removed by cutting vertically along the fillet weld connecting it to the web and horizontally into the hole, as also shown in Fig. 7. The fillet weld and remaining connection plate are ground away from the web, and the horizontal cut edge of the connection plate is also ground smooth. Liquid penetrant inspection identifies any cracks in the web gap or along the web-flange connection.

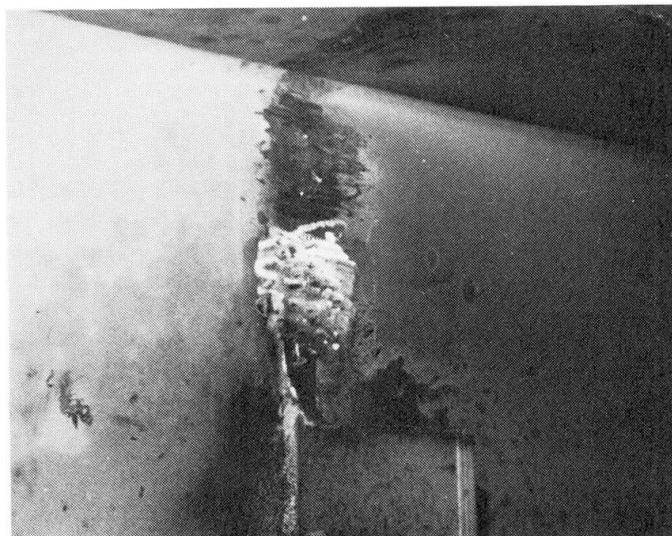
Fig. 8 Ground Surface of Web Gap

Figure 8 shows the surface of the web gap. Holes are then drilled in the web at the crack tip to prevent cracks from further propagation. Figure 9 shows a typical condition in the web gap with drilled holes isolating the cracked areas. High strength bolts are then installed in the holes as shown in Fig. 10 and tightened in order to further enhance the fatigue resistance of the drilled crack tips.

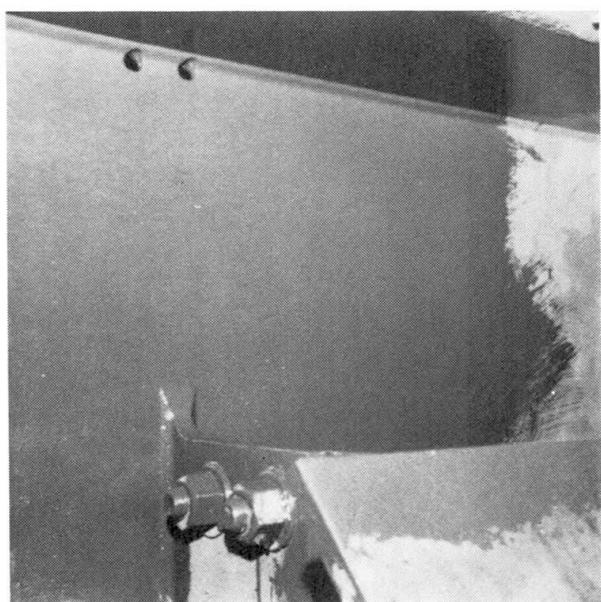
Fig. 9 Web with Drilled Holes Isolating the Cracks

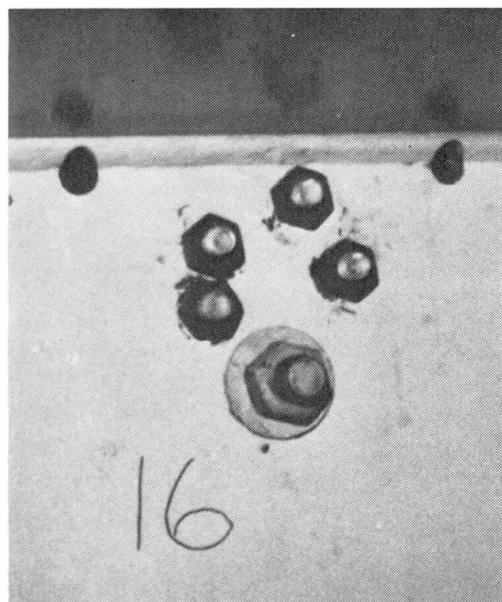
Fig. 10 Bolts Installed in Holes to Enhance Fatigue Resistance

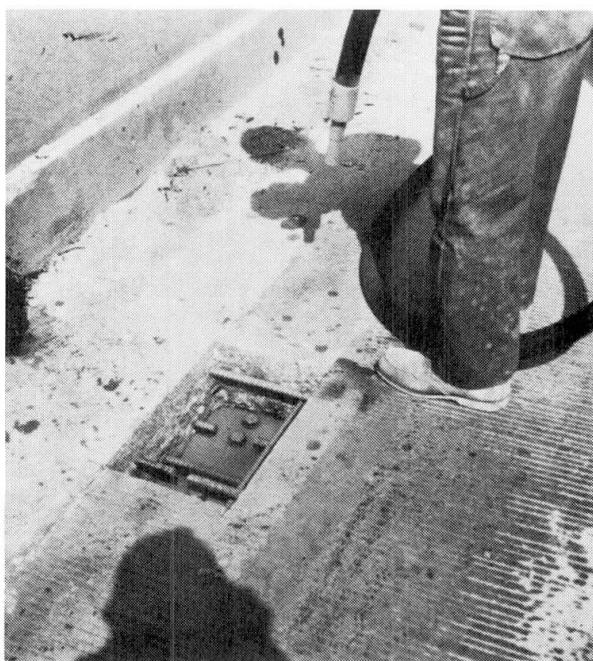
Fig. 11 Portion of Slab Removed to Gain Access to Flange

This can be accomplished by either welding or bolting the connection plate to the flange in order to provide a positive attachment and prevent the distortion. The alternative of welding the connection plate to the flange is generally not exercised for two reasons. First, there is concern regarding the quality of welds which can be provided under field conditions. Second, in older bridges, the weldability and fracture toughness of the flange material is unknown. Hence, welding the connection plate to the flange is generally not a practical alternative. The web gap distortion can be eliminated by providing a bolted connection between the connection plate and the flange. If the retrofit is carried out with the concrete slab in place, it is necessary to remove a rectangular portion of the slab in order to gain access to the embedded flange, as illustrated in Fig. 11. Bolt holes are then drilled in the flange and connection plate, and splice angles are inserted between the flange and the connection plate, as shown in Fig. 12. The resulting connection prevents distortion in the web gap.

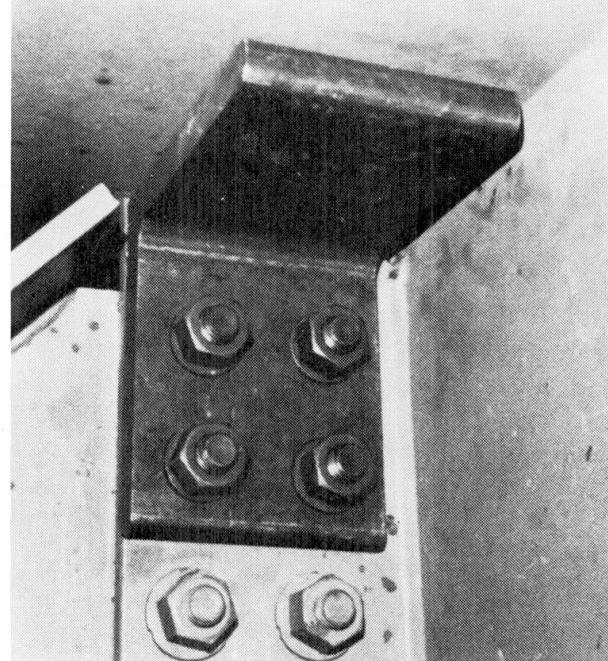
Fig. 12 Splice Angles Inserted Between Flange and Connection Plate
