Zeitschrift: IABSE reports = Rapports AIPC = IVBH Berichte
Band: 37 (1982)

Artikel: Design and retrofit for fatigue damage in web gap
Autor: Fisher, Thomas A. / Fisher, John W. / Kostem, Celal N.
DOI: <https://doi.org/10.5169/seals-28952>

Design and Retrofit for Fatigue Damage in Web Gap

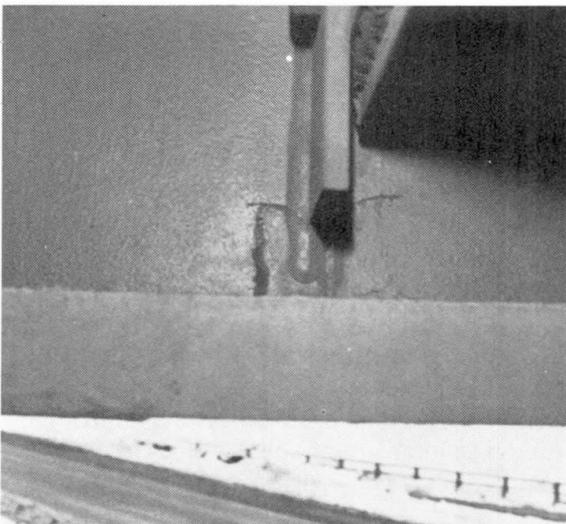
Fig. 1 Cracking at Transverse Diaphragm Web Connection Plate (Skewed Bridge)

Figure 1 shows an example of a detail which developed a fatigue crack. This crack is caused by displacements in the third dimension which occur as a result of interaction between primary (main girders) and secondary members (cross-frames, diaphragms, lateral bracings, etc.). This is the out-of-plane displacement which is not considered in the present design practice [2].

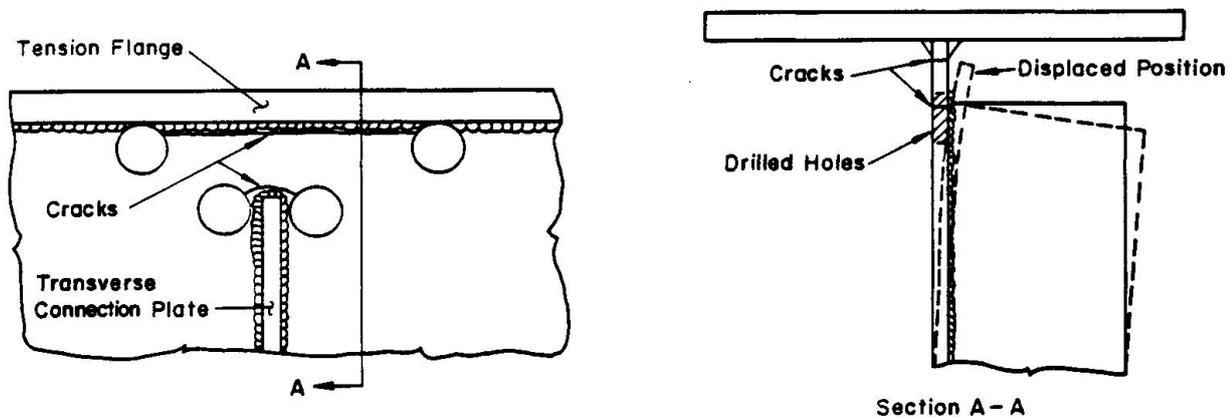
Upon the propagation of a fatigue crack in the short web gap, at the junction of the web and flange, and/or at the end of the transverse (vertical) connection plates, the flexibility of the gap relative to out-of-plane displacement has been increased, as the crack provides a horizontal slot. Therefore, when the displacement-induced stress has been reduced sufficiently due to the lengths of the cracks, drilling holes at the crack tips will often constitute a successful retrofit at diaphragm and floor beam connection plates. Figure 5 shows a schematic of the cracks, retrofit holes and resulting displacement.

Fig. 5 Schematic of Displacement-Induced Cracks

Several bridge structures have been retrofitted by this procedure for at least eight years and have not shown any evidence of further crack propagation [3,8]. Most of these structures are located on high volume arteries and are subjected to one to two million passages of trucks each year.

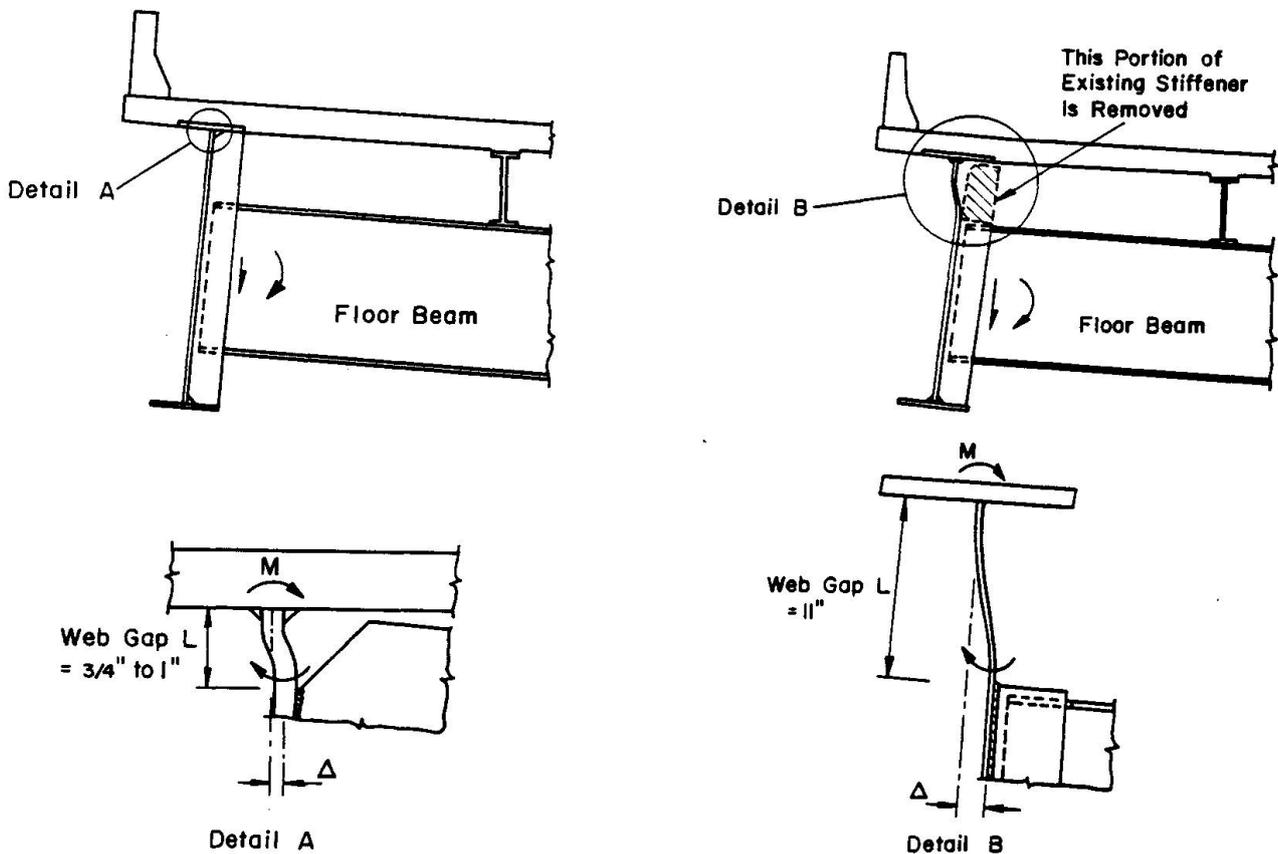
Fig. 6a Distortion of Original Web Gap Fig. 6b Distortion of Retrofitted Web Gap

A more reliable method to increase the flexibility of the web gap, and thus better accommodate the out-of-plane displacement, as well as prevent the reinitiation of cracks from the drilled holes, involves the removal of a portion of the connection plate (stiffener) adjacent to the web gap, as illustrated in Fig. 6. Through the removal of this stiffening element, the web gap can be lengthened to accommodate the displacement with a significant reduction in out-of-plane bending stress [1]. This decreases the stress range throughout the web gap between the web-flange fillet weld toe and the end of the connection plate, so that cyclic stresses are below the fatigue limit. This insures that cracks do not reinitiate from the holes drilled at the crack tips.

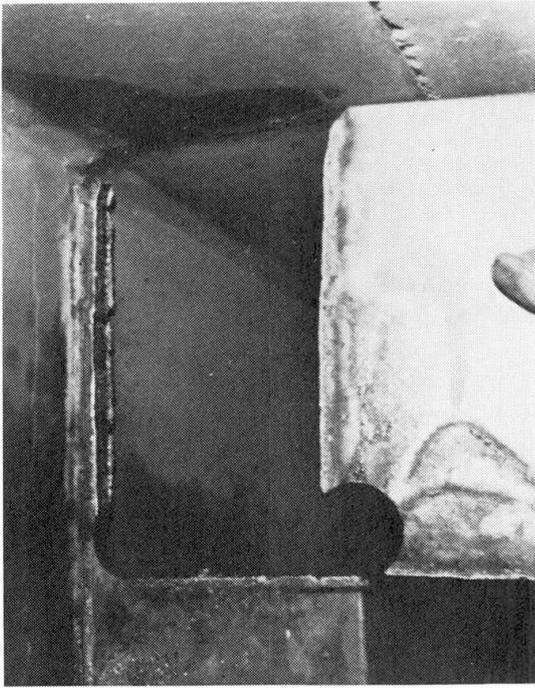
Fig. 7 Removal of a Portion of Connection Plate

In order to remove a portion of the connection plate, 50 mm diameter holes are drilled or cut by hole saw in the connection plate tangent to the girder web, as illustrated in Fig. 7. The hole is placed at the depth the stiffener is to be cut back. The connection plate is then removed by cutting vertically along the fillet weld connecting it to the web and horizontally into the hole, as also shown in Fig. 7. The fillet weld and remaining connection plate are ground away from the web, and the horizontal cut edge of the connection plate is also ground smooth. Liquid penetrant inspection identifies any cracks in the web gap or along the web-flange connection.

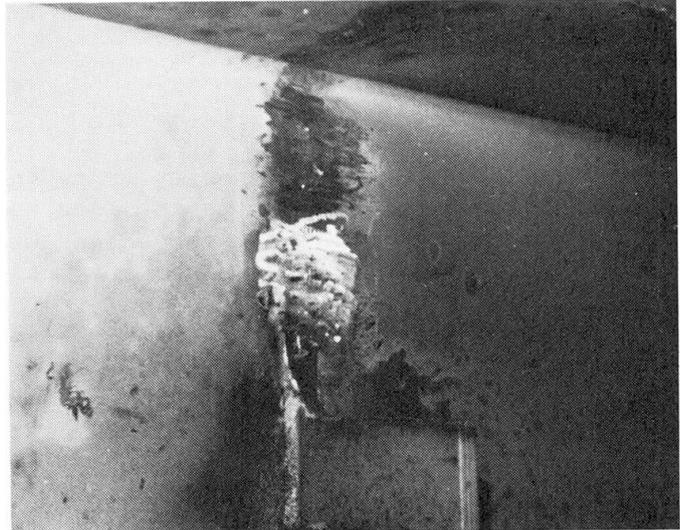
Fig. 8 Ground Surface of Web Gap

Figure 8 shows the surface of the web gap. Holes are then drilled in the web at the crack tip to prevent cracks from further propagation. Figure 9 shows a typical condition in the web gap with drilled holes isolating the cracked areas. High strength bolts are then installed in the holes as shown in Fig. 10 and tightened in order to further enhance the fatigue resistance of the drilled crack tips.

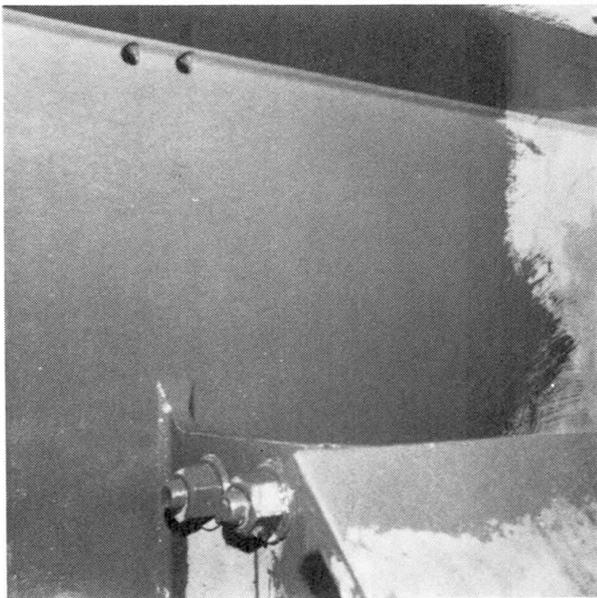
Fig. 9 Web with Drilled Holes Isolating the Cracks

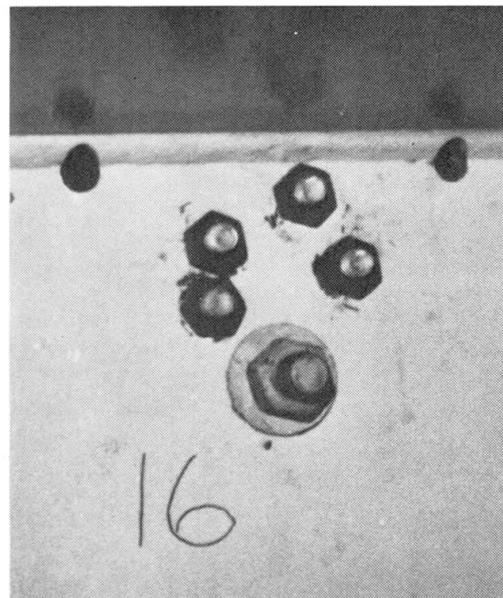
Fig. 10 Bolts Installed in Holes to Enhance Fatigue Resistance

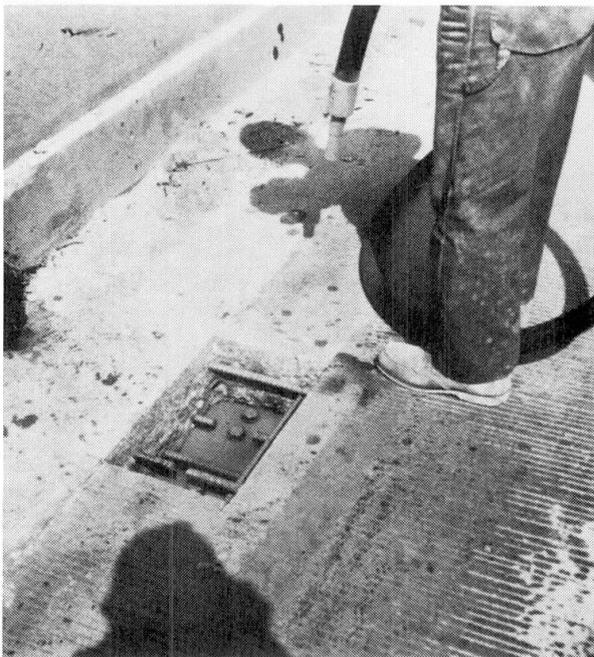
Fig. 11 Portion of Slab Removed to Gain Access to Flange

This can be accomplished by either welding or bolting the connection plate to the flange in order to provide a positive attachment and prevent the distortion. The alternative of welding the connection plate to the flange is generally not exercised for two reasons. First, there is concern regarding the quality of welds which can be provided under field conditions. Second, in older bridges, the weldability and fracture toughness of the flange material is unknown. Hence, welding the connection plate to the flange is generally not a practical alternative. The web gap distortion can be eliminated by providing a bolted connection between the connection plate and the flange. If the retrofit is carried out with the concrete slab in place, it is necessary to remove a rectangular portion of the slab in order to gain access to the embedded flange, as illustrated in Fig. 11. Bolt holes are then drilled in the flange and connection plate, and splice angles are inserted between the flange and the connection plate, as shown in Fig. 12. The resulting connection prevents distortion in the web gap.

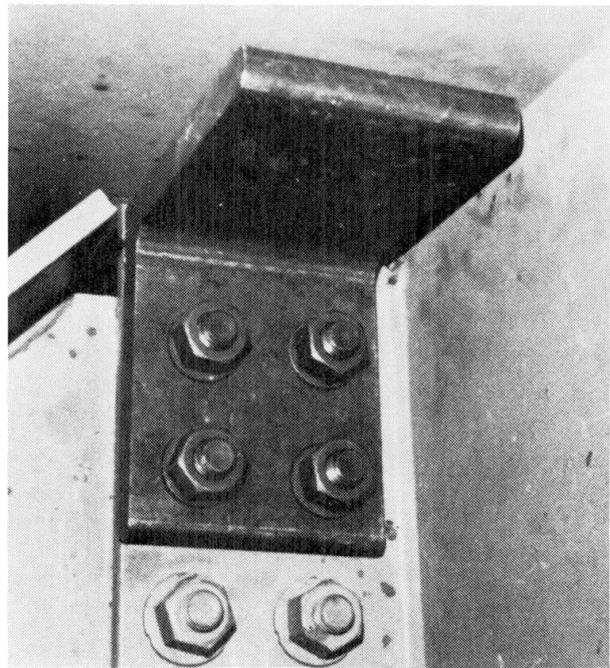
Fig. 12 Splice Angles Inserted Between Flange and Connection Plate
