**Artikel:** Design and retrofit for fatigue damage in web gap  
**Autor:** Fisher, Thomas A. / Fisher, John W. / Kostem, Celal N.  
**DOI:** <https://doi.org/10.5169/seals-28952>

## **Design and Retrofit for Fatigue Damage in Web Gap**

Unanticipated fatigue cracking has resulted because of out-of-plane distortions as a result of the three dimensional behaviour of structures. This paper provides a summary of two separate studies. In one, a recommendation is provided to minimize cracking in the web at diaphragm connection plates in right bridges. The second reviews retrofit procedures for the cracking in longitudinal girder webs at floor beam connection plates.

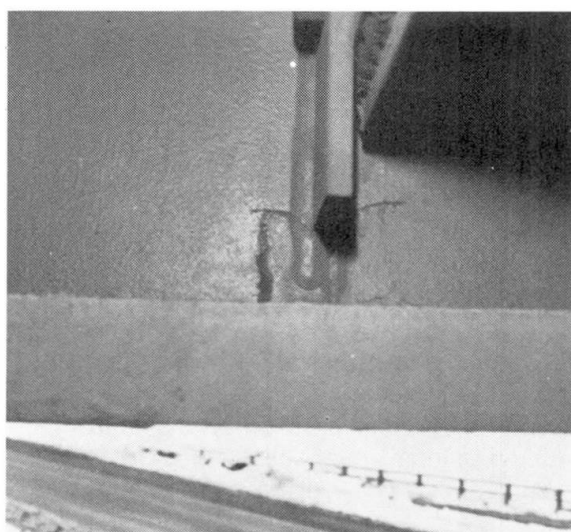
Fig. 1 Cracking at Transverse Diaphragm Web Connection Plate (Skewed Bridge)

Figure 1 shows an example of a detail which developed a fatigue crack. This crack is caused by displacements in the third dimension which occur as a result of interaction between primary (main girders) and secondary members (cross-frames, diaphragms, lateral bracings, etc.). This is the out-of-plane displacement which is not considered in the present design practice [2].

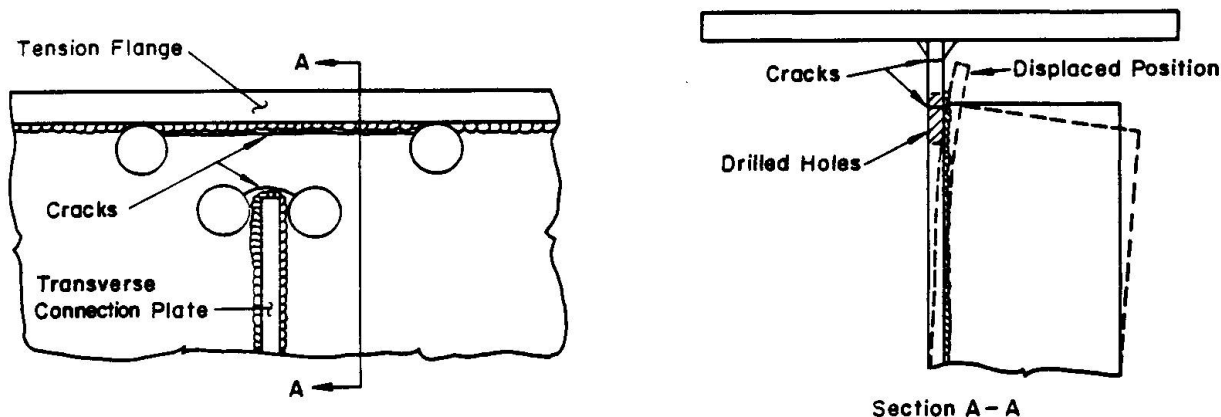
Upon the propagation of a fatigue crack in the short web gap, at the junction of the web and flange, and/or at the end of the transverse (vertical) connection plates, the flexibility of the gap relative to out-of-plane displacement has been increased, as the crack provides a horizontal slot. Therefore, when the displacement-induced stress has been reduced sufficiently due to the lengths of the cracks, drilling holes at the crack tips will often constitute a successful retrofit at diaphragm and floor beam connection plates. Figure 5 shows a schematic of the cracks, retrofit holes and resulting displacement.

Fig. 5 Schematic of Displacement-Induced Cracks

Several bridge structures have been retrofitted by this procedure for at least eight years and have not shown any evidence of further crack propagation [3,8]. Most of these structures are located on high volume arteries and are subjected to one to two million passages of trucks each year.

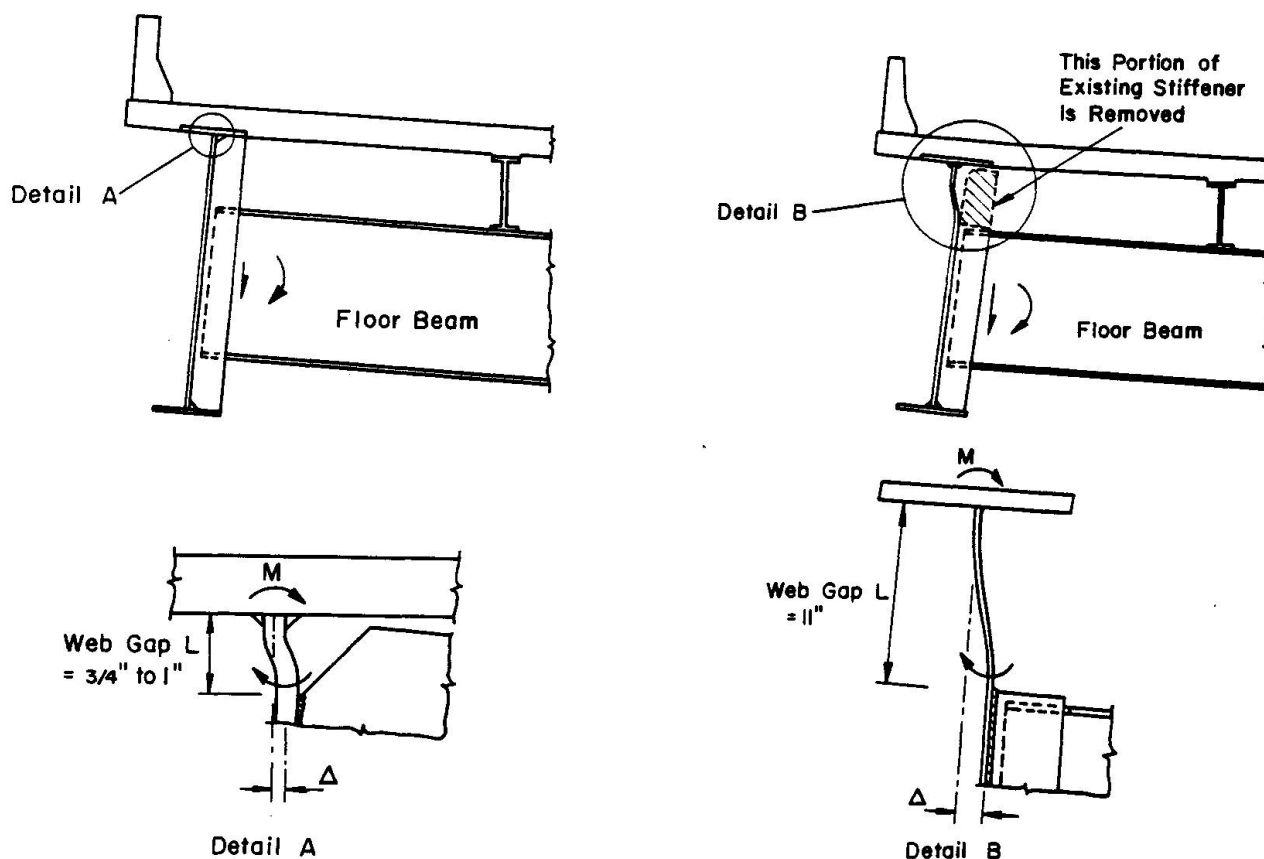
Fig. 6a Distortion of Original Web Gap      Fig. 6b Distortion of Retrofitted Web Gap

A more reliable method to increase the flexibility of the web gap, and thus better accommodate the out-of-plane displacement, as well as prevent the reinitiation of cracks from the drilled holes, involves the removal of a portion of the connection plate (stiffener) adjacent to the web gap, as illustrated in Fig. 6. Through the removal of this stiffening element, the web gap can be lengthened to accommodate the displacement with a significant reduction in out-of-plane bending stress [1]. This decreases the stress range throughout the web gap between the web-flange fillet weld toe and the end of the connection plate, so that cyclic stresses are below the fatigue limit. This insures that cracks do not reinitiate from the holes drilled at the crack tips.

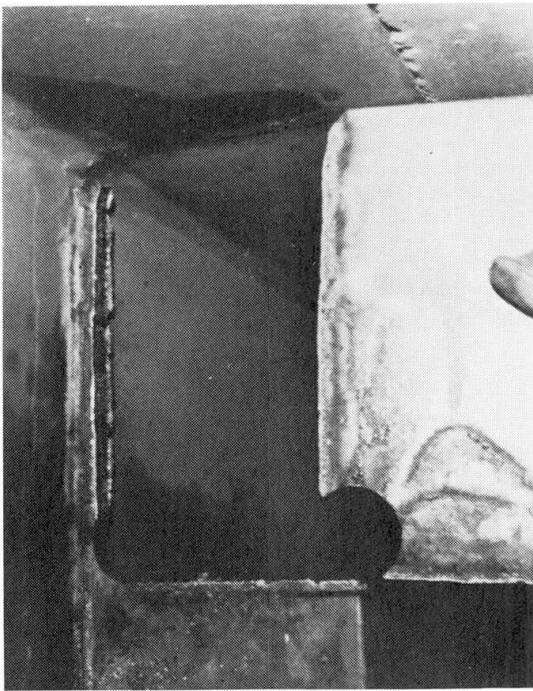
Fig. 7 Removal of a Portion of Connection Plate

In order to remove a portion of the connection plate, 50 mm diameter holes are drilled or cut by hole saw in the connection plate tangent to the girder web, as illustrated in Fig. 7. The hole is placed at the depth the stiffener is to be cut back. The connection plate is then removed by cutting vertically along the fillet weld connecting it to the web and horizontally into the hole, as also shown in Fig. 7. The fillet weld and remaining connection plate are ground away from the web, and the horizontal cut edge of the connection plate is also ground smooth. Liquid penetrant inspection identifies any cracks in the web gap or along the web-flange connection.

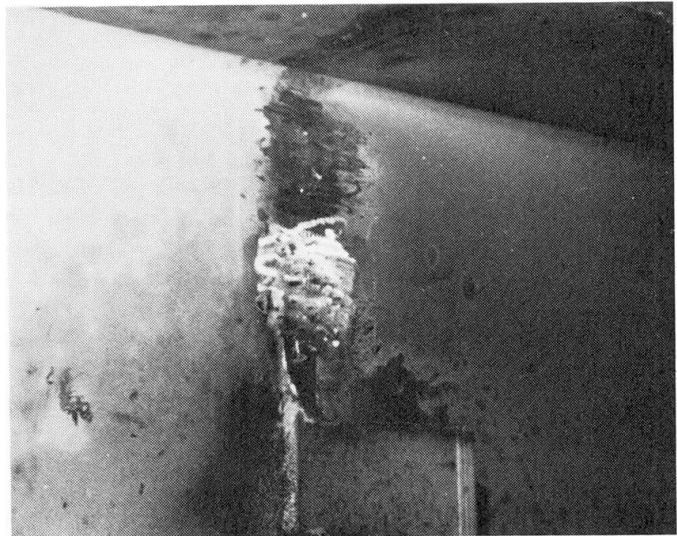
Fig. 8 Ground Surface of Web Gap

Figure 8 shows the surface of the web gap. Holes are then drilled in the web at the crack tip to prevent cracks from further propagation. Figure 9 shows a typical condition in the web gap with drilled holes isolating the cracked areas. High strength bolts are then installed in the holes as shown in Fig. 10 and tightened in order to further enhance the fatigue resistance of the drilled crack tips.

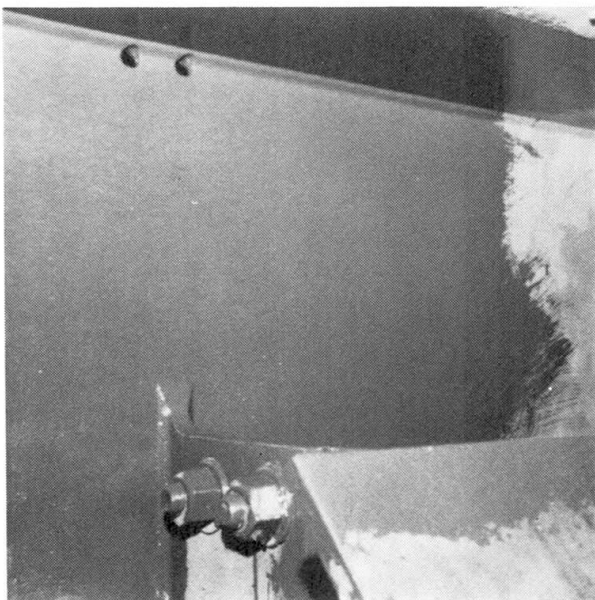
Fig. 9 Web with Drilled Holes Isolating the Cracks

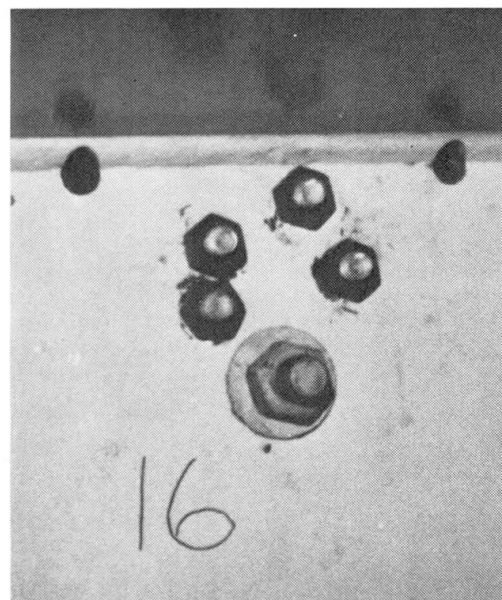
Fig. 10 Bolts Installed in Holes to Enhance Fatigue Resistance

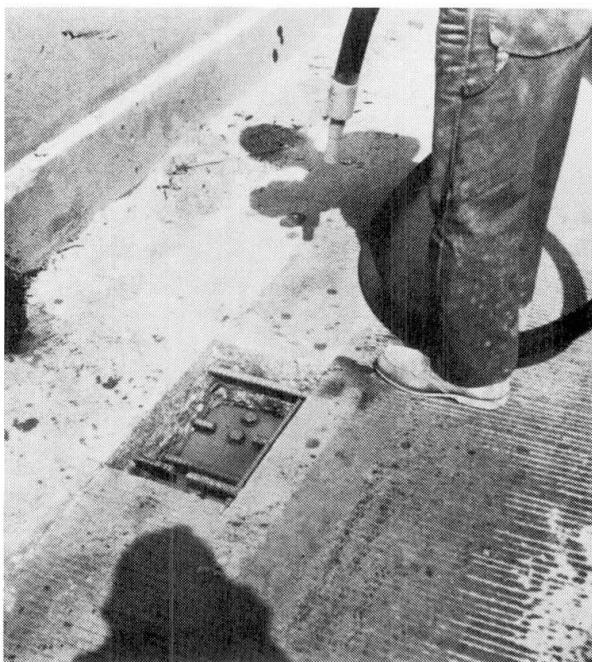
Fig. 11 Portion of Slab Removed to Gain Access to Flange

This can be accomplished by either welding or bolting the connection plate to the flange in order to provide a positive attachment and prevent the distortion. The alternative of welding the connection plate to the flange is generally not exercised for two reasons. First, there is concern regarding the quality of welds which can be provided under field conditions. Second, in older bridges, the weldability and fracture toughness of the flange material is unknown. Hence, welding the connection plate to the flange is generally not a practical alternative. The web gap distortion can be eliminated by providing a bolted connection between the connection plate and the flange. If the retrofit is carried out with the concrete slab in place, it is necessary to remove a rectangular portion of the slab in order to gain access to the embedded flange, as illustrated in Fig. 11. Bolt holes are then drilled in the flange and connection plate, and splice angles are inserted between the flange and the connection plate, as shown in Fig. 12. The resulting connection prevents distortion in the web gap.

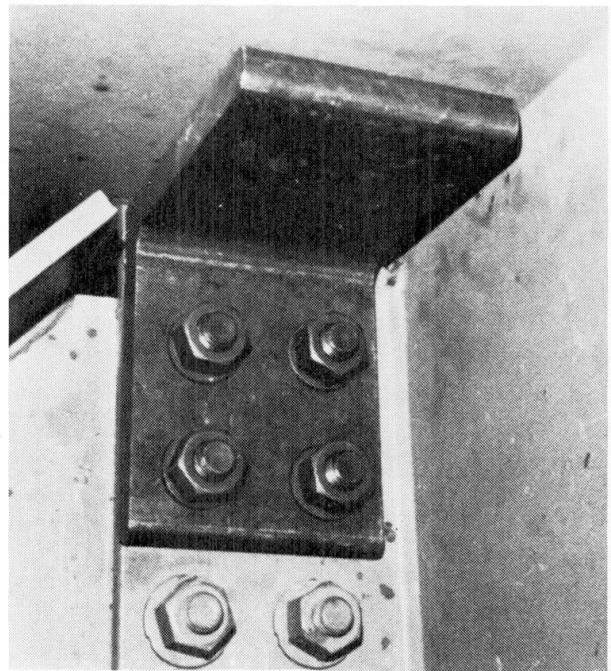
Fig. 12 Splice Angles Inserted Between Flange and Connection Plate
