## **Design and Retrofit for Fatigue Damage in Web Gap**

### **THOMAS A. FISHER**

### **JOHN W. FISHER**

### **CELAL N. KOSTEM**

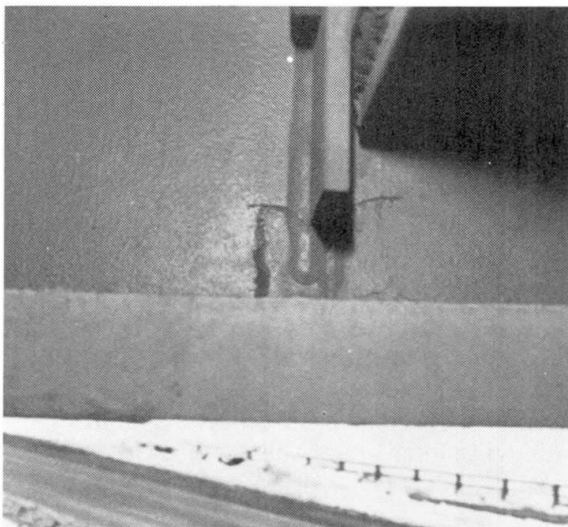
Fig. 1 Cracking at Transverse Diaphragm Web Connection Plate (Skewed Bridge)

Figure 1 shows an example of a detail which developed a fatigue crack. This crack is caused by displacements in the third dimension which occur as a result of interaction between primary (main girders) and secondary members (cross-frames, diaphragms, lateral bracings, etc.). This is the out-of-plane displacement which is not considered in the present design practice [2].

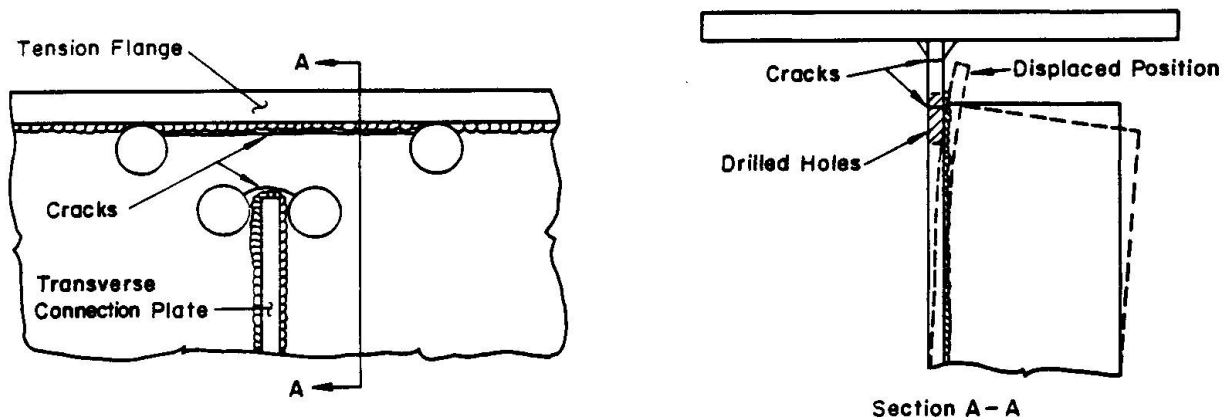
Upon the propagation of a fatigue crack in the short web gap, at the junction of the web and flange, and/or at the end of the transverse (vertical) connection plates, the flexibility of the gap relative to out-of-plane displacement has been increased, as the crack provides a horizontal slot. Therefore, when the displacement-induced stress has been reduced sufficiently due to the lengths of the cracks, drilling holes at the crack tips will often constitute a successful retrofit at diaphragm and floor beam connection plates. Figure 5 shows a schematic of the cracks, retrofit holes and resulting displacement.

Fig. 5 Schematic of Displacement-Induced Cracks

Several bridge structures have been retrofitted by this procedure for at least eight years and have not shown any evidence of further crack propagation [3,8]. Most of these structures are located on high volume arteries and are subjected to one to two million passages of trucks each year.

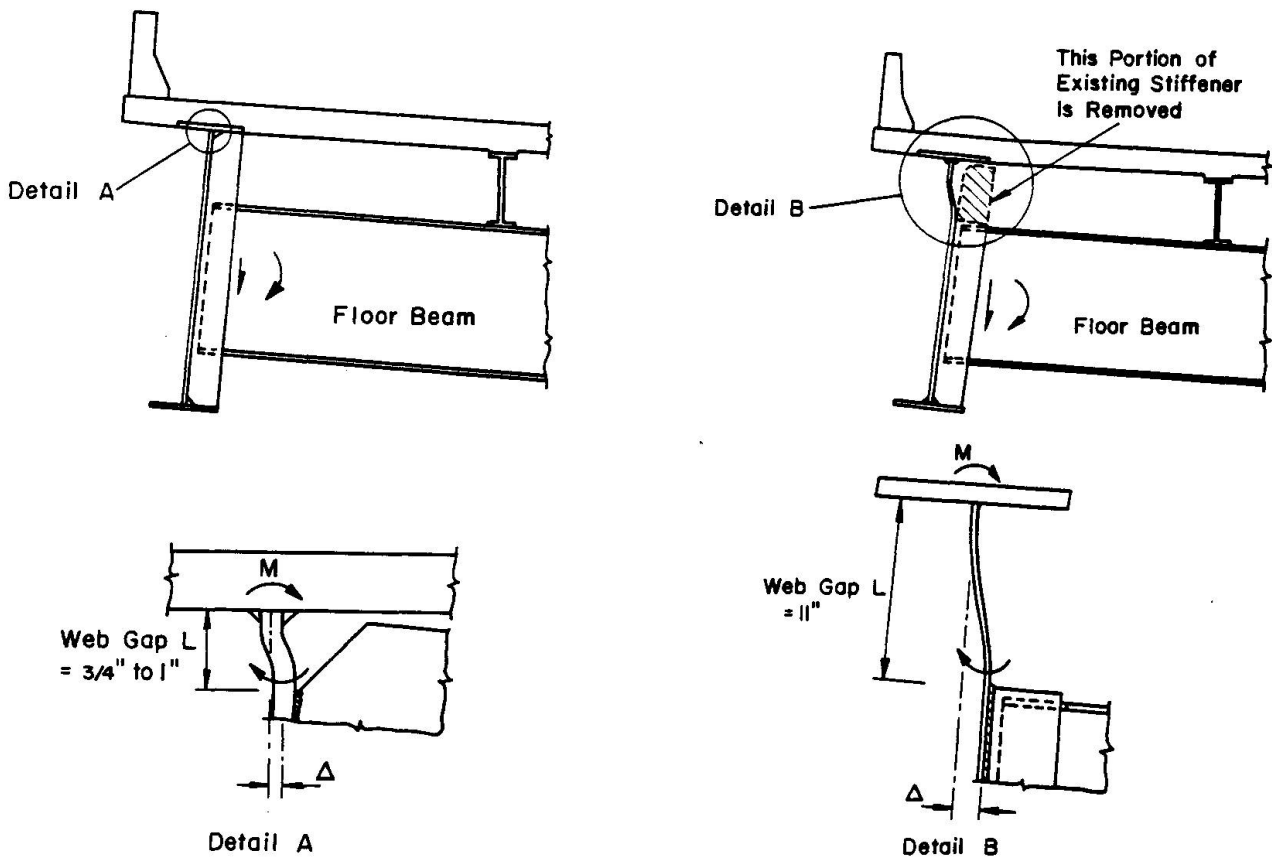
Fig. 6a Distortion of Original Web Gap Fig. 6b Distortion of Retrofitted Web Gap

A more reliable method to increase the flexibility of the web gap, and thus better accommodate the out-of-plane displacement, as well as prevent the reinitiation of cracks from the drilled holes, involves the removal of a portion of the connection plate (stiffener) adjacent to the web gap, as illustrated in Fig. 6. Through the removal of this stiffening element, the web gap can be lengthened to accommodate the displacement with a significant reduction in out-of-plane bending stress [1]. This decreases the stress range throughout the web gap between the web-flange fillet weld toe and the end of the connection plate, so that cyclic stresses are below the fatigue limit. This insures that cracks do not reinitiate from the holes drilled at the crack tips.

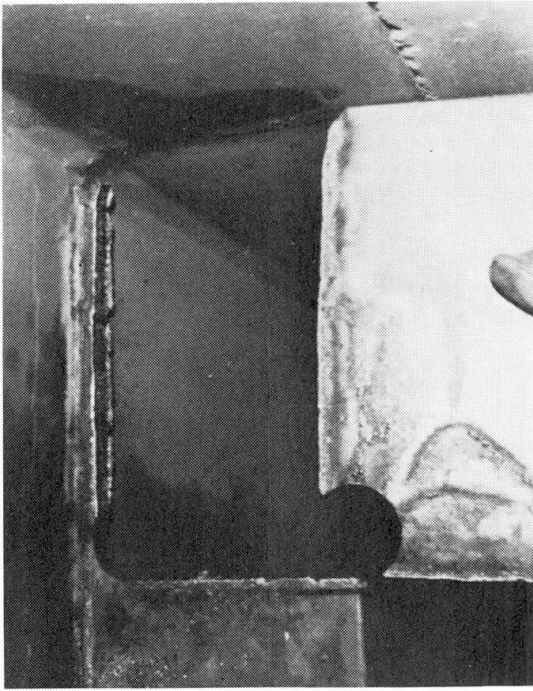
Fig. 7 Removal of a Portion of Connection Plate

In order to remove a portion of the connection plate, 50 mm diameter holes are drilled or cut by hole saw in the connection plate tangent to the girder web, as illustrated in Fig. 7. The hole is placed at the depth the stiffener is to be cut back. The connection plate is then removed by cutting vertically along the fillet weld connecting it to the web and horizontally into the hole, as also shown in Fig. 7. The fillet weld and remaining connection plate are ground away from the web, and the horizontal cut edge of the connection plate is also ground smooth. Liquid penetrant inspection identifies any cracks in the web gap or along the web-flange connection.

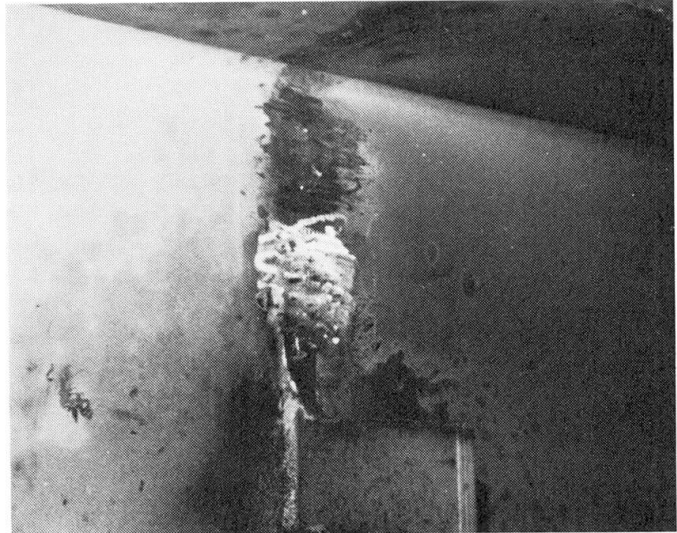
Fig. 8 Ground Surface of Web Gap

Figure 8 shows the surface of the web gap. Holes are then drilled in the web at the crack tip to prevent cracks from further propagation. Figure 9 shows a typical condition in the web gap with drilled holes isolating the cracked areas. High strength bolts are then installed in the holes as shown in Fig. 10 and tightened in order to further enhance the fatigue resistance of the drilled crack tips.

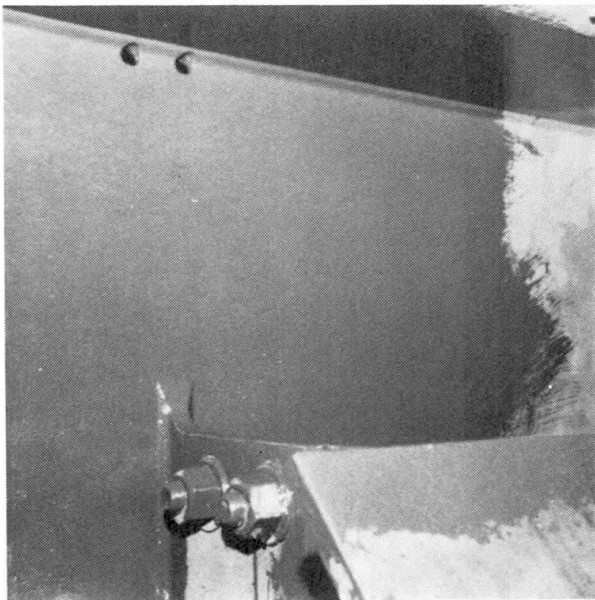
Fig. 9 Web with Drilled Holes Isolating the Cracks

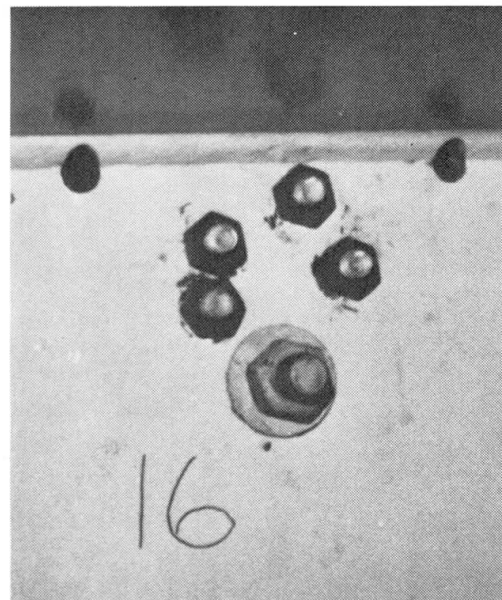
Fig. 10 Bolts Installed in Holes to Enhance Fatigue Resistance

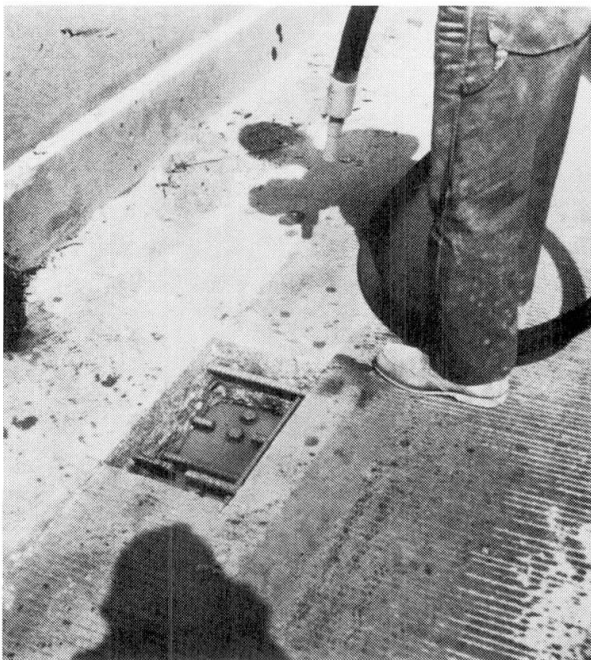
Fig. 11 Portion of Slab Removed to Gain Access to Flange

This can be accomplished by either welding or bolting the connection plate to the flange in order to provide a positive attachment and prevent the distortion. The alternative of welding the connection plate to the flange is generally not exercised for two reasons. First, there is concern regarding the quality of welds which can be provided under field conditions. Second, in older bridges, the weldability and fracture toughness of the flange material is unknown. Hence, welding the connection plate to the flange is generally not a practical alternative. The web gap distortion can be eliminated by providing a bolted connection between the connection plate and the flange. If the retrofit is carried out with the concrete slab in place, it is necessary to remove a rectangular portion of the slab in order to gain access to the embedded flange, as illustrated in Fig. 11. Bolt holes are then drilled in the flange and connection plate, and splice angles are inserted between the flange and the connection plate, as shown in Fig. 12. The resulting connection prevents distortion in the web gap.

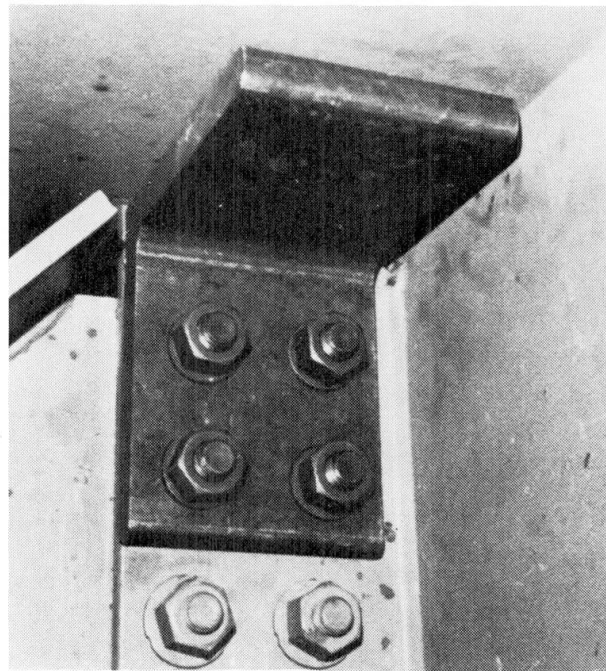
Fig. 12 Splice Angles Inserted Between Flange and Connection Plate
