Artikel: Design and retrofit for fatigue damage in web gap

Autor: Fisher, Thomas A. / Fisher, John W. / Kostem, Celal N.

Design and Retrofit for Fatigue Damage in Web Gap

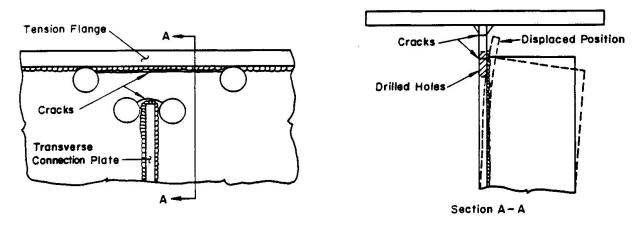
Upon the propagation of a fatigue crack in the short web gap, at the junction of the web and flange, and/or at the end of the transverse (vertical) connection plates, the flexibility of the gap relative to out-of-plane displacement has been increased, as the crack provides a horizontal slot. Therefore, when the displacement-induced stress has been reduced sufficiently due to the lengths of the cracks, drilling holes at the crack tips will often constitute a successful retrofit at diaphragm and floor beam connection plates. Figure 5 shows a schematic of the cracks, retrofit holes and resulting displacement.

Fig. 5 Schematic of Displacement-Induced Cracks

Several bridge structures have been retrofitted by this procedure for at least eight years and have not shown any evidence of further crack propagation [3,8]. Most of these structures are located on high volume arteries and are subjected to one to two million passages of trucks each year.

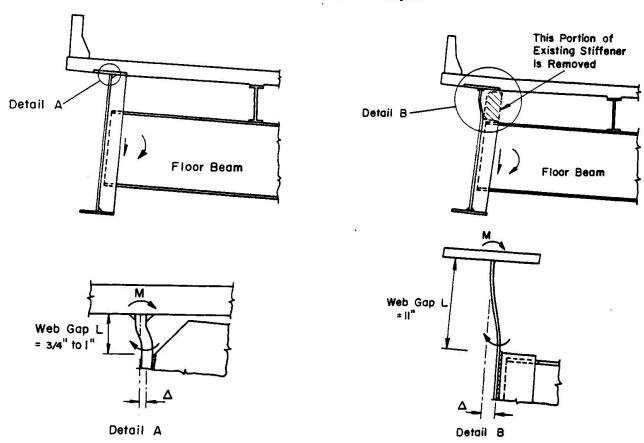
Fig. 6a Distortion of Original Web Gap Fig. 6b Distortion of Retrofitted Web Gap

A more reliable method to increase the flexibility of the web gap, and thus better accommodate the out-of-plane displacement, as well as prevent the reinitiation of cracks from the drilled holes, involves the removal of a portion of the connection plate (stiffener) adjacent to the web gap, as illustrated in Fig. 6. Through the removal of this stiffening element, the web gap can be lengthened to accommodate the displacement with a significant reduction in out-of-plane bending stress [1]. This decreases the stress range throughout the web gap between the web-flange fillet weld toe and the end of the connection plate, so that cyclic stresses are below the fatigue limit. This insures that cracks do not reinitiate from the holes drilled at the crack tips.

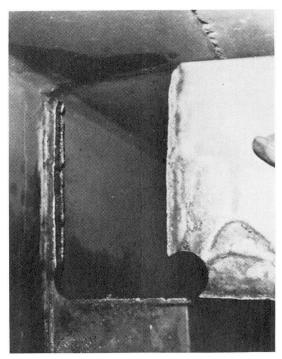
Fig. 7 Removal of a Portion of Connection Plate

In order to remove a portion of the connection plate, 50 mm diameter holes are drilled or cut by hole saw in the connection plate tangent to the girder web, as illustrated in Fig. 7. The hole is placed at the depth the stiffener is to be cut back. The connection plate is then removed by cutting vertically along the fillet weld connecting it to the web and horizontally into the hole, as also shown in Fig. 7. The fillet weld and remaining connection plate are ground away from the web, and the horizontal cut edge of the connection plate is also ground smooth. Liquid penetrant inspection identifies any cracks in the web gap or along the web-flange connection.

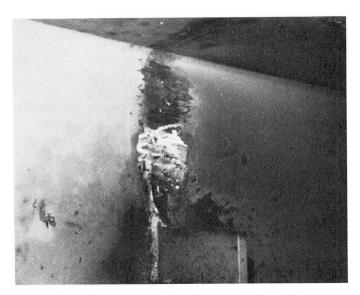
Fig. 8 Ground Surface of Web Gap

Figure 8 shows the surface of the web gap. Holes are then drilled in the web at the crack tip to prevent cracks from further propagation. Figure 9 shows a typical condition in the web gap with drilled holes isolating the cracked areas. High strength bolts are then installed in the holes as shown in Fig. 10 and tightened in order to further enhance the fatigue resistance of the drilled crack tips.

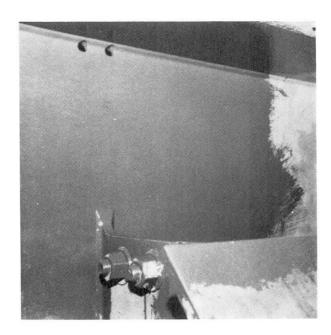
Fig. 9 Web with Drilled Holes
Isolating the Cracks

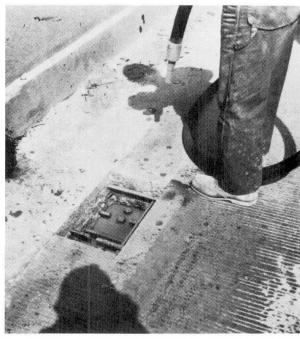
Fig. 11 Portion of Slab Removed to
Gain Access to Flange

This can be accomplished by either welding or bolting the connection plate to the flange in order to provide a positive attachment and prevent the distortion. The alternative of welding the connection plate to the flange is generally not exercised for two reasons. First, there is concern regarding the quality of welds which can be provided under field conditions. Second, in older bridges, the weldability and fracture toughness of the flange material is unknown. Hence, welding the connection plate to the flange is generally not a practical alternative. The web gap distortion can be eliminated by providing a bolted connection between the connection plate and the flange. If the retrofit is carried out with the concrete slab in place, it is necessary to remove a rectangular portion of the slab in order to gain access to the embedded flange, as illustrated in Fig. 11. Bolt holes are then drilled in the flange and connection plate, and splice angles are inserted between the flange and the connection plate, as shown in Fig. 12. The resulting connection prevents distortion in the web gap.

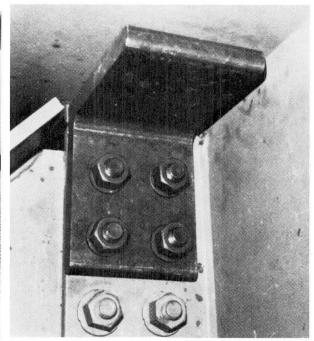
Fig. 12 Splice Angles Inserted Between Flange and Connection Plate
