Collapse of a Cantilevered Truss Supporting a Heavy Crane

JOHN M. HANSON

Wiss, Janney, Elstner & Assoc.

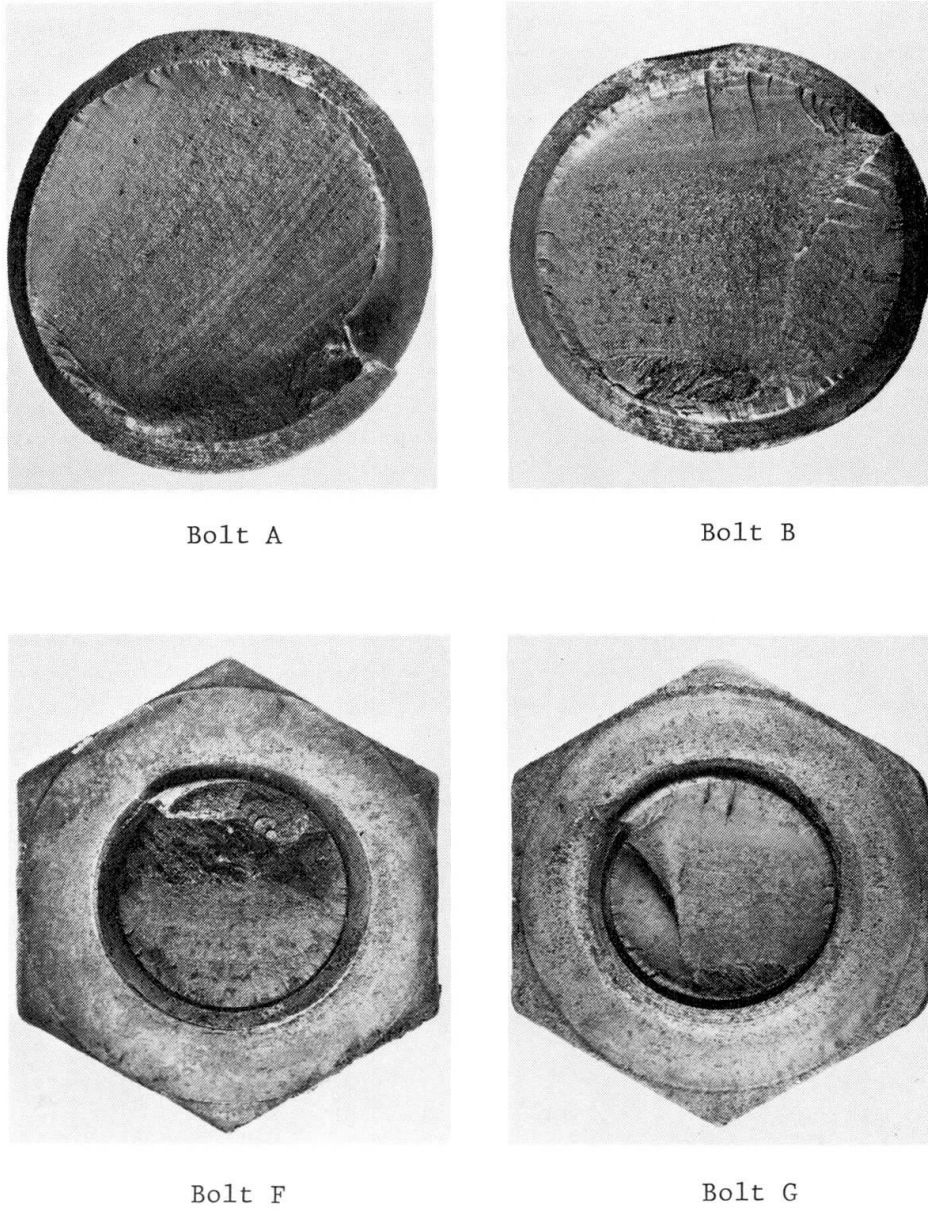
Fig. 5 Fracture Surfaces

Extensive metallurgical examinations of the bolts were carried out by several parties. There was general agreement that fatigue cracking and fracture had occurred in the threaded portion of all of the bolts. Views of the cracked and fractured surfaces in four of the bolts are shown in Fig. 5. The fatigue cracking appeared to have advanced across the bolts in an intermittent manner. Final ruptures appeared to be due to overloading.

also have had a significant influence on the stress conditions, irrespective of their adequate end anchorage. Consequently, it is likely that stress ranges as high as 150 to 200 MPa may have occurred in some of the bolts. As noted earlier, the examination of the fracture surfaces indicated that the fatigue cracks advanced across the bolts in a variable manner.
