**Artikel:** Collapse of the Viennese Reichsbrücke: causes and lessons

Autor: Reiffenstuhl, Hans

Hans REIFFENSTUHL
Prof. Dr. techn.
Technical University
Vienna, Austria

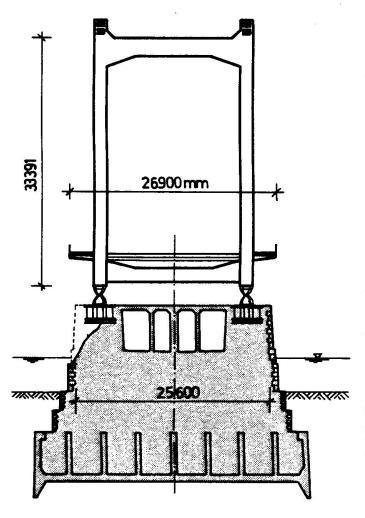
FIG. 1: CROSS SECTION AT PIER XVII a

bridge covering 10 000 m<sup>2</sup>
collapsed practically without
live load - only two automobiles were on the bridge - and
claimed the loss of one human
life. It seemed that the collapse originated from the
failure of a river pier. In
figure 1, the cross section
through the bridge and the concerned river pier, this fact
is displayed by omission of the
plunged parts of concrete and
ashlar.

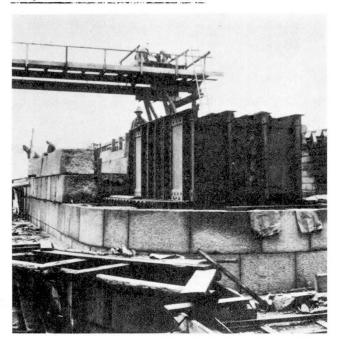
FIG. 3: PIER XVII a DURING ERECTION (1935) rolled beams found enough

Under each pylon bearing a heavy grid of bolted steel girders of 1,60 m hight was concreted into the head of the pier. For better distribution of the load the grid rested upon rolled I-beams layed closely to eachother (Fig.1 to 3). No other reinforcement of the piers was provided. The external dimensions of the pier shaft were just so large that the steel grid and the mat of

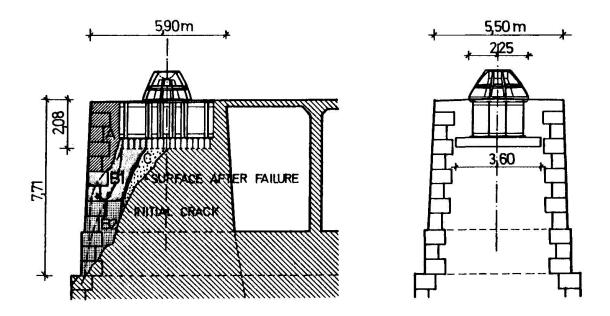
As subsequent measurements revealed, the stones of the granite ashlar must have been broken from a zone close to the surface of the quarry. They had a modulus of elasticity which for granite was very low indeed. The order of magnitude was about the same as the one of the neighbouring concrete. Therefore, the flow of forces underneath the grid at first corresponded rather well to that one which can be expected in a homogenious material. The dashed line in fig. 4 indicates this behaviour.

Since the granite has no ability to creep in the course of decades redistribution of forces occurred in the pier's head: Because of the unyielding granite a steadily increasing amount of the load flowed from the concrete into the granite ashlar at the front surface of the pier (indicated by the dash-dotted line in fig.4). Some time or other the splitting forces developping at the same time produced an initial crack in the concrete (heavy line in fig. 4) so that the forces due to deflection of the load path charged the squat bar developped at the left side of the initial crack in bending. With increasing redistribution of the load flow the bending stresses of the squat bar and the length of the initial crack became greater and greater.

FIG. 4: PIER XVII a CRACK FORMATION AT FAILURE
A, B1, B2 FRACTIONS C CRUSHED PART

Until ten days before the collapse Austria had been struck by a longlasting heatwave which had been superseded by unusually cold weather. The slowly penetrating cooling of the pier, still warm in its interior, led to the maximum of tensile stresses in the zones close to the surface after several days. Combined with the bending tensile stresses due to the redistribution of the load flow as a consequence of creep they led to the failure in bending of the squat bar to the left of the initial crack - fortunately in an unloaded state of the bridge. The mechanism can be realized from the parts B1 and B2 (fig. 4) salvaged from the Danube seven months after the disaster.
