**Artikel:** Collapse of the Viennese Reichsbrücke: causes and lessons  
**Autor:** Reiffenstuhl, Hans  
**DOI:** <https://doi.org/10.5169/seals-30168>

## **Collapse of the Viennese Reichsbrücke: Causes and Lessons**

### **Hans REIFFENSTUHL**

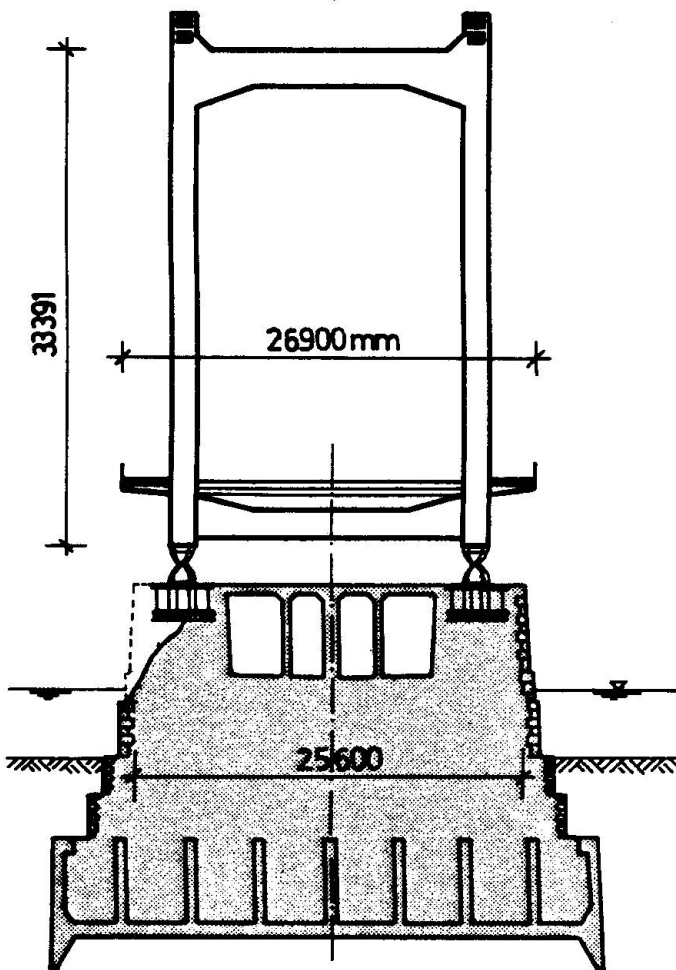
FIG. 1: CROSS SECTION AT PIER XVIIa

Sunday, August 1<sup>st</sup>, 1976, a quarter to five a.m. the suspension bridge covering 10 000 m<sup>2</sup> collapsed practically without live load - only two automobiles were on the bridge - and claimed the loss of one human life. It seemed that the collapse originated from the failure of a river pier. In figure 1, the cross section through the bridge and the concerned river pier, this fact is displayed by omission of the plunged parts of concrete and ashlar.

Under each pylon bearing a heavy grid of bolted steel girders of 1,60 m high was concreted into the head of the pier. For better distribution of the load the grid rested upon rolled I-beams layed closely to each other (Fig.1 to 3). No other reinforcement of the piers was provided. The external dimensions of the pier shaft were just so large that the steel grid and the mat of rolled beams found enough

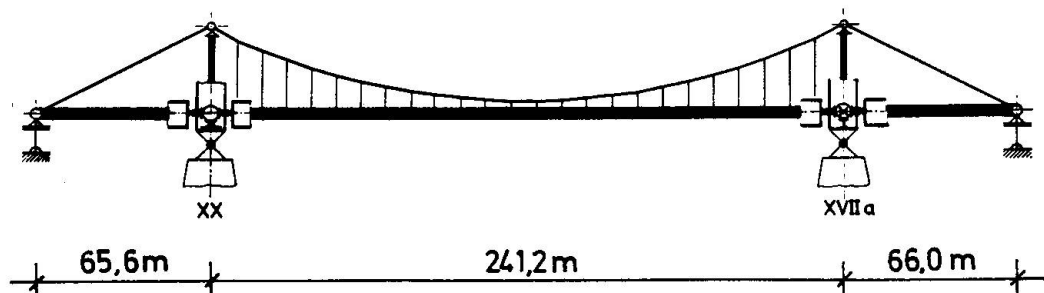
FIG. 2: STATICAL SYSTEM

stiffening girder in the main span the statical system of the bridge was changed to a self anchored suspension bridge due to rather strong differences in the judgement of the soil properties; therefore it was necessary to anchor the horizontal tension of the chains to the suspended stiffening girder and strengthen it correspondingly.

This measure led to an unusual statical system with hinged connections of the stiffening girder at the piers, penetrating the pylons which acted as columns hinged at both ends. For the main loads this system was statically determinate. Failure of one essential member was sure to lead to the collapse of the whole structure.

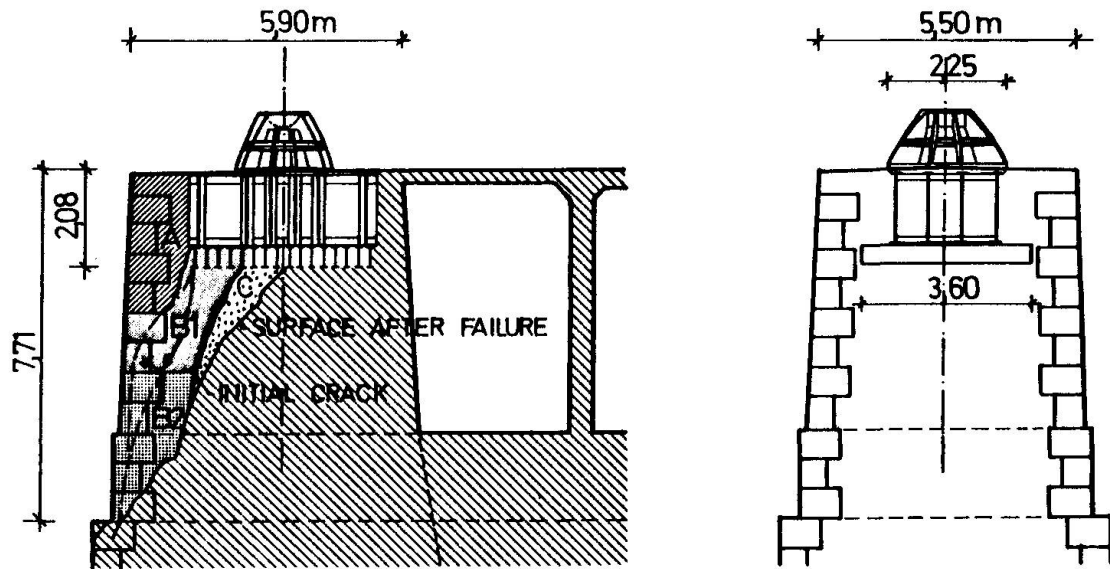
FIG. 4: PIER XVIIa CRACK FORMATION AT FAILURE  
A, B1, B2 FRACTIONS C CRUSHED PART

As subsequent measurements revealed, the stones of the granite ashlar must have been broken from a zone close to the surface of the quarry. They had a modulus of elasticity which for granite was very low indeed. The order of magnitude was about the same as the one of the neighbouring concrete. Therefore, the flow of forces underneath the grid at first corresponded rather well to that one which can be expected in a homogenous material. The dashed line in fig. 4 indicates this behaviour.

Since the granite has no ability to creep in the course of decades redistribution of forces occurred in the pier's head: Because of the unyielding granite a steadily increasing amount of the load flowed from the concrete into the granite ashlar at the front surface of the pier (indicated by the dash-dotted line in fig.4). Some time or other the splitting forces developping at the same time produced an initial crack in the concrete (heavy line in fig. 4) so that the forces due to deflection of the load path charged the squat bar developped at the left side of the initial crack in bending. With increasing redistribution of the load flow the bending stresses of the squat bar and the length of the initial crack became greater and greater.

Until ten days before the collapse Austria had been struck by a longlasting heatwave which had been superseded by unusually cold weather. The slowly penetrating cooling of the pier, still warm in its interior, led to the maximum of tensile stresses in the zones close to the surface after several days. Combined with the bending tensile stresses due to the redistribution of the load flow as a consequence of creep they led to the failure in bending of the squat bar to the left of the initial crack - fortunately in an unloaded state of the bridge. The mechanism can be realized from the parts B1 and B2 (fig. 4) salvaged from the Danube seven months after the disaster.

After a portion of the grid's bottom area had become unsupported due to the plunge of the granite and concrete parts the pressure at the edge of the remaining supporting area under the grid crushed the concrete. The whole grid tilted and produced great excentricity of the pylon's load in the spherical contact surfaces of the pylon bearing which bursted immediately and introduced the collapse of the total superstructure. The kinds of damages and the final position of the parts as well as the sequence of the further events are explained and interpreted in the

4.1 Unreinforced piers with stone ashlar can be endangered by time dependent splitting forces, especially when bearing loads are introduced directly into the concrete or the like between the ashlar.

4.2 Larger structures generally should be investigated from time to time with respect to new scientific findings.
