Artikel: Displacement-induced fatigue cracking of a box girder bridge
Autor: Fisher, John W. / Mertz, Dennis R. / Wu, Kuang-Chong
DOI: <https://doi.org/10.5169/seals-30171>

Displacement-Induced Fatigue Cracking of a Box Girder Bridge

John W. FISHER
Prof. of Civil Eng.
Lehigh University
Bethlehem, PA, USA

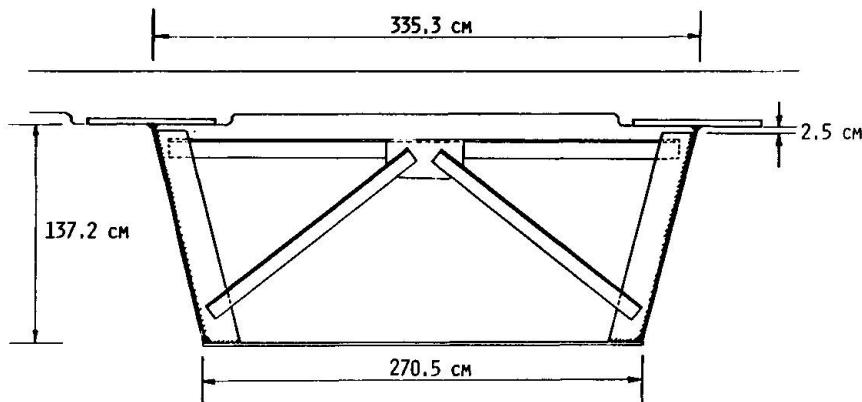
Fig. 1 Cross-Section of Curved Box Girder

Diaphragms and cross-framing are frequently used in curved box girders to prevent the cross-section from grossly distorting. It has been the practice to utilize transverse connection plates shop welded to the girder web and compression flange to connect the diaphragm members between the box girder webs. The end of the transverse connection plate is cut short or coped and fitted creating an unstiffened web gap adjacent to the tension flange. Figure 1 shows a cross-section of the curved box girder with the internal diaphragm in the negative moment region.

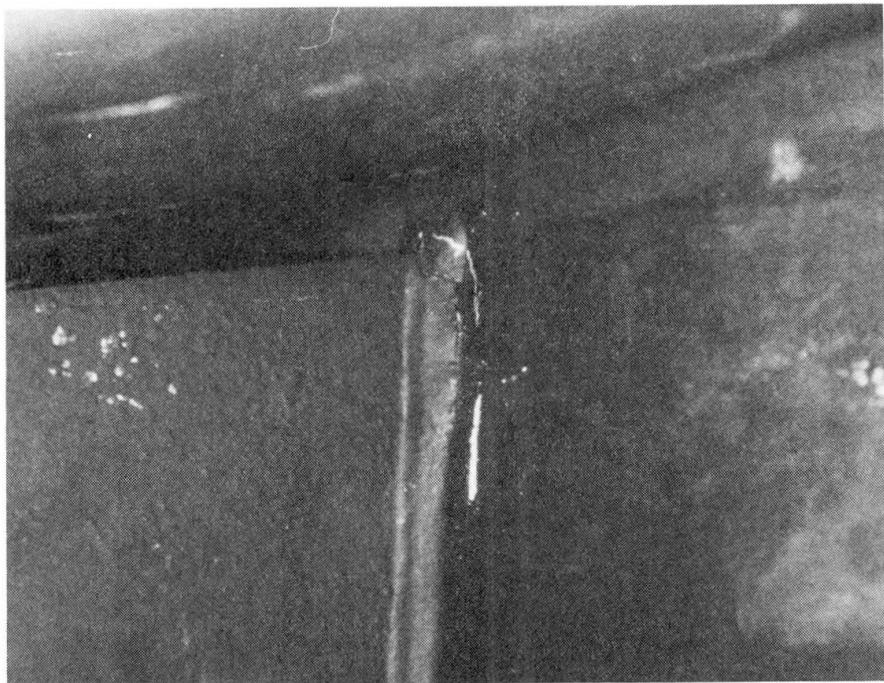
Fig. 2 Typical Crack in Transverse Connection Plate-Web Weld

The observed cracks all exhibited the characteristics that are associated with out-of-plane movement of the web in the relatively small gap at the end of the transverse connection plate. Figure 2 shows a photograph of a typical crack that was observed in the box on the outside web under the southbound lanes. Cracking has occurred in the web gap at the upper end of the transverse connection plate where no attachment was made to the tension flange in the negative moment region. This cracking is directly comparable to cracking that has been

observed elsewhere in bridges with longitudinal girders and transverse floor beams.

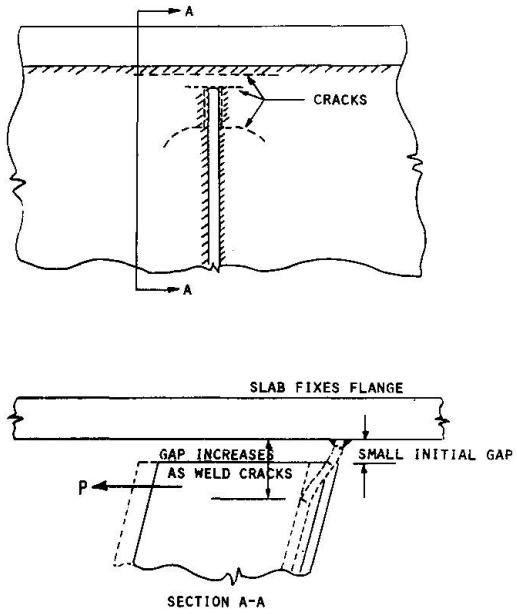
Fig. 3 Schematic of Crack Development

When the web gap is relatively small, i.e. 2.5 cm, the movement of the diaphragm introduces large stresses on the upper end of the fillet weld connecting the diaphragm to the girder web and in the web gap. This results in cracking of the diaphragm-web weld connection at smaller welds, as illustrated in Fig. 3. If this cracking is not arrested through some retrofitting procedure, eventually between 2.5 cm and 5.0 cm of the weld will crack introducing enough additional flexibility into the girder such that the web gap is forced into greater double curvature. This distortion is shown schematically in Fig. 3. Cracking along the web-flange weld connection and longitudinal cracking in the girder web at the lower end of the diaphragm-web connection crack result from this cyclic distortion. At several locations, cracks formed in the web without significant weld cracking.

This observed cracking results from the distortion of the curved box section and subsequent loading of the diaphragms due to this distortion. This causes forces to be introduced into the girder web adjacent to the top flange, since the transverse connection plate is not welded to the flange. At the bottom end of the transverse connection plates, fillet welds positively attach the plate to the bottom flange which is acting in compression. Therefore, no cracks can develop at this welded end.

Most of the cracking was detected in the outside web of the curved box section and not in the inside web. This is a result of the direction of the out-of-plane movement. The transverse angle that is attached to the upper ends of the web connection plates is relatively stiff compared to the web gap. The outside web is pulled in on one side by the transverse angle producing cyclic tension stresses and subsequent cracking. On the other side, the web is pushed out resulting in cyclic compressive stresses. Since the effective stress range is less, severe cracking was not as extensive prior to retrofitting the structure.

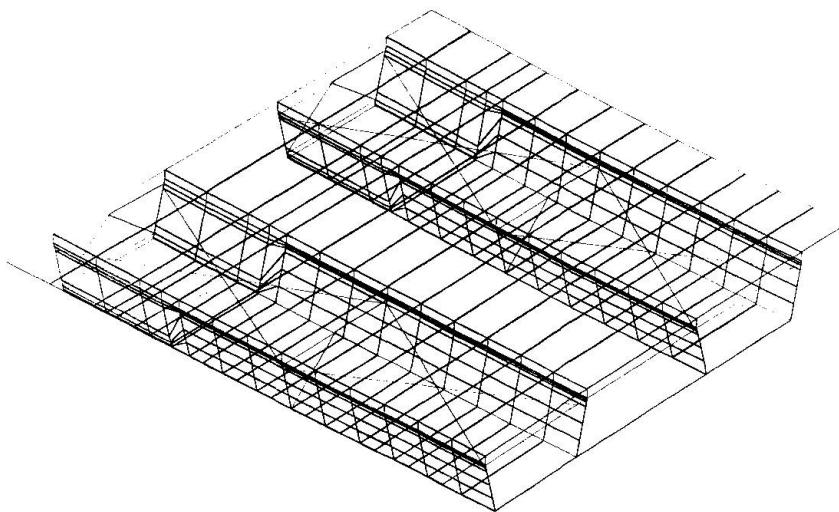
Fig. 4 Typical Finite Element Substructure Model

One unit of the three unit Ramp C Viaduct structure was analyzed using the finite element method. SAP4 - A Structural Analysis Program for Static and Dynamic Response of Linear Systems [3] was used to perform the two phase analysis. The first phase consisted of analyzing the entire structure utilizing a gross discretization to model overall structural behavior. The resultant displacements from this and subsequent analyses were used to load the boundaries of substructure models of the region of the structure adjacent to the point of detected fatigue cracking. This second phase produced a better representation of the web gap behavior while conserving computer resources. One such sub-structure is shown in Fig. 4.

Using an HS 20-44 truck statically placed on the structure to represent live load, the uncracked web gap was distorted sufficiently to produce cyclic stresses varying from -7.13 MPa to +52.53 MPa. The maximum stress range exceeds the fatigue limit of the weld toes and crack propagation is unavoidable. An

ongoing more extensive investigation suggests that the gap condition may be even more severe than this preliminary study indicates. The stress range in the gap, during passage of the HS 20-44 truck, may be as high as 90 MPa. Under random variable truck traffic, an effective stress range of 45 MPa ($0.35^{1/3}$ times stress range H20) would result in visible cracking from the estimated 15 million vehicles that have crossed the structure since it was placed in service. Hence, the observed behavior is in agreement with experiment test data and predicted crack propagation.
