**Artikel:** Displacement-induced fatigue cracking of a box girder bridge  
**Autor:** Fisher, John W. / Mertz, Dennis R. / Wu, Kuang-Chong  
**DOI:** <https://doi.org/10.5169/seals-30171>

## Displacement-Induced Fatigue Cracking of a Box Girder Bridge

**John W. FISHER**  
Prof. of Civil Eng.  
Lehigh University  
Bethlehem, PA, USA

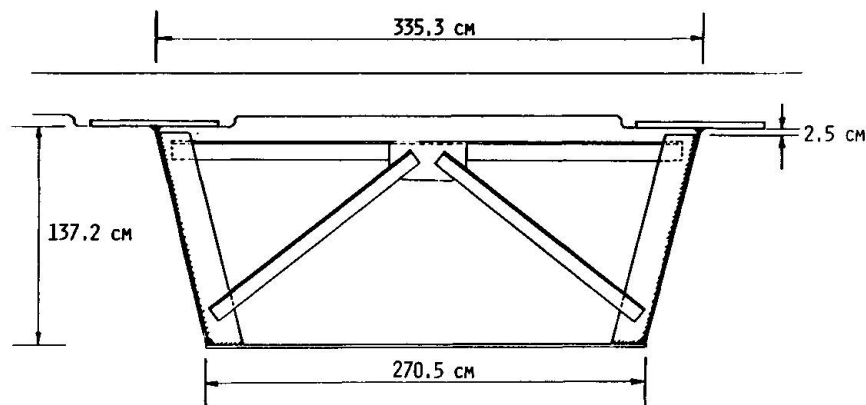
Fig. 1 Cross-Section of Curved Box Girder

Diaphragms and cross-framing are frequently used in curved box girders to prevent the cross-section from grossly distorting. It has been the practice to utilize transverse connection plates shop welded to the girder web and compression flange to connect the diaphragm members between the box girder webs. The end of the transverse connection plate is cut short or coped and fitted creating an unstiffened web gap adjacent to the tension flange. Figure 1 shows a cross-section of the curved box girder with the internal diaphragm in the negative moment region.

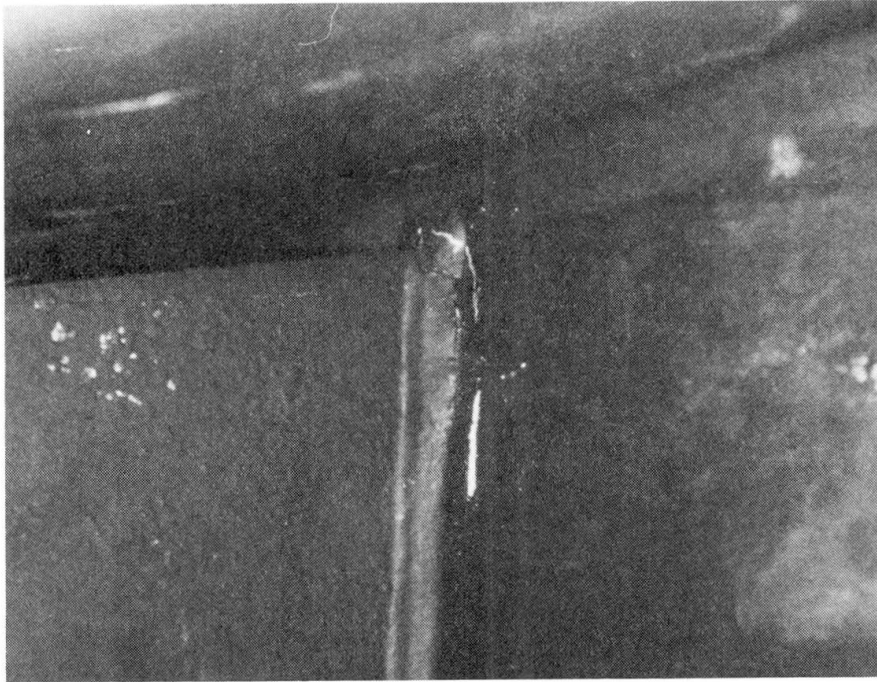
Fig. 2 Typical Crack in Transverse Connection Plate-Web Weld

The observed cracks all exhibited the characteristics that are associated with out-of-plane movement of the web in the relatively small gap at the end of the transverse connection plate. Figure 2 shows a photograph of a typical crack that was observed in the box on the outside web under the southbound lanes. Cracking has occurred in the web gap at the upper end of the transverse connection plate where no attachment was made to the tension flange in the negative moment region. This cracking is directly comparable to cracking that has been

observed elsewhere in bridges with longitudinal girders and transverse floor beams.

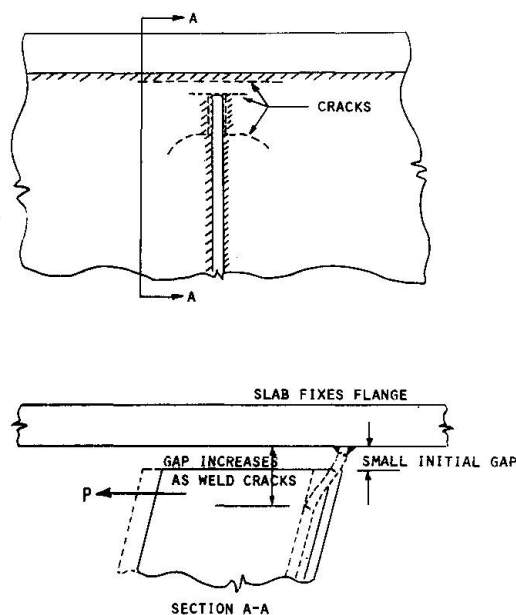
Fig. 3 Schematic of Crack Development

When the web gap is relatively small, i.e. 2.5 cm, the movement of the diaphragm introduces large stresses on the upper end of the fillet weld connecting the diaphragm to the girder web and in the web gap. This results in cracking of the diaphragm-web weld connection at smaller welds, as illustrated in Fig. 3. If this cracking is not arrested through some retrofitting procedure, eventually between 2.5 cm and 5.0 cm of the weld will crack introducing enough additional flexibility into the girder such that the web gap is forced into greater double curvature. This distortion is shown schematically in Fig. 3. Cracking along the web-flange weld connection and longitudinal cracking in the girder web at the lower end of the diaphragm-web connection crack result from this cyclic distortion. At several locations, cracks formed in the web without significant weld cracking.

This observed cracking results from the distortion of the curved box section and subsequent loading of the diaphragms due to this distortion. This causes forces to be introduced into the girder web adjacent to the top flange, since the transverse connection plate is not welded to the flange. At the bottom end of the transverse connection plates, fillet welds positively attach the plate to the bottom flange which is acting in compression. Therefore, no cracks can develop at this welded end.

Most of the cracking was detected in the outside web of the curved box section and not in the inside web. This is a result of the direction of the out-of-plane movement. The transverse angle that is attached to the upper ends of the web connection plates is relatively stiff compared to the web gap. The outside web is pulled in on one side by the transverse angle producing cyclic tension stresses and subsequent cracking. On the other side, the web is pushed out resulting in cyclic compressive stresses. Since the effective stress range is less, severe cracking was not as extensive prior to retrofitting the structure.

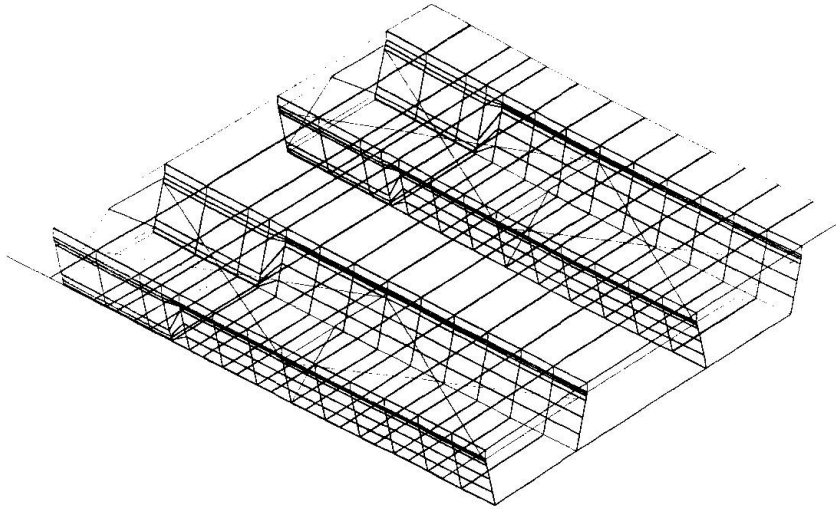
Fig. 4 Typical Finite Element Substructure Model

One unit of the three unit Ramp C Viaduct structure was analyzed using the finite element method. SAP4 - A Structural Analysis Program for Static and Dynamic Response of Linear Systems [3] was used to perform the two phase analysis. The first phase consisted of analyzing the entire structure utilizing a gross discretization to model overall structural behavior. The resultant displacements from this and subsequent analyses were used to load the boundaries of substructure models of the region of the structure adjacent to the point of detected fatigue cracking. This second phase produced a better representation of the web gap behavior while conserving computer resources. One such substructure is shown in Fig. 4.

Using an HS 20-44 truck statically placed on the structure to represent live load, the uncracked web gap was distorted sufficiently to produce cyclic stresses varying from  $-7.13$  MPa to  $+52.53$  MPa. The maximum stress range exceeds the fatigue limit of the weld toes and crack propagation is unavoidable. An

ongoing more extensive investigation suggests that the gap condition may be even more severe than this preliminary study indicates. The stress range in the gap, during passage of the HS 20-44 truck, may be as high as 90 MPa. Under random variable truck traffic, an effective stress range of 45 MPa ( $0.35^{1/3}$  times stress range H20) would result in visible cracking from the estimated 15 million vehicles that have crossed the structure since it was placed in service. Hence, the observed behavior is in agreement with experiment test data and predicted crack propagation.
