Zeitschrift: IABSE reports = Rapports AIPC = IVBH Berichte
Band: 39 (1982)

Artikel: Displacement-induced fatigue cracking of a box girder bridge
Autor: Fisher, John W. / Mertz, Dennis R. / Wu, Kuang-Chong
DOI: <https://doi.org/10.5169/seals-30171>

Displacement-Induced Fatigue Cracking of a Box Girder Bridge

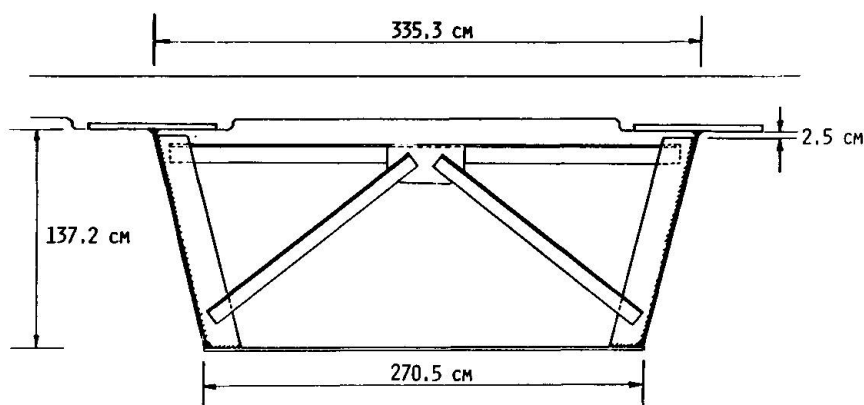
Fig. 1 Cross-Section of Curved Box Girder

Diaphragms and cross-framing are frequently used in curved box girders to prevent the cross-section from grossly distorting. It has been the practice to utilize transverse connection plates shop welded to the girder web and compression flange to connect the diaphragm members between the box girder webs. The end of the transverse connection plate is cut short or coped and fitted creating an unstiffened web gap adjacent to the tension flange. Figure 1 shows a cross-section of the curved box girder with the internal diaphragm in the negative moment region.

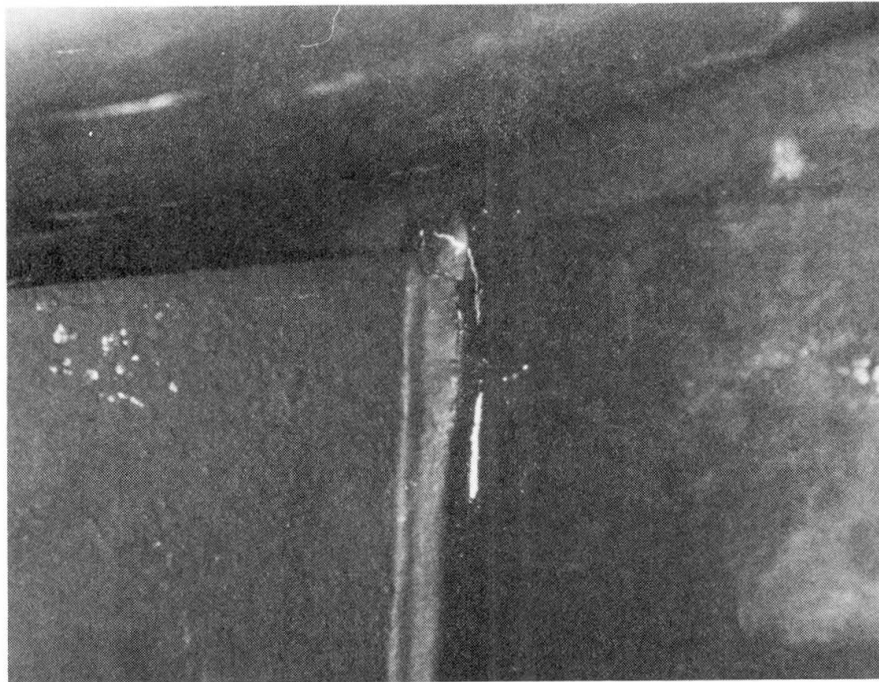
Fig. 2 Typical Crack in Transverse Connection Plate-Web Weld

The observed cracks all exhibited the characteristics that are associated with out-of-plane movement of the web in the relatively small gap at the end of the transverse connection plate. Figure 2 shows a photograph of a typical crack that was observed in the box on the outside web under the southbound lanes. Cracking has occurred in the web gap at the upper end of the transverse connection plate where no attachment was made to the tension flange in the negative moment region. This cracking is directly comparable to cracking that has been

observed elsewhere in bridges with longitudinal girders and transverse floor beams.

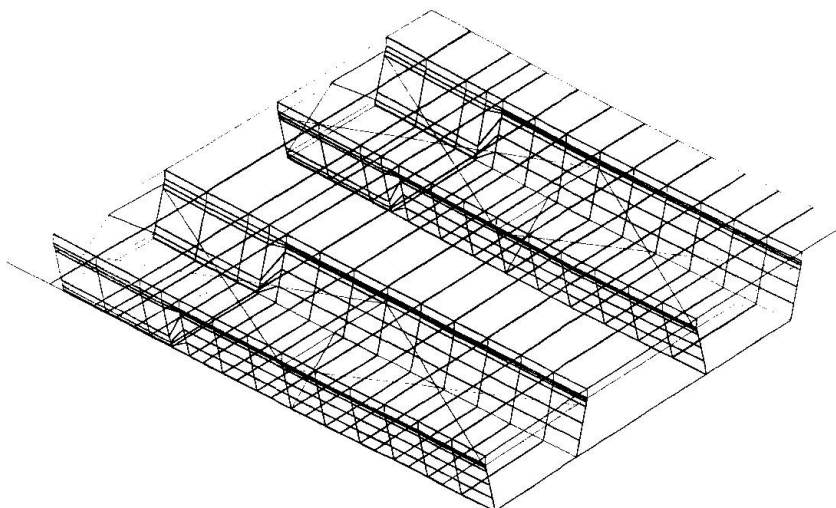
Fig. 4 Typical Finite Element Substructure Model

One unit of the three unit Ramp C Viaduct structure was analyzed using the finite element method. SAP4 - A Structural Analysis Program for Static and Dynamic Response of Linear Systems [3] was used to perform the two phase analysis. The first phase consisted of analyzing the entire structure utilizing a gross discretization to model overall structural behavior. The resultant displacements from this and subsequent analyses were used to load the boundaries of substructure models of the region of the structure adjacent to the point of detected fatigue cracking. This second phase produced a better representation of the web gap behavior while conserving computer resources. One such substructure is shown in Fig. 4.

Using an HS 20-44 truck statically placed on the structure to represent live load, the uncracked web gap was distorted sufficiently to produce cyclic stresses varying from -7.13 MPa to $+52.53$ MPa. The maximum stress range exceeds the fatigue limit of the weld toes and crack propagation is unavoidable. An

ongoing more extensive investigation suggests that the gap condition may be even more severe than this preliminary study indicates. The stress range in the gap, during passage of the HS 20-44 truck, may be as high as 90 MPa. Under random variable truck traffic, an effective stress range of 45 MPa ($0.35^{1/3}$ times stress range H20) would result in visible cracking from the estimated 15 million vehicles that have crossed the structure since it was placed in service. Hence, the observed behavior is in agreement with experiment test data and predicted crack propagation.
