Displacement-induced fatigue cracking of a box girder bridge

Zeitschrift: **IABSE reports = Rapports AIPC = IVBH Berichte**

Band (Jahr): **39 (1982)**

Displacement-Induced Fatigue Cracking of a Box Girder Bridge

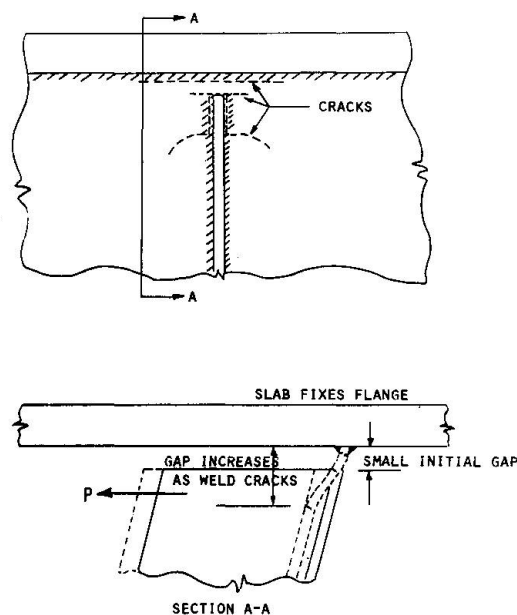
Fig. 3 Schematic of Crack Development

When the web gap is relatively small, i.e. 2.5 cm, the movement of the diaphragm introduces large stresses on the upper end of the fillet weld connecting the diaphragm to the girder web and in the web gap. This results in cracking of the diaphragm-web weld connection at smaller welds, as illustrated in Fig. 3. If this cracking is not arrested through some retrofitting procedure, eventually between 2.5 cm and 5.0 cm of the weld will crack introducing enough additional flexibility into the girder such that the web gap is forced into greater double curvature. This distortion is shown schematically in Fig. 3. Cracking along the web-flange weld connection and longitudinal cracking in the girder web at the lower end of the diaphragm-web connection crack result from this cyclic distortion. At several locations, cracks formed in the web without significant weld cracking.

This observed cracking results from the distortion of the curved box section and subsequent loading of the diaphragms due to this distortion. This causes forces to be introduced into the girder web adjacent to the top flange, since the transverse connection plate is not welded to the flange. At the bottom end of the transverse connection plates, fillet welds positively attach the plate to the bottom flange which is acting in compression. Therefore, no cracks can develop at this welded end.
