**Zeitschrift:** IABSE reports = Rapports AIPC = IVBH Berichte  
**Band:** 39 (1982)

**Rubrik:** Session 3: Rehabilitation and repair of bridges

## Maintenance of Reinforced and Prestressed Concrete Bridges in the Federal Republic of Germany

### Heribert THUL

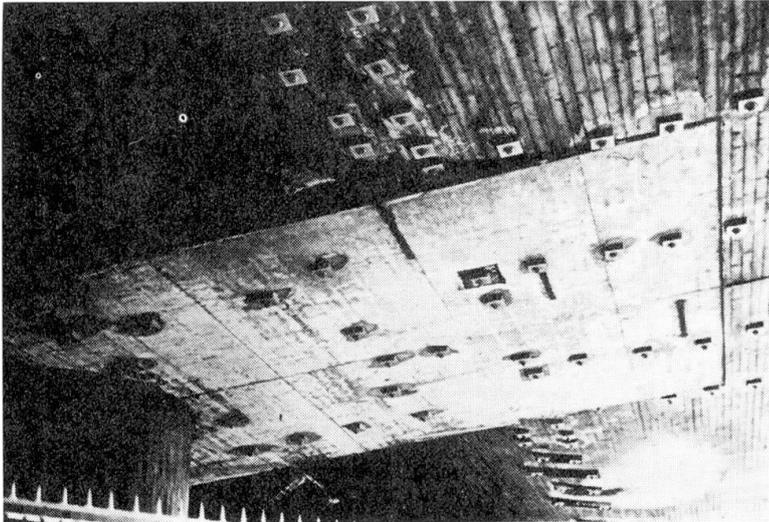
- We discovered another type of damage in the Schmargendorf bridge. This bridge was built between 1959 and 1961. A faulty assessment of the shear stresses together with insufficient ordinary reinforcement, the omission of reinforcement to counteract the effects of the indirect support of stringers at the cross-beam, as well as a lack of reinforcement to cover the forces due to horizontally curved prestressing tendons resulted, in this case, in severe cracking and corrosion of some tendons. Despite repeated rehabilitation and strengthening measures

Fig. 15 Underside view of the region of pier with vertical additional tendons inside the structure (1st rehabilitation) (Schmargendorf bridge)

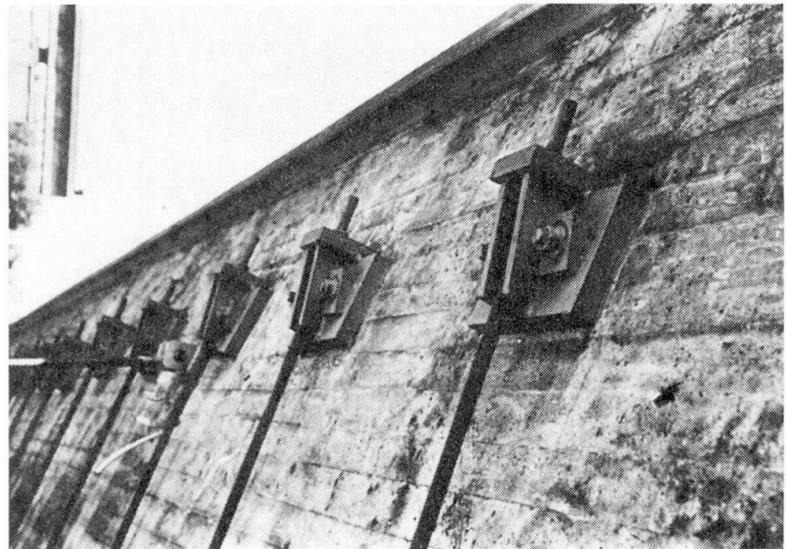
Fig. 16 Underside view with anchoring of outside additional tendons (1st rehabilitation) (Schmargendorf bridge)

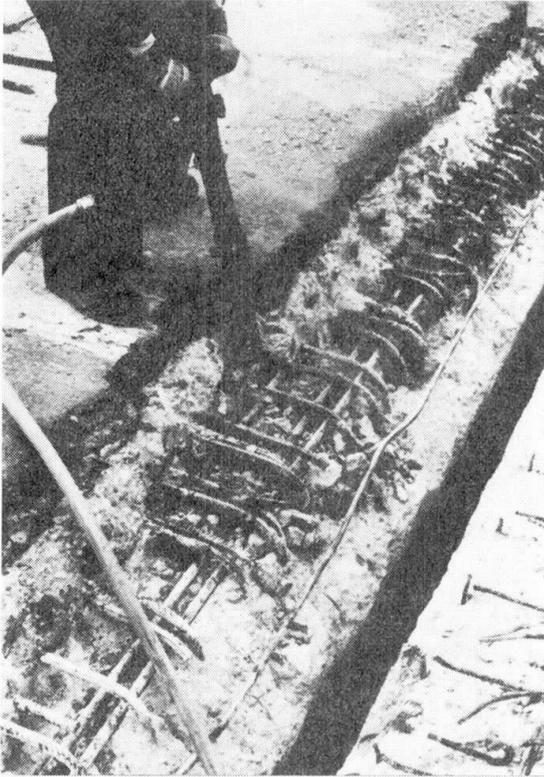
A great number of cracks and surface scaling of the concrete, especially at the ends of the prefabricated girders and at the cross beams, constituted a risk to the stability at the points of support (Figures 17 and 18).

Fig. 17 Expansion joint removed  
(valley bridge  
Pfädchensgraben)

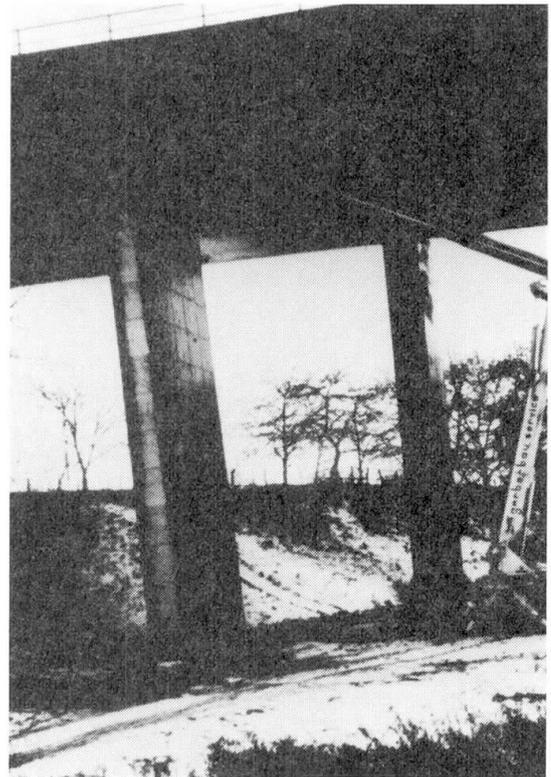
- As an example of severe damage caused by the failure of bearings I would like to mention the valley bridge Blockheide.

There, extremely low temperatures led to the roller bearings rolling off. The expansion movements were calculated in accordance with the code valid at the time the design was made. However they did not contain any calculational or constructional safety in view of the probable deformation values.

Fig. 19 Damage to the pier due to  
rolled off bearing (valley  
bridge Blockheide)

Owing to the failure of a roller bearing the superstructure sagged by 27 cm which caused an eccentric load on the pier and entailed heavy damage to the super- and substructures (Figure 19).

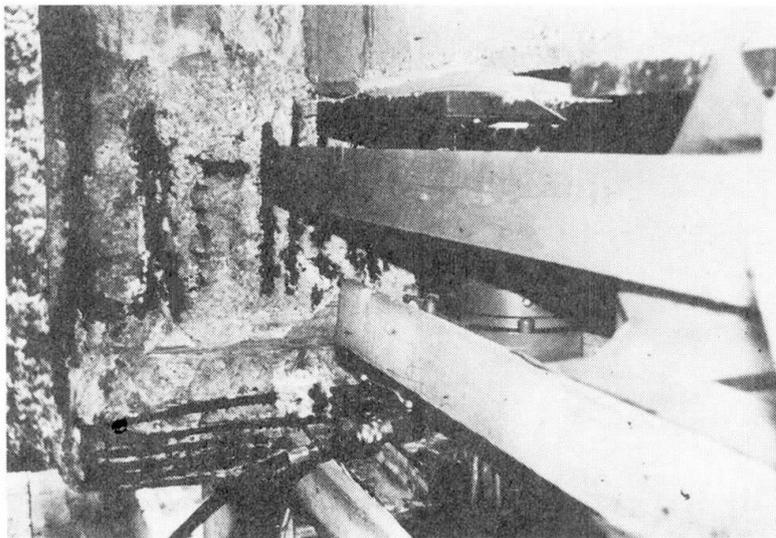
Fig. 18 Jacks under cross-beam to relieve longi-  
tudinal girder during repair work  
(valley bridge Pfädchensgraben)

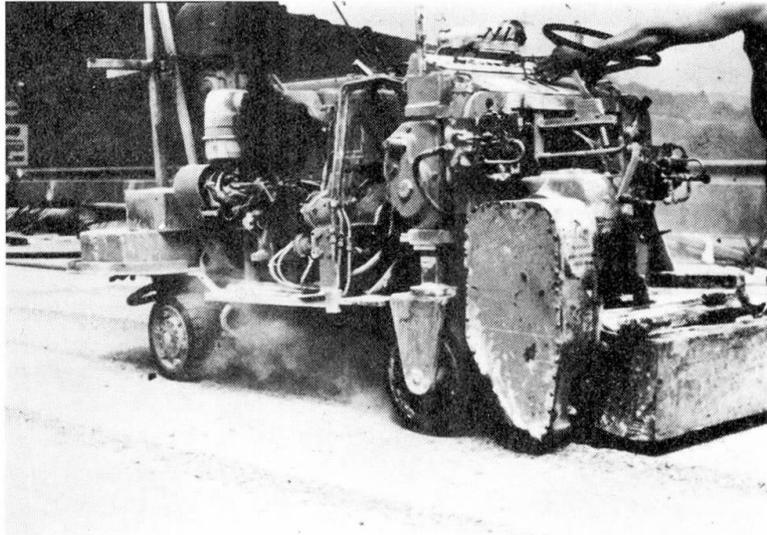
Fig. 20 Mechanical removal of carbonated top concrete layer from carriageway (bridge over the river Nahe at Dietersheim)

- In the case of damage to the concrete deck slab due to chloride, both the pavement and the waterproofing must first be removed. In case of surface contamination the concrete is either treated mechanically or by high-pressure water. If required, deteriorated concrete should be removed. In case of contamination to greater depths, contaminated concrete is completely removed and replaced by new concrete with resin applied as a bonding agent. After that a bituminous waterproofing or an elastic plastic coating is applied by spraying. The advantage of the spraying method is that subsequently occurring cracks can be bridged and the structure thus be permanently protected.

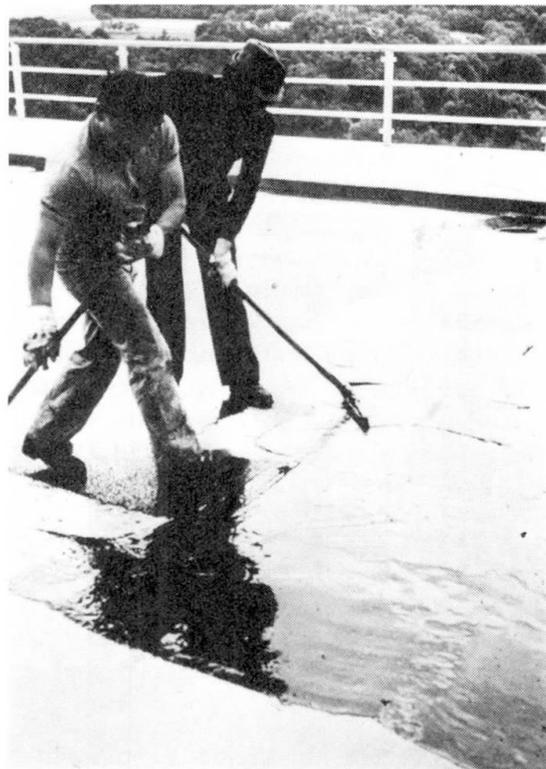
Fig. 21 Spreading of the bitumen epoxy resin waterproofing by hand (bridge over the Kocher valley at Geislingen)

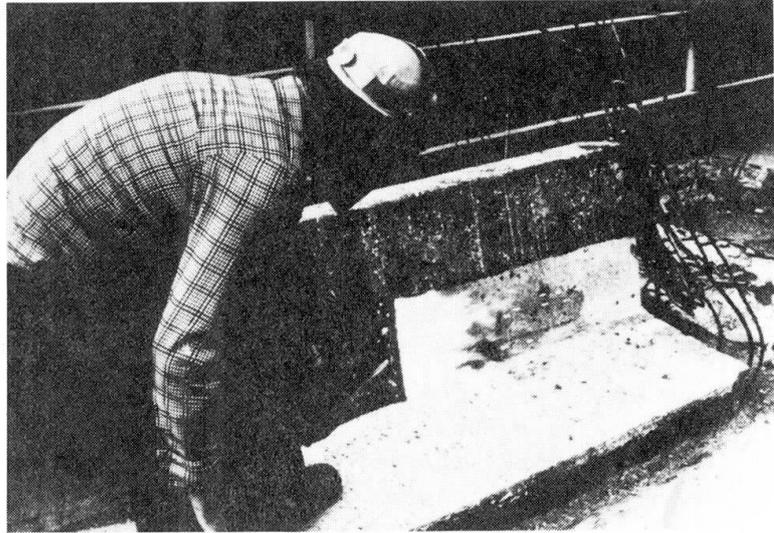
Fig. 22 Flame-cleaning of carbonated top concrete layer of concrete guard kerbs (valley bridge Pfädchensgraben)

- In the case of defects in load-carrying concrete components, the loose and the chloride contaminated concrete is removed and the reinforcement sandblasted and corrosion-protected by a double coating. Then the concrete is replaced by shotcrete to the required dimension.

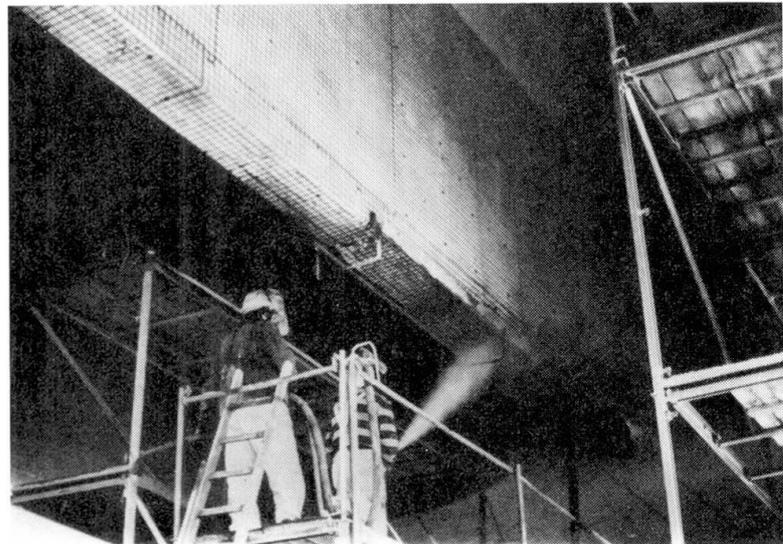
Fig. 23 Restoration of the required dimension by means of shotcrete (bridge over the river Lahn at the Taubenstein)

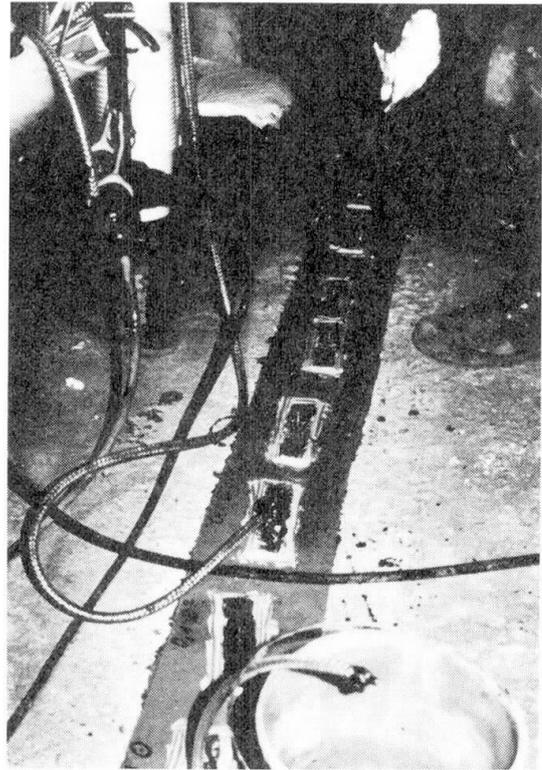
Fig. 24 Injection of joints with epoxy resin (bridge over the Lahn valley near Limburg)

Only cold-hardening, solvent-free epoxy resin systems are suitable for injection work. The crack width at the place of injection must have a minimum width of 0.1 to 0.2 mm in order to achieve a successful injection. Injection of cracks is then possible for crack widths up to less than 0.02 mm. Before injection the crack must be sealed at its surface.

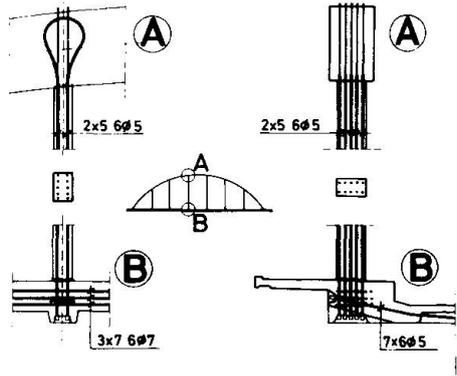
During the detailed surveying vertical cracks almost on all suspenders were observed. In view of the vital significance of these members, possible causes of deterioration, the actual state and the necessity of interventions were analysed in detail. The results of the examination of concrete showed that the required

Fig. 2 Suspender cables

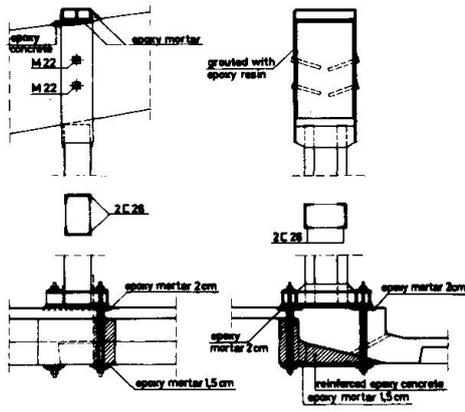
Fig. 3 Suspender rehabilitation

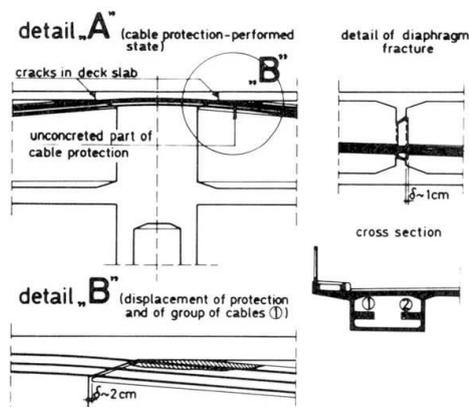
Fig.6 Cable damage arrangement

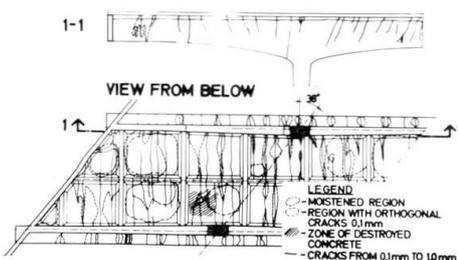
Fig.8 Detail of cracks

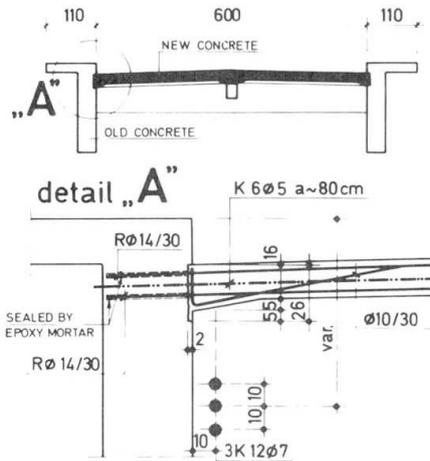
This fact required an urgent intervention. Opposite to the author's opinion that the best solution was to construct a new bridge, nevertheless, for certain reasons (of administrative nature) it was concluded to rehabilitate the existing bridge. The old carriageway slab was removed and a new one made (Fig.9).

Fig.9 Replaced deck slab
