Zeitschrift: IABSE reports = Rapports AIPC = IVBH Berichte
Band: 39 (1982)

Rubrik: Session 3: Rehabilitation and repair of bridges

Maintenance of Reinforced and Prestressed Concrete Bridges in the Federal Republic of Germany

Heribert THUL

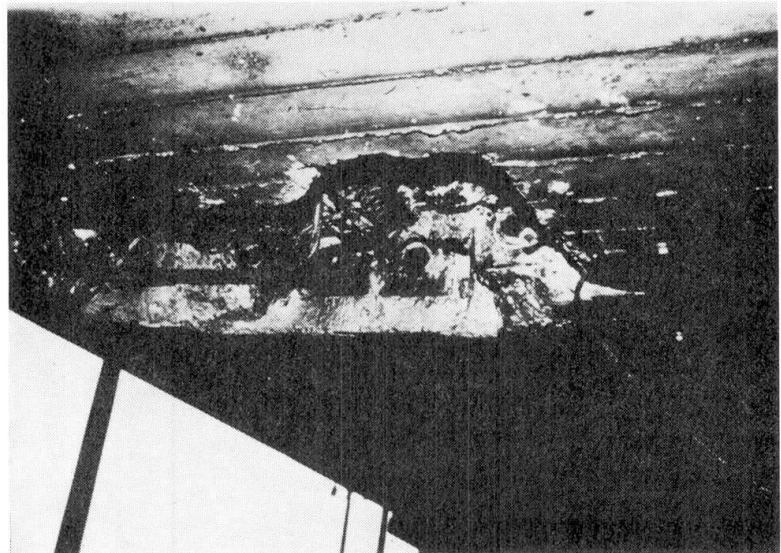
Proof of the stresses due to non-uniform temperature through the cross-section of the superstructure not previously required, moments in the coupling joints not covered by reinforcement, as well as the lack of sufficient minimum reinforcement at the coupling joints caused serious cracks in some bridges, and in one case even the breaking of tendons at such a joint. It will probably be necessary in the long run to reinforce about 15 prestressed concrete bridges by means of additional tendons or bonded plates or bonded reinforced concrete plates.

The costs of the repair and reinforcement work are not inconsiderable in these cases. In a particular case, e.g. the fly-over Prinzenallee in Düsseldorf, they amounted to about 5.5 million DM (Figure 14).

Fig. 14 Underside view of hollow box in the region of coupling joint - laid open (flyover Prinzenallee)

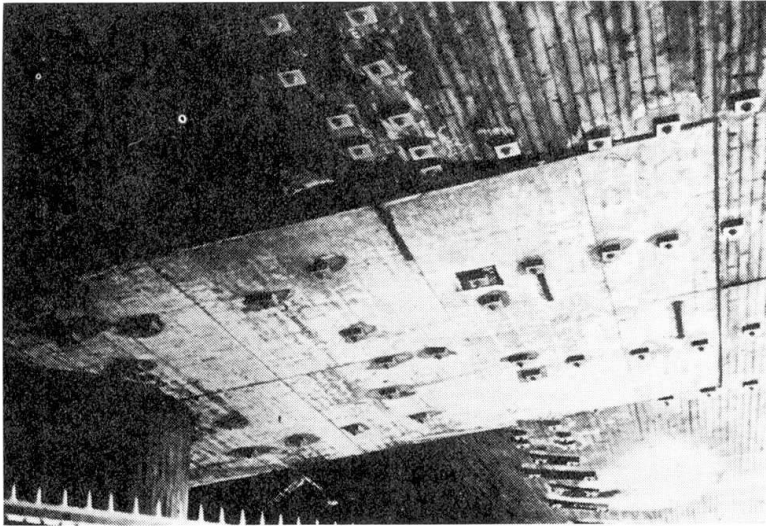
- We discovered another type of damage in the Schmargendorf bridge. This bridge was built between 1959 and 1961. A faulty assessment of the shear stresses together with insufficient ordinary reinforcement, the omission of reinforcement to counteract the effects of the indirect support of stringers at the cross-beam, as well as a lack of reinforcement to cover the forces due to horizontally curved prestressing tendons resulted, in this case, in severe cracking and corrosion of some tendons. Despite repeated rehabilitation and strengthening measures

Fig. 15 Underside view of the region of pier with vertical additional tendons inside the structure (1st rehabilitation) (Schmargendorf bridge)

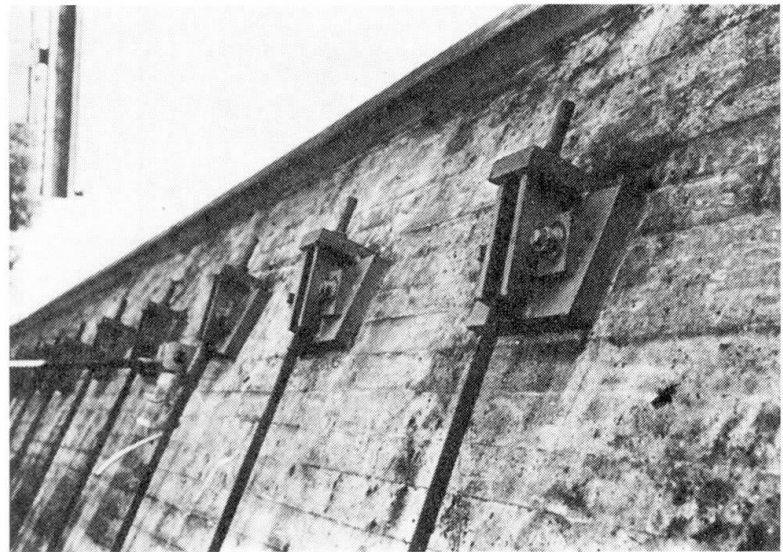
Fig. 16 Underside view with anchoring of outside additional tendons (1st rehabilitation) (Schmargendorf bridge)

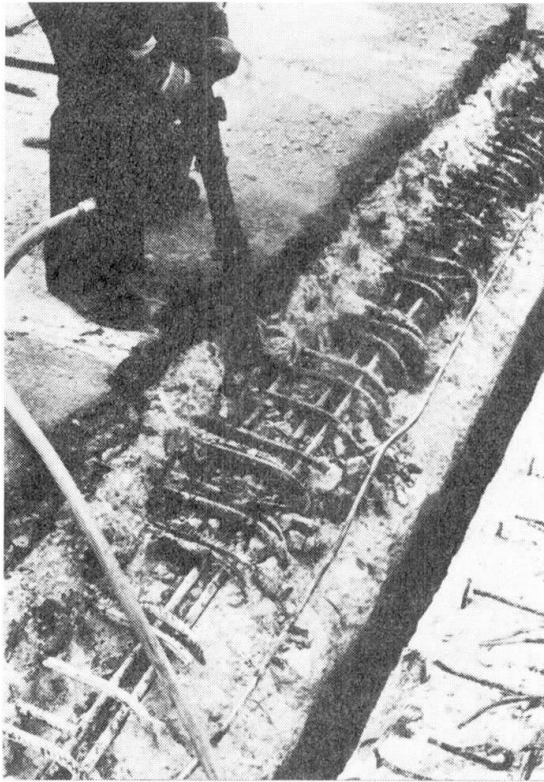
A great number of cracks and surface scaling of the concrete, especially at the ends of the prefabricated girders and at the cross beams, constituted a risk to the stability at the points of support (Figures 17 and 18).

Fig. 17 Expansion joint removed
(valley bridge
Pfädchensgraben)

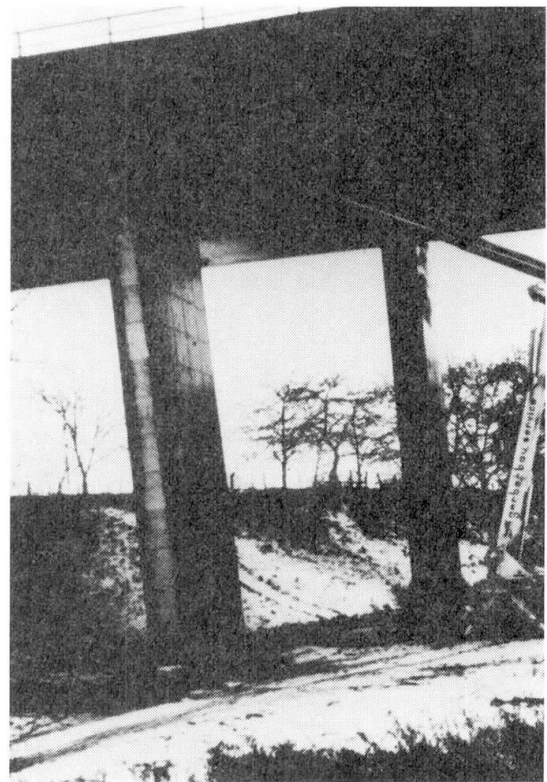
- As an example of severe damage caused by the failure of bearings I would like to mention the valley bridge Blockheide.

There, extremely low temperatures led to the roller bearings rolling off. The expansion movements were calculated in accordance with the code valid at the time the design was made. However they did not contain any calculational or constructional safety in view of the probable deformation values.

Fig. 19 Damage to the pier due to
rolled off bearing (valley
bridge Blockheide)

Owing to the failure of a roller bearing the superstructure sagged by 27 cm which caused an eccentric load on the pier and entailed heavy damage to the super- and substructures (Figure 19).

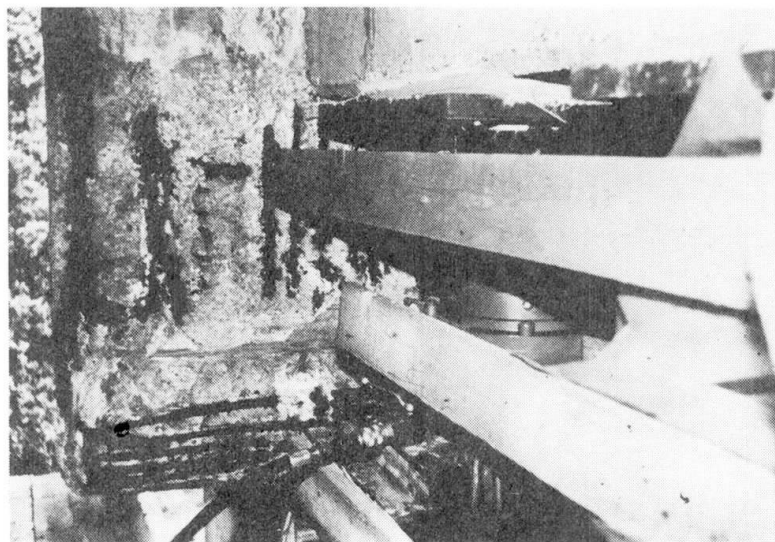
Fig. 18 Jacks under cross-beam to relieve longi-
tudinal girder during repair work
(valley bridge Pfädchensgraben)

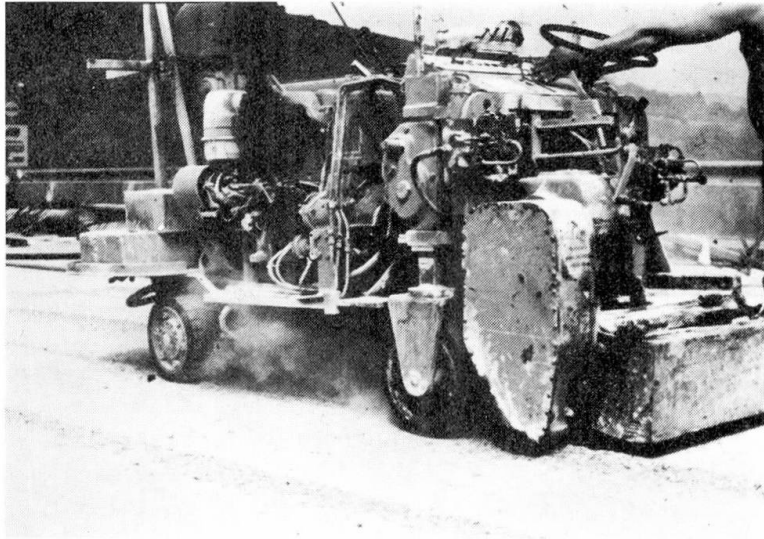
Fig. 20 Mechanical removal of carbonated top concrete layer from carriageway (bridge over the river Nahe at Dietersheim)

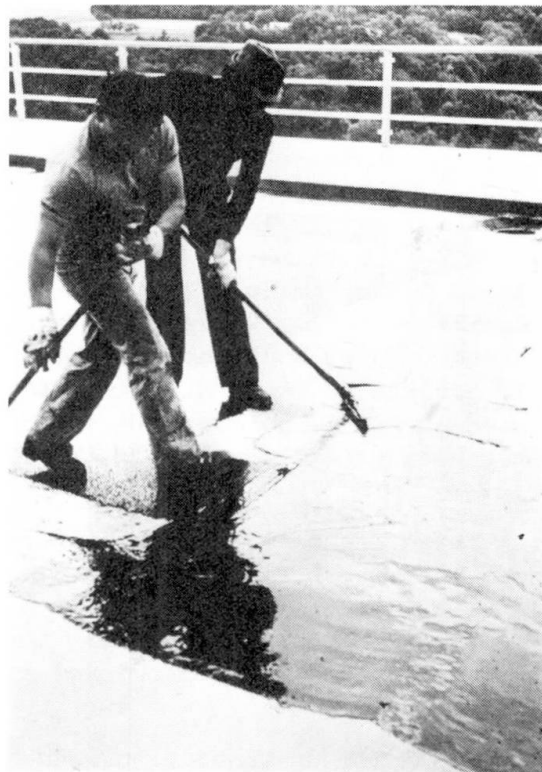
Fig. 21 Spreading of the bitumen epoxy resin waterproofing by hand (bridge over the Kocher valley at Geislingen)

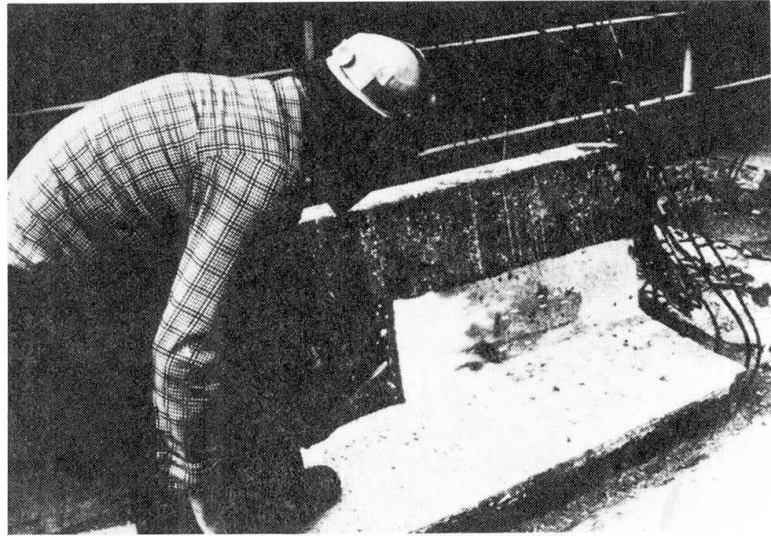
Fig. 22 Flame-cleaning of carbonated top concrete layer of concrete guard kerbs (valley bridge Pfädchensgraben)

- In the case of defects in load-carrying concrete components, the loose and the chloride contaminated concrete is removed and the reinforcement sandblasted and corrosion-protected by a double coating. Then the concrete is replaced by shotcrete to the required dimension.

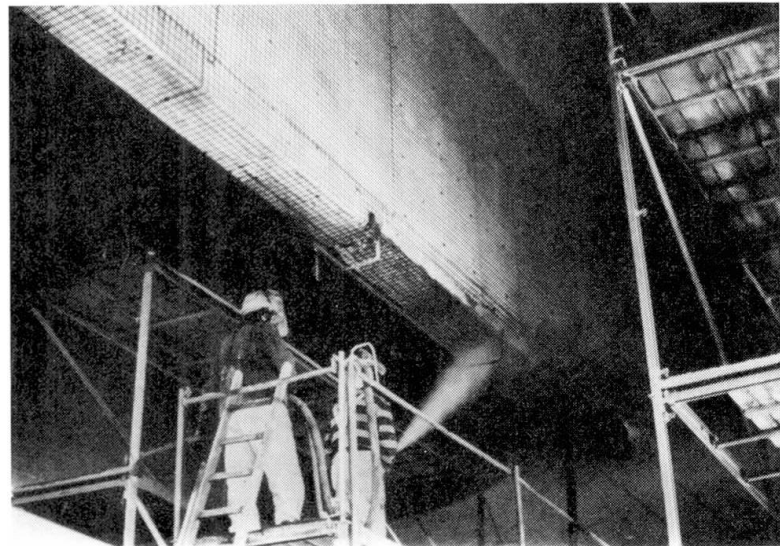
Fig. 23 Restoration of the required dimension by means of shotcrete (bridge over the river Lahn at the Taubenstein)

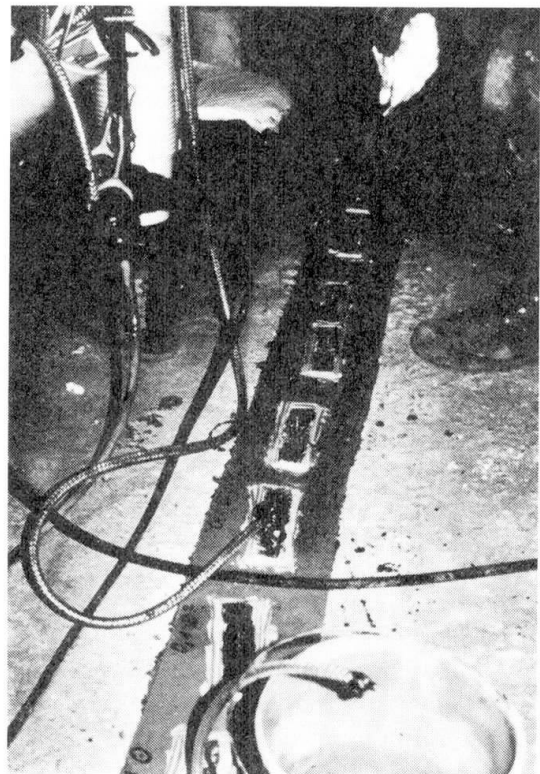
Fig. 24 Injection of joints with epoxy resin (bridge over the Lahn valley near Limburg)

Only cold-hardening, solvent-free epoxy resin systems are suitable for injection work. The crack width at the place of injection must have a minimum width of 0.1 to 0.2 mm in order to achieve a successful injection. Injection of cracks is then possible for crack widths up to less than 0.02 mm. Before injection the crack must be sealed at its surface.

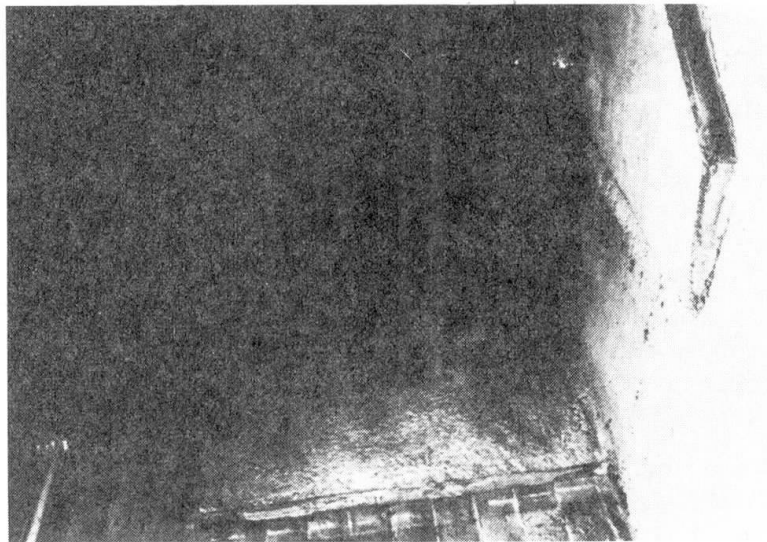
Fig. 25 Strengthening of coupling joints by means of bonded reinforced concrete plates in the hollow box (bridge over the Lahn valley near Limburg)

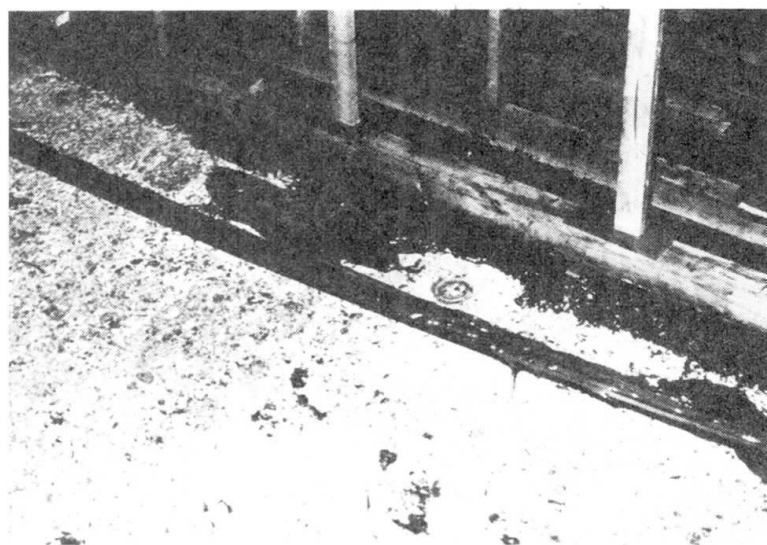
Fig. 26 Application of the steel plate (valley bridge Sterbecke)

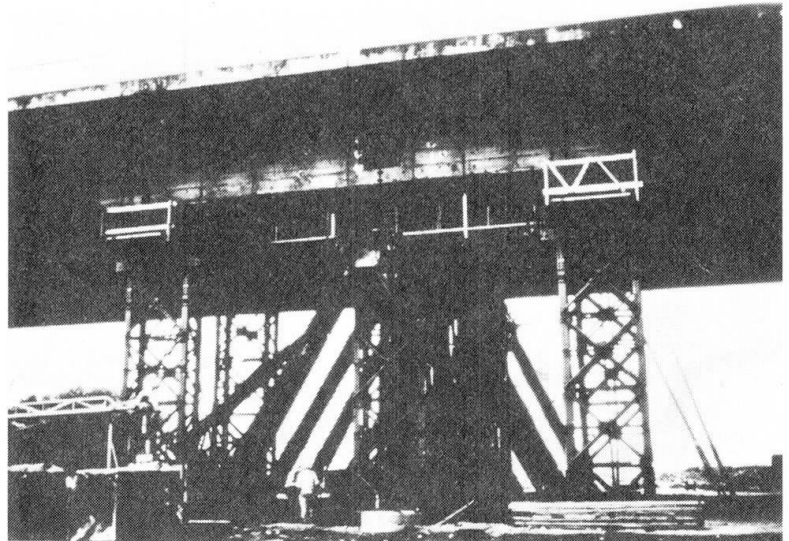
Fig. 27 Erecting tower for the replacement of the bearing (bridge over the river Main at Hochheim

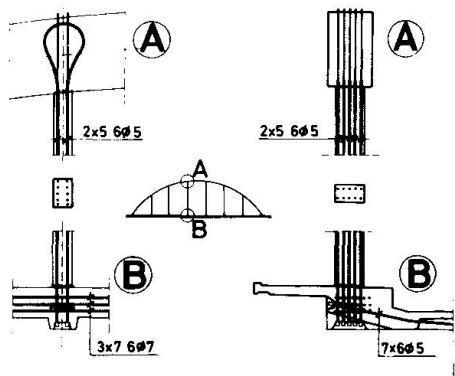
Fig.2 Suspender cables

During the detailed surveying vertical cracks almost on all suspenders were observed. In view of the vital significance of these members, possible causes of deterioration, the actual state and the necessity of interventions were analysed in detail. The results of the examination of concrete showed that the required

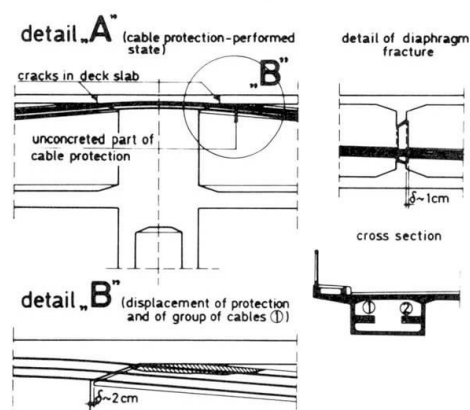
Fig.6 Cable damage arrangement

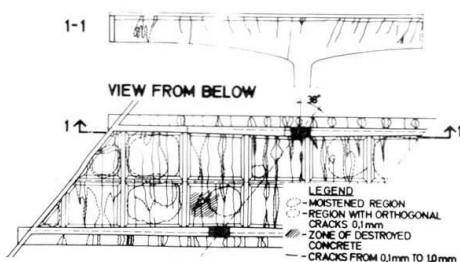
Fig.8 Detail of cracks

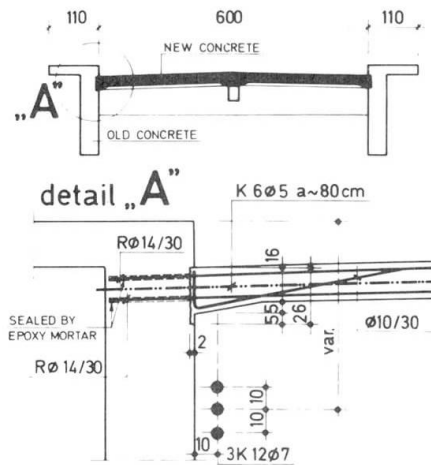
Fig.9 Replaced deck slab

This fact required an urgent intervention. Opposite to the author's opinion that the best solution was to construct a new bridge, nevertheless, for certain reasons (of administrative nature) it was concluded to rehabilitate the existing bridge. The old carriageway slab was removed and a new one made (Fig.9). The connection

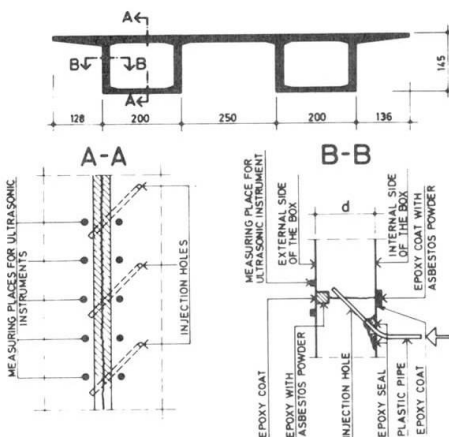
Even before the bridges were put into operation, four structures, due to the appearance of cracks, were improved by additional prestressing with cables inside the box. Subsequent detailed observation revealed a comparatively large number of cracks, as well as an unattained prestressing force and badly protected cables, attacked by corrosion, and even completely broken (Fig.10).
