Rehabilitation and Repair of Bridges

Maintenance of Reinforced and Prestressed Concrete Bridges in the Federal Republic of Germany

Heribert THUL

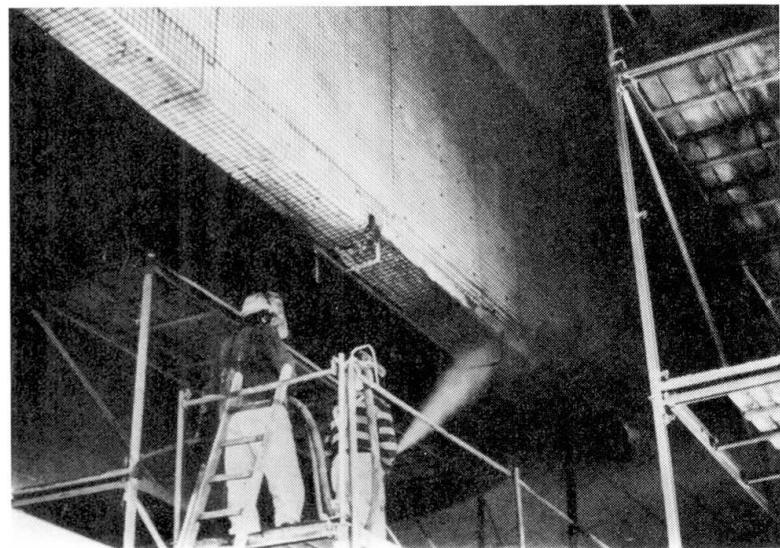
Fig. 23 Restoration of the required dimension by means of shotcrete (bridge over the river Lahn at the Taubenstein)

- In the case of defects in load-carrying concrete components, the loose and the chloride contaminated concrete is removed and the reinforcement sandblasted and corrosion-protected by a double coating. Then the concrete is replaced by shotcrete to the required dimension.

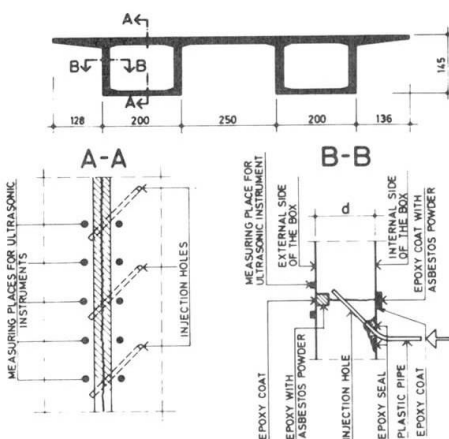
Even before the bridges were put into operation, four structures, due to the appearance of cracks, were improved by additional prestressing with cables inside the box. Subsequent detailed observation revealed a comparatively large number of cracks, as well as an unattained prestressing force and badly protected cables, attacked by corrosion, and even completely broken (Fig.10).
