Artikel: Repairs on the Givors Bridge
Autor: Bouvy, Bernhard / Moreau, Philippe
DOI: <https://doi.org/10.5169/seals-30175>

Repairs on the Givors Bridge

Bernhard BOUVY

Philippe MOREAU

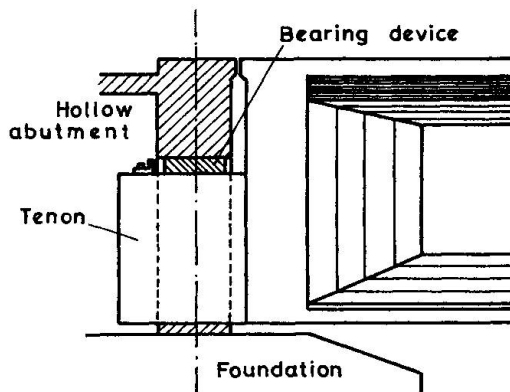
Fig. 3 - Abutment device
(longitudinal section)

The abutments are sunk into the access embankments and are each founded on open caissons. The deck-abutment connection has the particular feature of opposing the permanent raising of the bank span ends thanks to a tenon and mortise device, each tenon being in the projection of a web. Free expansion and rotations on the abutments are provided by bearing devices in reinforced neoprene. The abutment is transversely prestressed to withstand the forces applied to it, a lean concrete ballasting being used to prevent lifting.

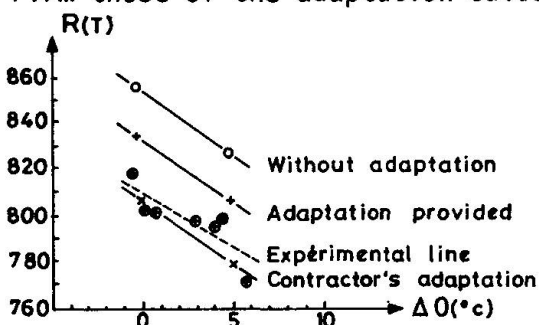
Fig.5 - Variation of bearing pressure on abutment with temperature gradient

Let us finally point out that the results of bearing pressure measurements confirm those of the adaptation calculations of the contracting firm.
