**Zeitschrift:** IABSE reports = Rapports AIPC = IVBH Berichte  
**Band:** 39 (1982)

**Artikel:** Repairs on the Givors Bridge  
**Autor:** Bouvy, Bernhard / Moreau, Philippe  
**DOI:** <https://doi.org/10.5169/seals-30175>

## Repairs on the Givors Bridge

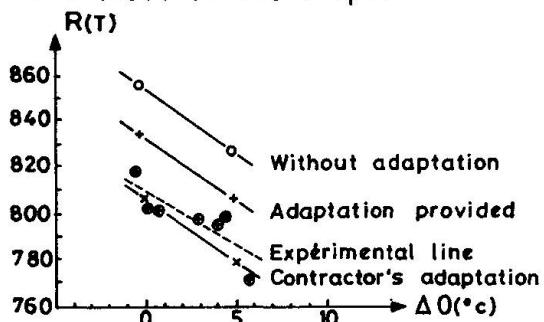
Fig.5 - Variation of bearing pressure on abutment with temperature gradient

All these accumulated factors bring about tensile stresses of 4,7 Mpa in the lower slab, largely sufficient to explain the cracking especially as the joints between voussoirs are not reinforced.

Let us finally point out that the results of bearing pressure measurements confirm those of the adaptation calculations of the contracting firm.
