**Artikel:** Repairs on the Givors Bridge  
**Autor:** Bouvy, Bernhard / Moreau, Philippe  
**DOI:** <https://doi.org/10.5169/seals-30175>

## Repairs on the Givors Bridge

The Givors motorway bridge exhibited certain disorders which were liable, with time, to reduce its bearing capacity and would have required it to be taken out of service in the longer term. Repairs consisted in providing additional prestressing and protecting the deck against the action of aggressive environmental agents.

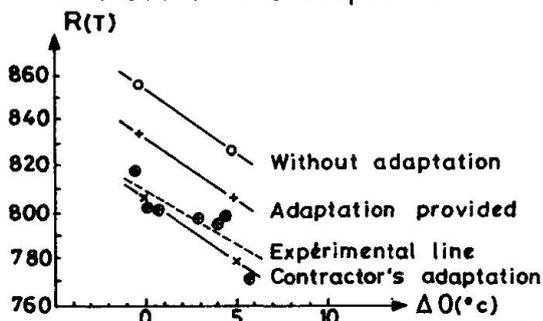
Fig.5 - Variation of bearing pressure on abutment with temperature gradient

Let us finally point out that the results of bearing pressure measurements confirm those of the adaptation calculations of the contracting firm.
