Wheeling Suspension Bridge, USA – Case Study

Raymond McCABE

Howard Needles Tammen & Bergendoff
New York, NY, USA

This paper reports on all aspects of the inspection, condition and rehabilitation of the Wheeling Suspension Bridge, WV, USA, one of the worlds oldest existing suspension bridges.

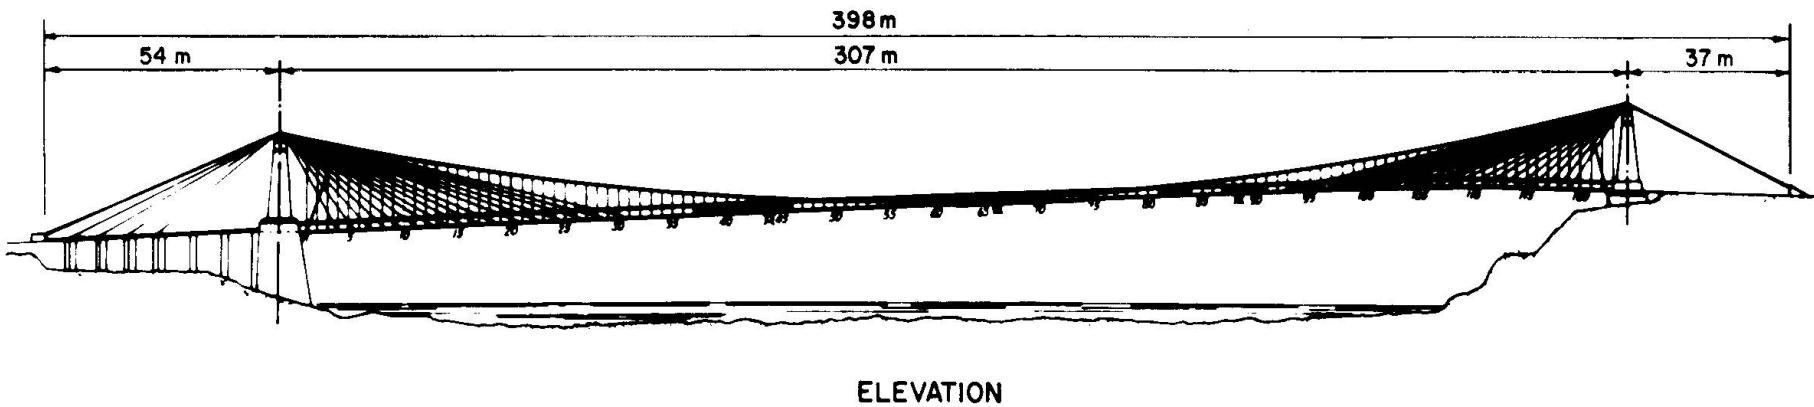
ELEVATION

The present day bridge has a main span of 307 meters between centers of masonry towers. The bridge roadway is 6.1 meters wide accommodating two lanes of automobile traffic and there are two 1.2 meter sidewalks. A general elevation and typical deck cross section of the bridge are given in Figure 1.

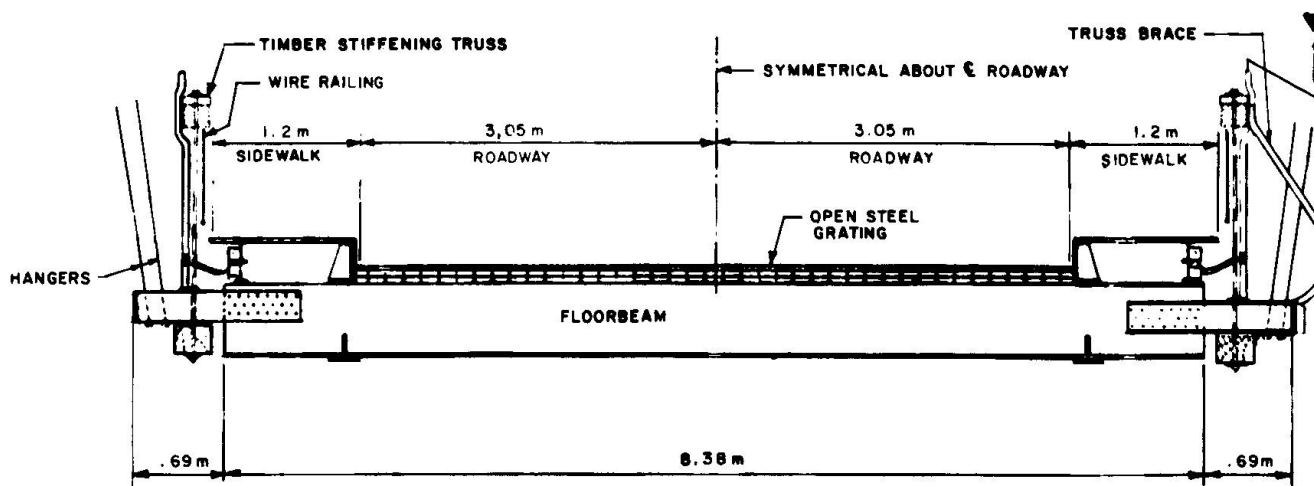
TYPICAL DECK CROSS SECTION

In general, the cable hangers exhibited minor corrosion. As shown in Figure 1, one hanger from each cable is connected to the floorbeam at every panel point. At a number of panel point locations, one of the hangers was slack and carrying no load while the adjacent hanger was carrying the full load.
