Wheeling Suspension Bridge, USA – Case Study

Raymond McCABE

Howard Needles Tammen & Bergendoff
New York, NY, USA

This paper reports on all aspects of the inspection, condition and rehabilitation of the Wheeling Suspension Bridge, WV, USA, one of the worlds oldest existing suspension bridges.

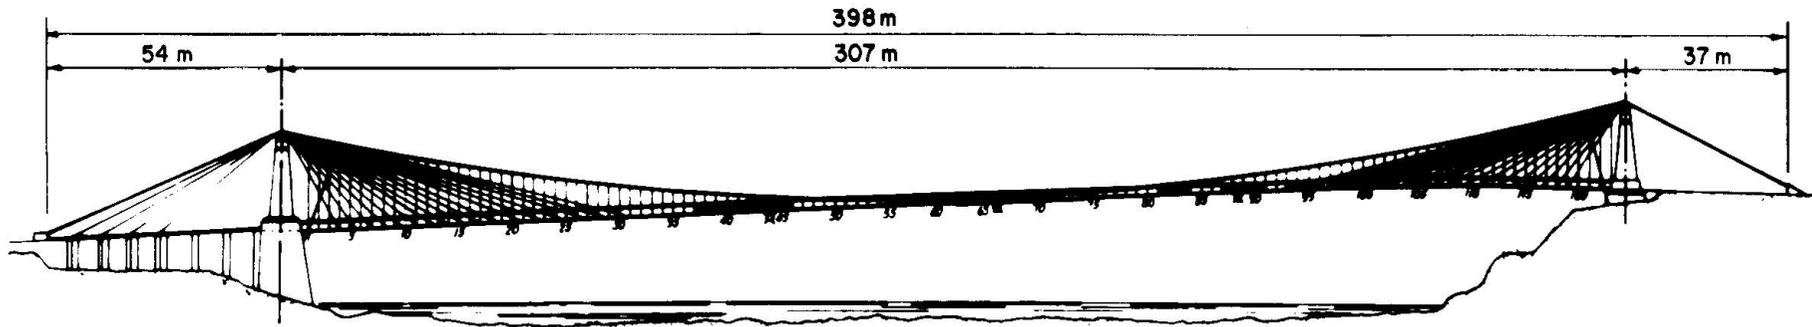
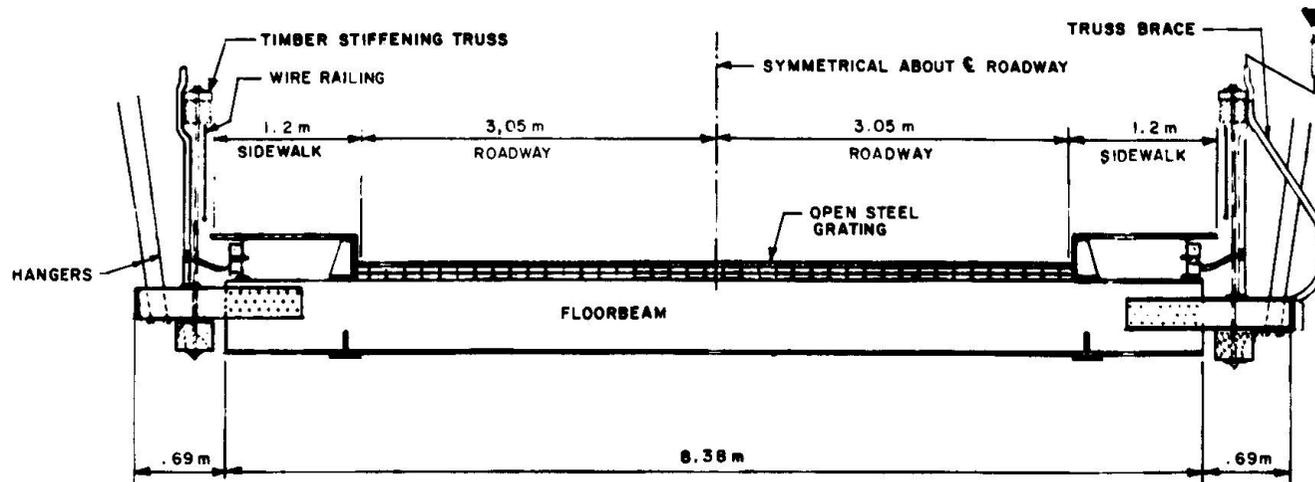
WHEELING SUSPENSION BRIDGE
FIGURE 1

In general, the cable hangers exhibited minor corrosion. As shown in Figure 1, one hanger from each cable is connected to the floorbeam at every panel point. At a number of panel point locations, one of the hangers was slack and carrying no load while the adjacent hanger was carrying the full load.
