**Artikel:** Wheeling suspension bridge, USA: case study  
**Autor:** McCabe, Raymond  
**DOI:** <https://doi.org/10.5169/seals-30179>

## **Wheeling Suspension Bridge, USA — Case Study**

This paper reports on all aspects of the inspection, condition and rehabilitation of the Wheeling Suspension Bridge, WV, USA, one of the worlds oldest existing suspension bridges.

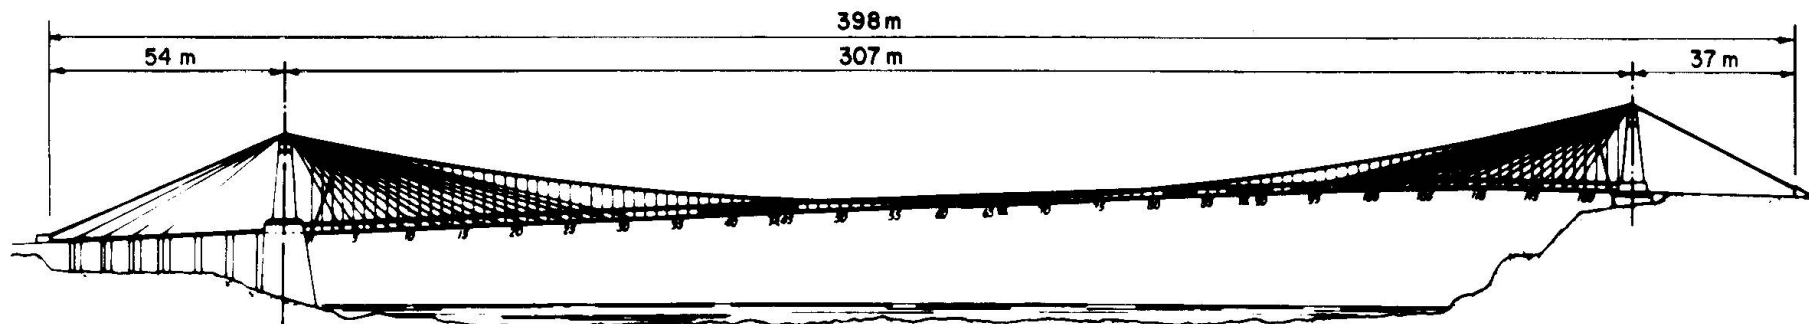
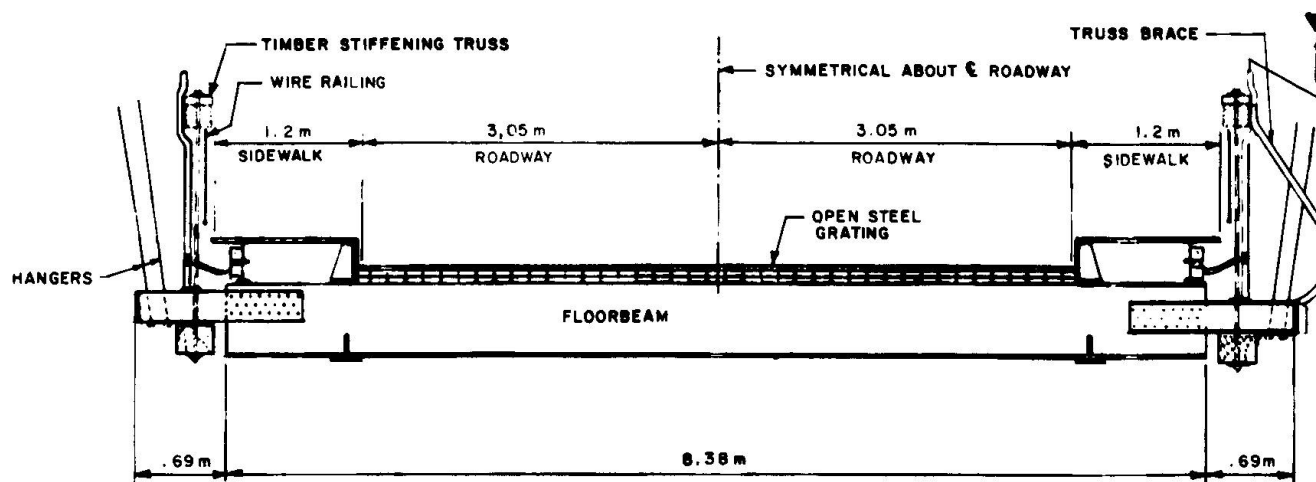
WHEELING SUSPENSION BRIDGE  
FIGURE 1

The present day bridge has a main span of 307 meters between centers of masonry towers. The bridge roadway is 6.1 meters wide accommodating two lanes of automobile traffic and there are two-1.2 meter sidewalks. A general elevation and typical deck cross section of the bridge are given in Figure 1.

In general, the cable hangers exhibited minor corrosion. As shown in Figure 1, one hanger from each cable is connected to the floorbeam at every panel point. At a number of panel point locations, one of the hangers was slack and carrying no load while the adjacent hanger was carrying the full load.
