**Zeitschrift:** IABSE reports = Rapports AIPC = IVBH Berichte  
**Band:** 39 (1982)

### **Wheeling Suspension Bridge, USA — Case Study**

#### **Raymond McCABE**

Howard Needles Tammen & Bergendoff  
New York, NY, USA

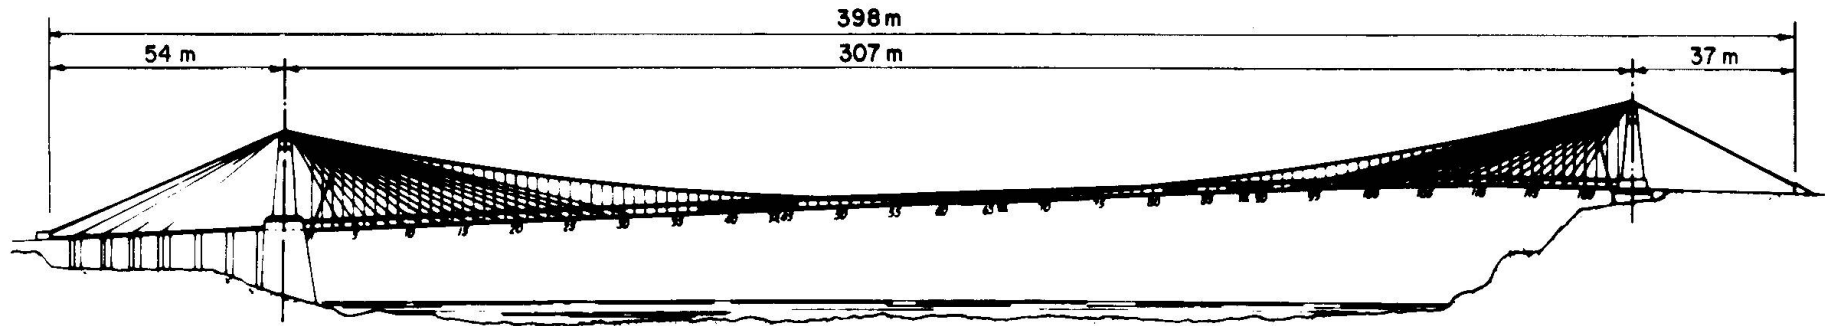
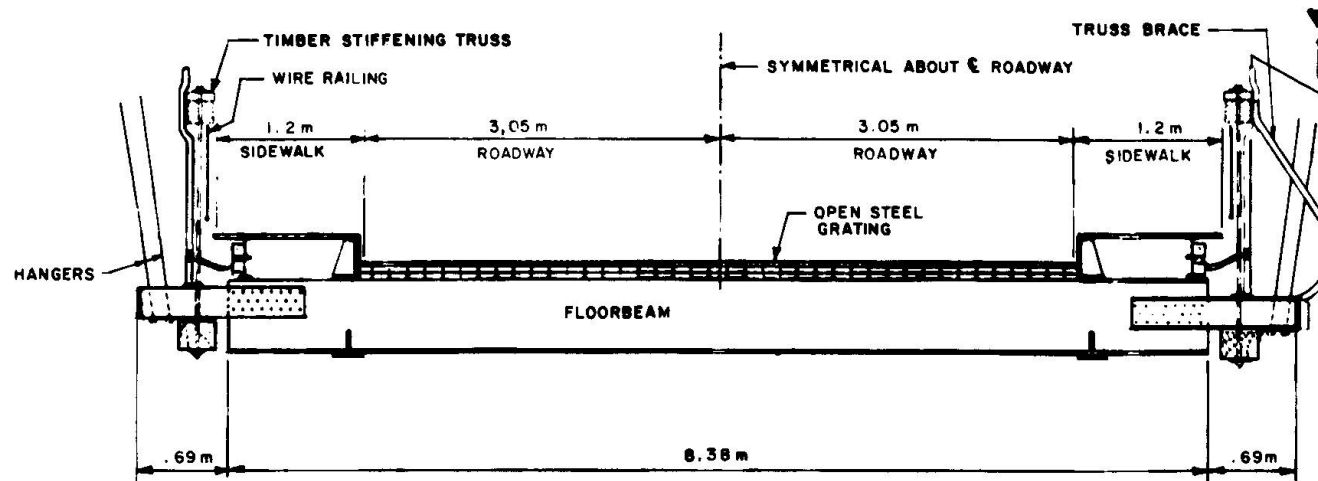
WHEELING SUSPENSION BRIDGE  
FIGURE 1

The present day bridge has a main span of 307 meters between centers of masonry towers. The bridge roadway is 6.1 meters wide accommodating two lanes of automobile traffic and there are two-1.2 meter sidewalks. A general elevation and typical deck cross section of the bridge are given in Figure 1.

In general, the cable hangers exhibited minor corrosion. As shown in Figure 1, one hanger from each cable is connected to the floorbeam at every panel point. At a number of panel point locations, one of the hangers was slack and carrying no load while the adjacent hanger was carrying the full load.
