**Zeitschrift:** IABSE reports = Rapports AIPC = IVBH Berichte  
**Band:** 41 (1983)

**Artikel:** Accidents involving bridges  
**Autor:** Frandsen, Aksel G.  
**DOI:** <https://doi.org/10.5169/seals-31652>

**Accidents Involving Bridges**  
Accidents impliquant des ponts  
Brückenunfälle

**Aksel G. FRANSEN**  
Consulting Engineer  
Cowiconsult  
Copenhagen, Denmark

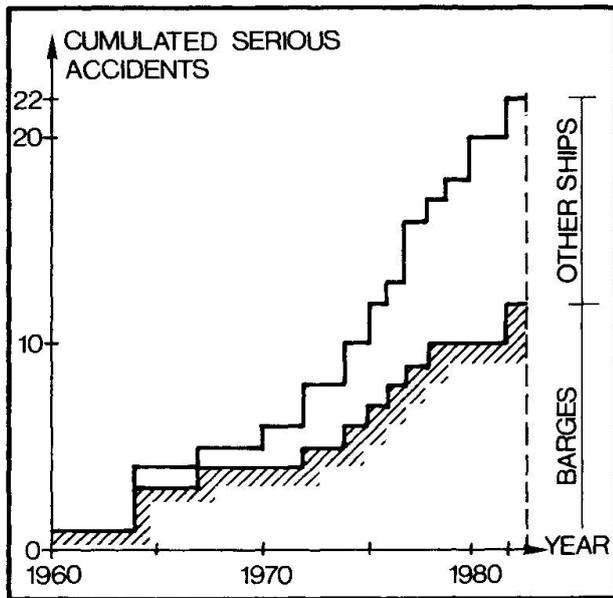
Fig. 1 shows the cumulated number of serious ship collisions since 1960. It can be seen, that the annual rate of such collisions has increased from 0.5 to 1.5 during the last two decades. It can also be seen from this figure, that collisions involving barges constitute about 55% of all the cases. This corresponds well with the above mentioned distribution of the accidents on rivers and channels, as one group, compared to the group of all the other navigable waters.

Fig. 1 Serious ship collisions with bridges 1960-1982.

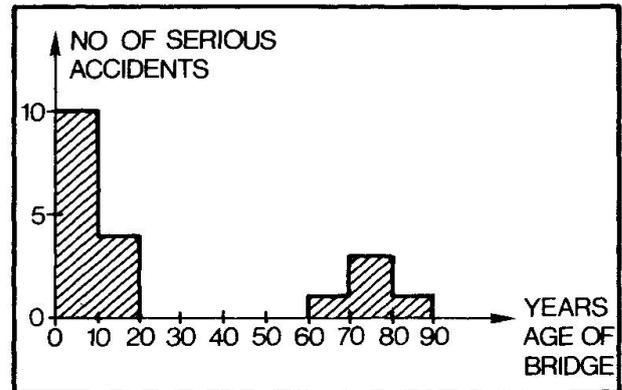
Fig. 2 No of serious accidents in relation to age of bridge.

In most of the cases it has been possible to establish how old the bridges are/were. Fig. 2 shows the number of serious accidents set in relation to the age of the bridge at the time of the accident. It is interesting to note, that most of the bridges were seriously hit while they were quite young - under 10 years of age, that no bridge between 20 and 60 years of age was hit, and that some very old bridges - between 60 and 90 years - were also hit. This pattern is known from many other areas, and is probably quite natural.
