Accidents Involving Bridges

Aksel G. FRANDSEN
 Consulting Engineer
 Cowiconsult
 Copenhagen, Denmark

The paper gives a summarized systematic account of 22 serious accidents, from the period 1960-1982, in which ships have interrupted bridge connections. The available data are far from complete. This fact, together with the small number of cases and the varying conditions, makes it impossible to draw general conclusions from the material. How the material can be utilized, and how the data sources should be improved is discussed in the paper.

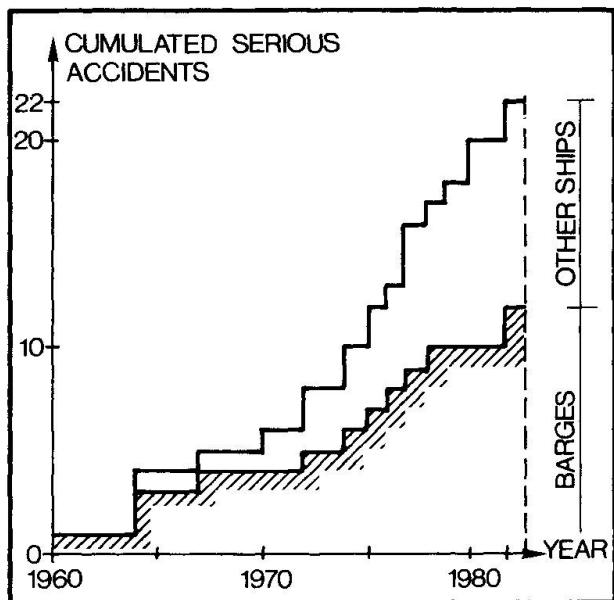
Fig. 1 Serious ship collisions with bridges 1960-1982.

Fig. 1 shows the cumulated number of serious ship collisions since 1960. It can be seen, that the annual rate of such collisions has increased from 0.5 to 1.5 during the last two decades. It can also be seen from this figure, that collisions involving barges constitute about 55% of all the cases. This corresponds well with the above mentioned distribution of the accidents on rivers and channels, as one group, compared to the group of all the other navigable waters.

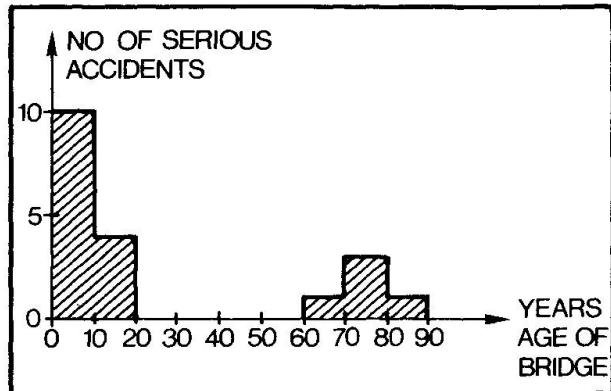
Fig. 2 No of serious accidents in relation to age of bridge.

In most of the cases it has been possible to establish how old the bridges are/were. Fig. 2 shows the number of serious accidents set in relation to the age of the bridge at the time of the accident. It is interesting to note, that most of the bridges were seriously hit while they were quite young - under 10 years of age, that no bridge between 20 and 60 years of age was hit, and that some very old bridges - between 60 and 90 years - were also hit. This pattern is known from many other areas, and is probably quite natural.
