Artikel: Case stories of dolphin accidents and remedies
Autor: Naoi, Yoshiaki / Ishikawa, Toshiyuki
DOI: <https://doi.org/10.5169/seals-32401>

Case Stories of Dolphin Accidents and Remedies

The report outlines recent ship collision accidents with dolphins in Iwakuni, Japan and their remedies.

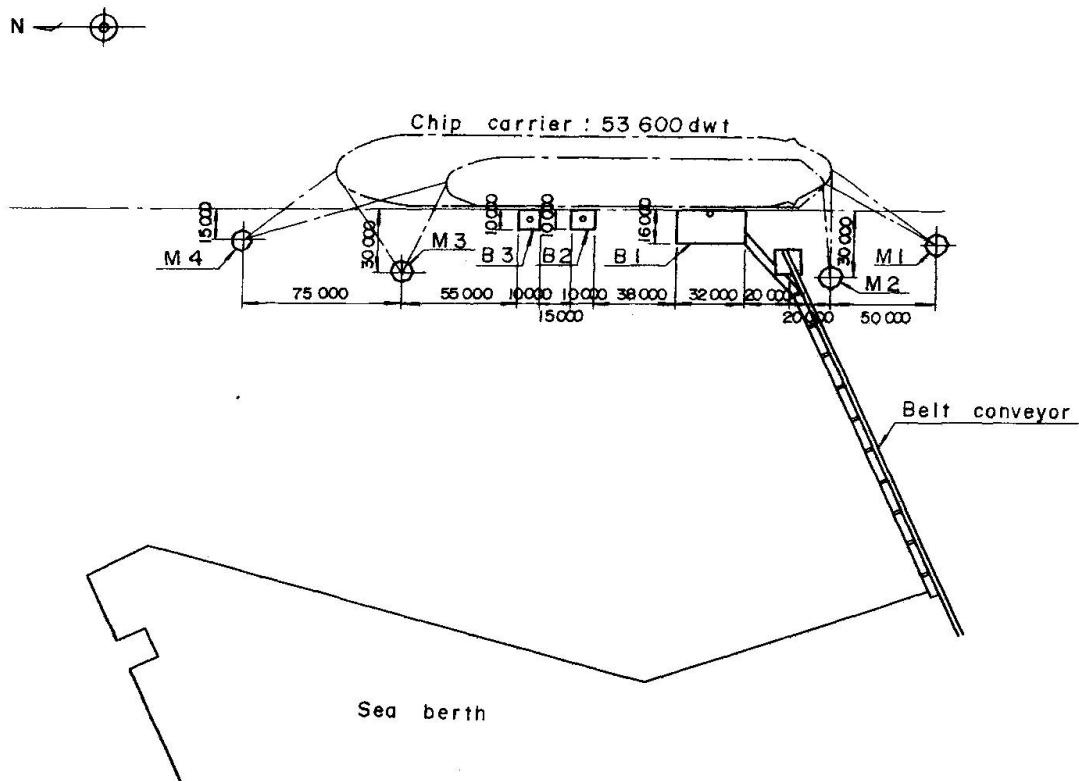
Fig.1 Outline Plan of the Berth

The harbour structure of concern here has a landing berth for wooden chips for paper-making and the berth was designed for foreign chip carriers with 53,600 dwt. As shown in Fig.1 the berth consists of 1 main-breasting dolphin, and 2 sub-breasting ones, and 4 mooring ones.

The north sub-breasting dolphin (B-3 in Fig.1) was damaged in the first collision in 1978, and the south mooring dolphin (M-1 in Fig.1) was again damaged in 1979.

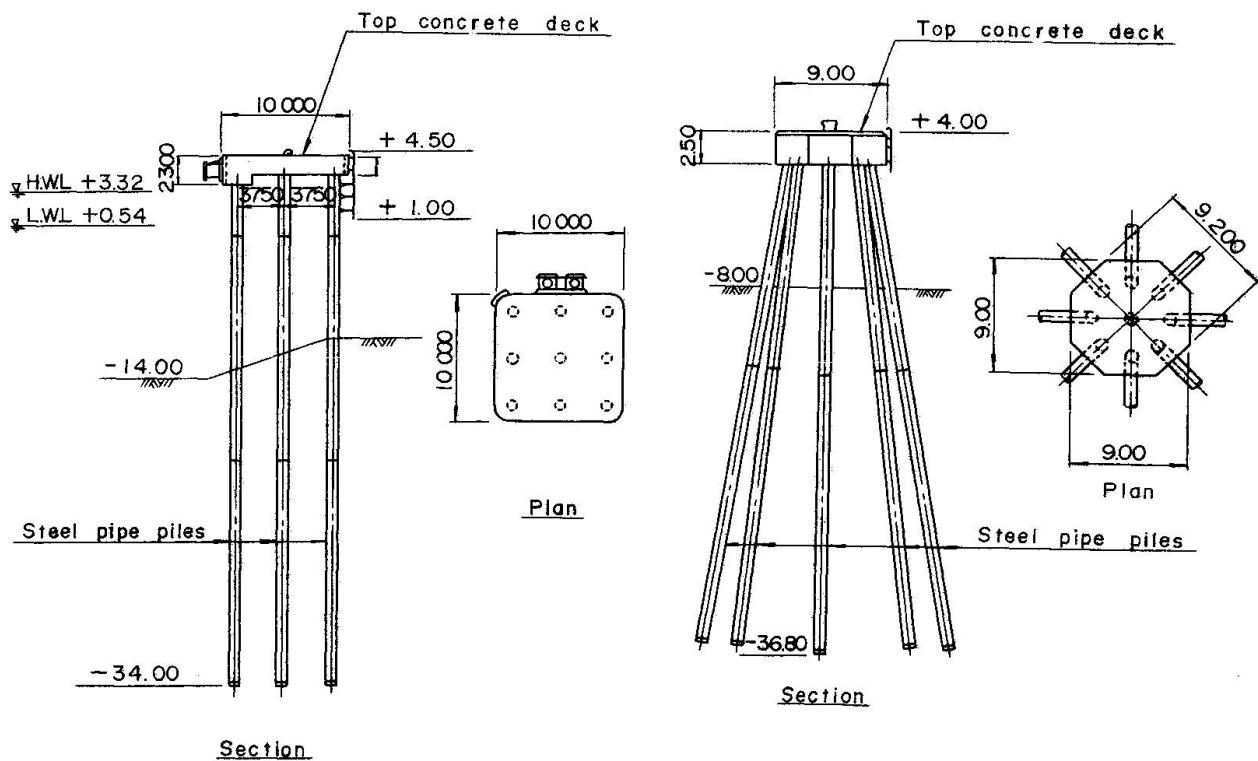
Fig.2 Structure of Dolphin B-3

As shown in Fig.2 the Dolphin B-3 consists of 9 steel pipe piles (914.4 mm in diameter, 16.0 mm in thickness, and 41.5 m in length) and the top concrete deck. The structure has the flexibility to absorb the kinetic energy of ship berthing for an approaching velocity of 15 cm/sec. That is, the resisting capacity against impact is maintained by the mutual effect between the rigidity of the steel pipe piles and the viscoelasticity of the foundation strata.

In the structure of the Dolphin M-1, 9 steel pipe piles (609.6 mm in diameter, 12.7 mm in thickness, and 40.5 m in length) composed of 8 radial battered piles and 1 vertical pile are rigidly connected with the top concrete deck. This mooring dolphin has a rigid structure in contrast with the breasting dolphin, that is, the static load worked through mooring ropes is borne by the structure so that a ship can keep a certain distance with the berth.

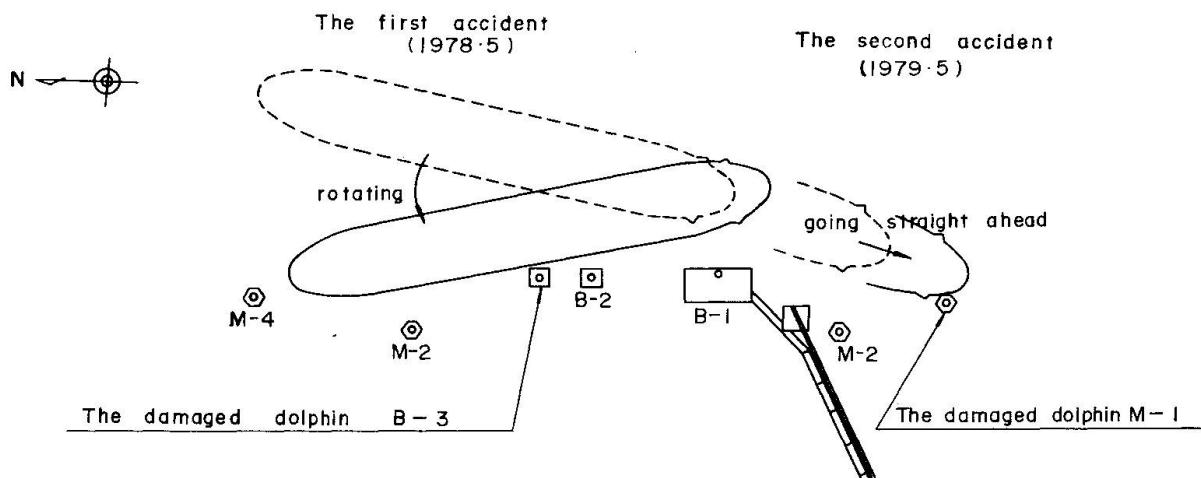
Fig.4 Geometry of the Collisions

The circumstances of the first collision accident in 1978 is described as follows: (See Fig.4)

While the vessel was approaching on her starboard side to the sea berth, the ship swung her stern towards the right side in order to maintain the correct direction for her berthing. After that, the side of the vessel collided with the fender on the corner of the north sub-breasting dolphin B-3.

The fender itself had no function to absorb the impact energy of ships, therefore, the inertia force of the moving ship was directly loaded on the dolphin structure, and the foundation piles were deformed.

As in the first accident the same cargo vessel, in 1979, lost proper speed while she was approaching the berth from the north, then collided with the south mooring dolphin M-1.

Both collisions were caused by the mistakes of the operators. But, as described in the beginning of the article, Japanese coastal/offshore structures are located in very confused sea areas and it is one of the reasons of the frequent occurrence of ship collision casualties.

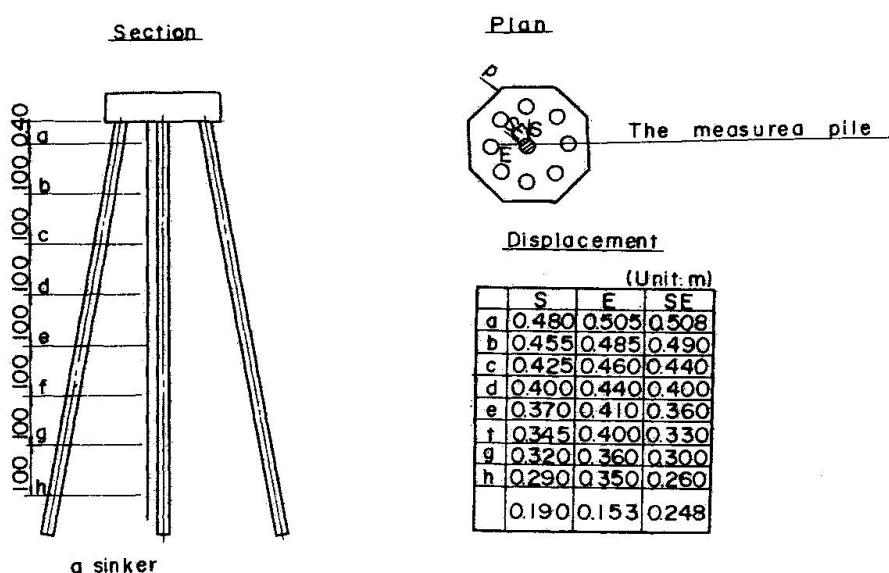
Fig.6 Deformation of Dolphin M-1

An opening made by the collision was found at the junction of the top concrete deck with the steel pipe piles. This opening was 20 cm at its maximum in a direction of north-west. At the same time a wedge from the shearing force (1.6 m in width, 0.2 m in height, and 0.4 m in depth) appeared in the concrete deck.

Upon measuring the deformation of the central vertical pile in three directions, the maximum displacement of 25 cm was observed in the direction of south-east. (See Fig.6)

Shells of barnacles and sea mussels had been torn off around the tidal zone at the top of the piles, and it indicated the hysteresis of deformation.
