Zeitschrift: IABSE reports = Rapports AIPC = IVBH Berichte

Artikel: Case stories of dolphin accidents and remedies

Case Stories of Dolphin Accidents and Remedies

We have investigated ten cases of marine accidents, in which oil tankers and cargo vessels collided with dolphins. In the following pages two collisions which occured at Iwakuni, Yamaguchi Prefecture, Japan in 1978 and 1979 are investigated.

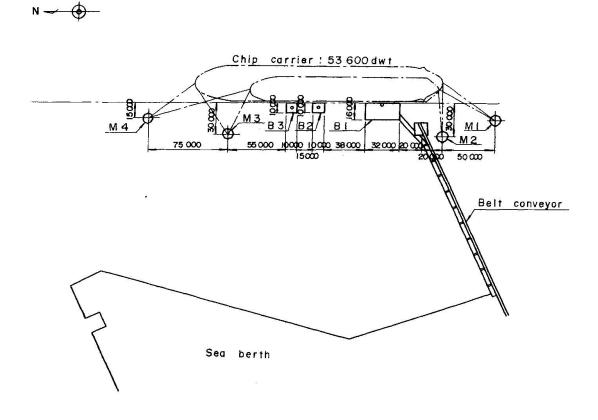
Fig.1 Outline Plan of the Berth

The harbour structure of concern here has a landing berth for wooden chips for paper-making and the berth was designed for foreign chip carriers with 53,600 dwt. As shown in Fig.1 the berth consists of 1 main-breasting dolphin, and 2 sub-breasting ones, and 4 mooring ones.

The north sub-breasting dolphin (B-3 in Fig.1) was damaged in the first collision in 1978, and the south mooring dolphin (M-1 in Fig.1) was again damaged in 1979.

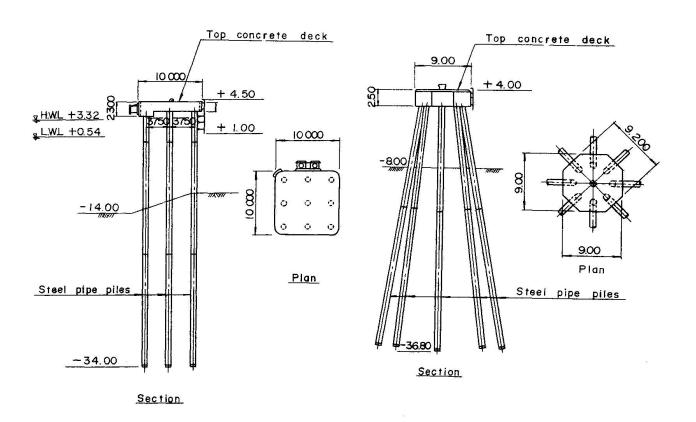
Fig. 2 Structure of Dolphin B-3

As shown in Fig.2 the Dolphin B-3 consists of 9 steel pipe piles (914.4 mm in diameter, 16.0 mm in thickness, and 41.5 m in length) and the top concrete deck. The structure has the flexibility to absorb the kinetic energy of ship berthing for an approaching velocity of 15 cm/sec. That is, the resisting capacity against impact is maintained by the mutual effect between the rigidity of the steel pipe piles and the viscoelasticity of the foundation strata.

In the structure of the Dolphin M-1, 9 steel pipe piles (609.6 mm in diameter, 12.7 mm in thickness, and 40.5 m in length) composed of 8 radial battered piles and 1 vertical pile are rigidly connected with the top concrete deck. This mooring dolphin has a rigid structure in contrast with the breasting dolphin, that is, the static load worked through mooring ropes is borne by the structure so that a ship can keep a certain distance with the berth.

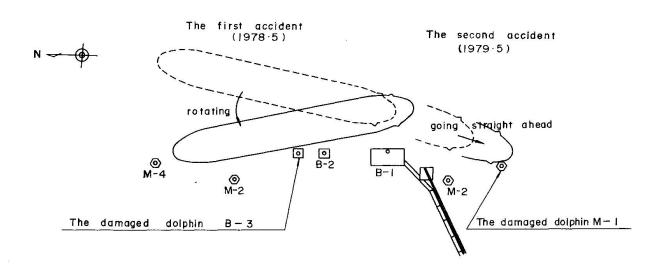
Fig. 4 Geometry of the Collisions

The circumstances of the first collision accident in 1978 is described as follows: (See Fig.4)

While the vessel was approaching on her starboard side to the sea berth, the ship swung her stern towards the right side in order to maintain the correct direction for her berthing. After that, the side of the vessel collided with the fender on the corner of the north sub-breasting dolphin B-3.

The fender itself had no function to absorbe the impact energy of ships, therefore, the inertia force of the moving ship was directly loaded on the dolphin structure, and the foundation piles were deformed.

As in the first accident the same cargo vessel, in 1979, lost proper speed while she was approaching the berth from the north, then collided with the south mooring dolphin M-1.

Both collisions were caused by the mistakes of the operators. But, as described in the beginning of the article, Japanese coastal/offshore structures are located in very confused sea areas and it is one of the reasons of the frequent occurence of ship collision casualties.

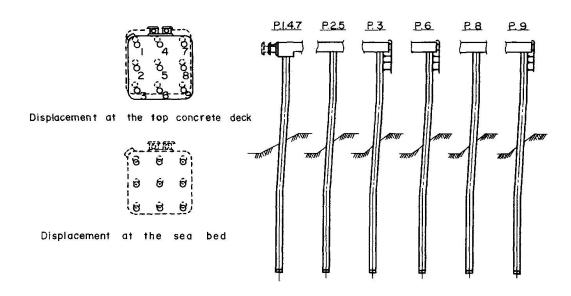
Fig. 5 Deformation of Dolphin B-3

The results of our inspection carried out immediately after the accidents are briefly as follows: (See Fig.5)

Upon measuring the damaged dolphin, the deformation was found to be the residual displacement of the top concrete deck:

Horizontal displacement:

In the direction of the berthing line ---- 25.2 cm In the direction of right angle to the berthing line ---- 97.2 cm

Vertical displacement:

Inclination towards the shore on the diagonal line
---- 0° 20'

Upon inspecting the piles in the water, the buckling on the piles were found near the welded joints of No.3,6,8 & 9 piles 2 m deep in the water and the shells thereon had been torn off.

The deformation by the collision was more severe on the opposite piles of the collision side. From that fact it was presumed that the dolphin was rotated by the collision impact (the horizontal force) so that those opposite piles were loaded by both the force at a right angle to the axes and the axial force (the compressive forces).

Further, the maximum deformation was found on the middle piles (12.7 mm in thickness) while the upper piles above D.L. -0.50 m were still vertical with little deformation. The reason for this is that the materials of the upper piles were thicker (16.0 mm in thickness) and they were stuffed with filling concrete.

After the diving inspection, voids of 40 cm in width and 100 cm in depth were observed in the sea bed on the offshore side of the piles. It indicated that plastic deformation in the ground occurred by the energy exerted by the collision.

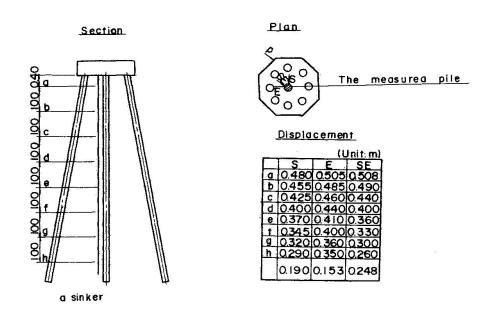
Fig.6 Deformation of Dolphin M-1

An opening made by the collision was found at the junction of the top concrete deck with the steel pipe piles. This opening was 20 cm at its maximum in a direction of north-west. At the same time a wedge from the shearing force (1.6 m in width, 0.2 m in height, and 0.4 m in depth) appeared in the concrete deck.

Upon measuring the deformation of the central vertical pile in three directions, the maximum displacement of 25 cm was observed in the direction of south-east. (See Fig.6)

Shells of barnacles and sea mussels had been torn off around the tidal zone at the top of the piles, and it indicated the hysteresis of deformation.
