Artikel: Case stories of dolphin accidents and remedies
Autor: Naoi, Yoshiaki / Ishikawa, Toshiyuki
DOI: <https://doi.org/10.5169/seals-32401>

Case Stories of Dolphin Accidents and Remedies

Yoshiaki NAOI

The report outlines recent ship collision accidents with dolphins in Iwakuni, Japan and their remedies.

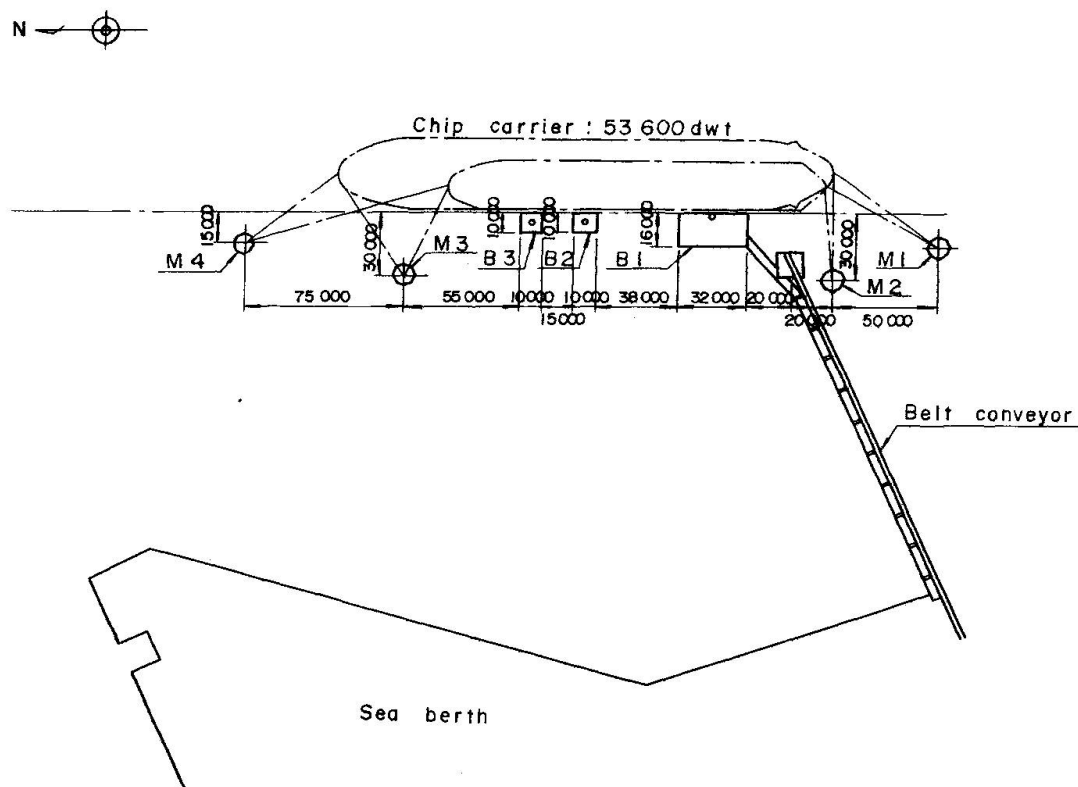
Fig.1 Outline Plan of the Berth

The north sub-breasting dolphin (B-3 in Fig.1) was damaged in the first collision in 1978, and the south mooring dolphin (M-1 in Fig.1) was again damaged in 1979.

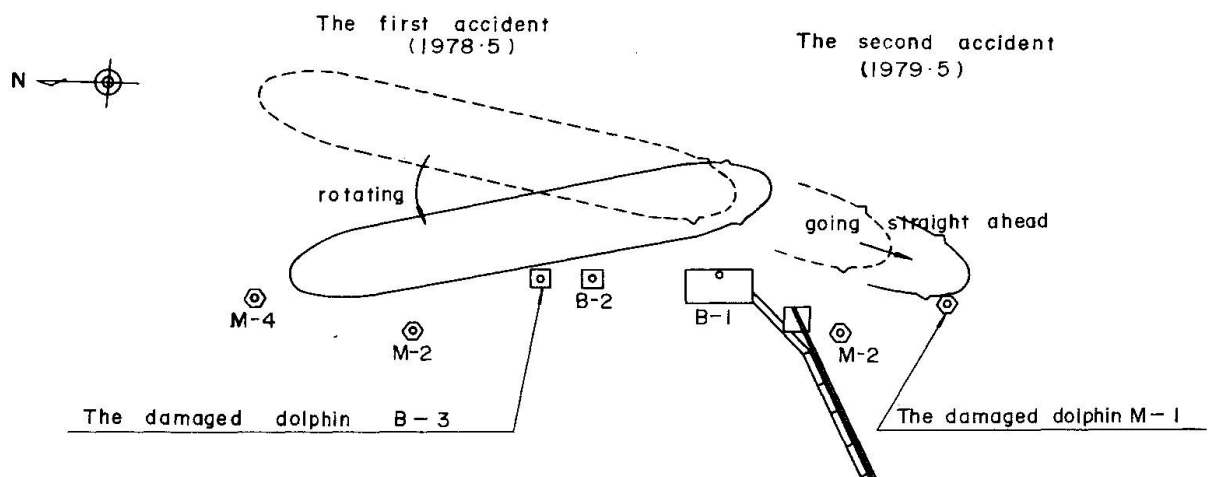
Fig.4 Geometry of the Collisions

While the vessel was approaching on her starboard side to the sea berth, the ship swung her stern towards the right side in order to maintain the correct direction for her berthing. After that, the side of the vessel collided with the fender on the corner of the north sub-breasting dolphin B-3.

The fender itself had no function to absorb the impact energy of ships, therefore, the inertia force of the moving ship was directly loaded on the dolphin structure, and the foundation piles were deformed.

As in the first accident the same cargo vessel, in 1979, lost proper speed while she was approaching the berth from the north, then collided with the south mooring dolphin M-1.

Both collisions were caused by the mistakes of the operators. But, as described in the beginning of the article, Japanese coastal/offshore structures are located in very confused sea areas and it is one of the reasons of the frequent occurrence of ship collision casualties.

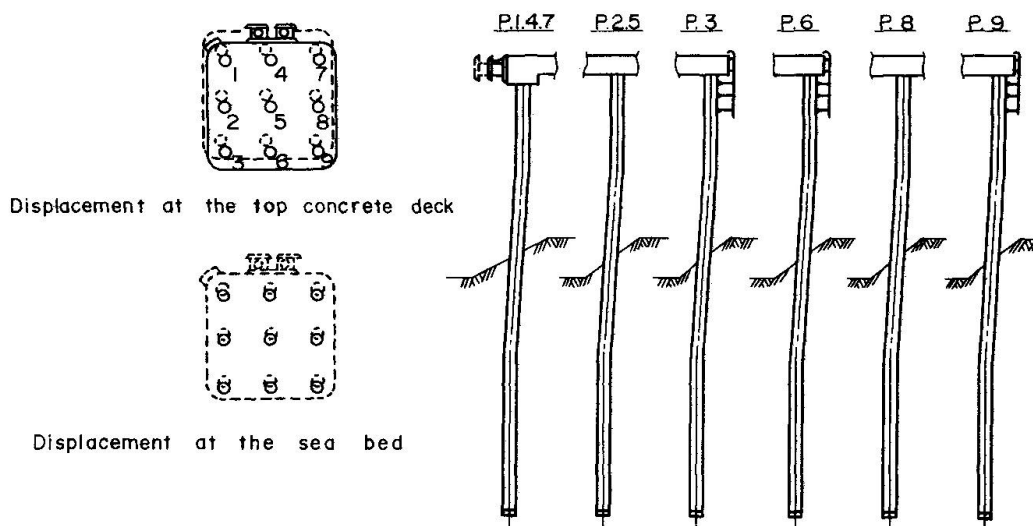
Fig.5 Deformation of Dolphin B-3

The results of our inspection carried out immediately after the accidents are briefly as follows: (See Fig.5)

Upon measuring the damaged dolphin, the deformation was found to be the residual displacement of the top concrete deck:

In the direction of the berthing line ----- 25.2 cm
In the direction of right angle to the berthing line ----- 97.2 cm

Inclination towards the shore on the diagonal line ----- 0° 20'

Upon inspecting the piles in the water, the buckling on the piles were found near the welded joints of No.3,6,8 & 9 piles 2 m deep in the water and the shells thereon had been torn off.

The deformation by the collision was more severe on the opposite piles of the collision side. From that fact it was presumed that the dolphin was rotated by the collision impact (the horizontal force) so that those opposite piles were loaded by both the force at a right angle to the axes and the axial force (the compressive forces).

Further, the maximum deformation was found on the middle piles (12.7 mm in thickness) while the upper piles above D.L. -0.50 m were still vertical with little deformation. The reason for this is that the materials of the upper piles were thicker (16.0 mm in thickness) and they were stuffed with filling concrete.

After the diving inspection, voids of 40 cm in width and 100 cm in depth were observed in the sea bed on the offshore side of the piles. It indicated that plastic deformation in the ground occurred by the energy exerted by the collision.

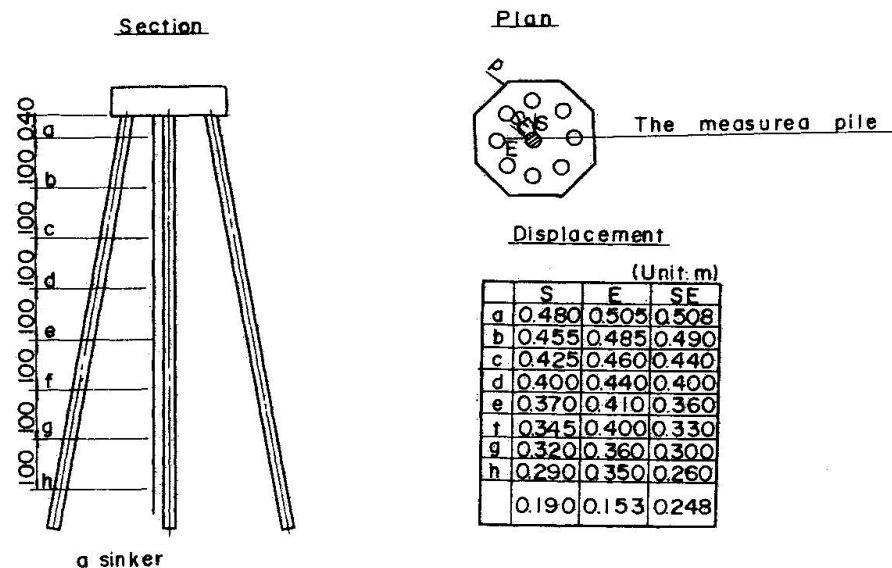
Fig.6 Deformation of Dolphin M-1

An opening made by the collision was found at the junction of the top concrete deck with the steel pipe piles. This opening was 20 cm at its maximum in a direction of north-west. At the same time a wedge from the shearing force (1.6 m in width, 0.2 m in height, and 0.4 m in depth) appeared in the concrete deck.

Upon measuring the deformation of the central vertical pile in three directions, the maximum displacement of 25 cm was observed in the direction of south-east. (See Fig.6)

Shells of barnacles and sea mussels had been torn off around the tidal zone at the top of the piles, and it indicated the hysteresis of deformation.
