Artikel: Case stories of dolphin accidents and remedies
Autor: Naoi, Yoshiaki / Ishikawa, Toshiyuki
DOI: <https://doi.org/10.5169/seals-32401>

Case Stories of Dolphin Accidents and Remedies

The report outlines recent ship collision accidents with dolphins in Iwakuni, Japan and their remedies.

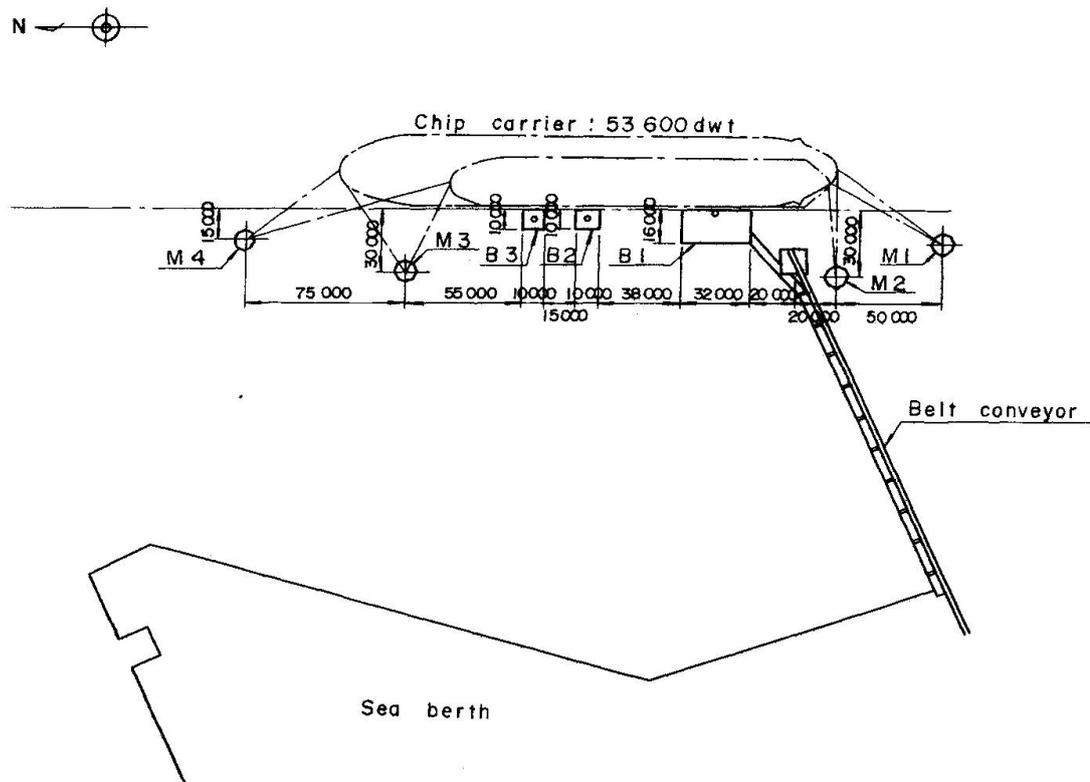
Fig.1 Outline Plan of the Berth

The harbour structure of concern here has a landing berth for wooden chips for paper-making and the berth was designed for foreign chip carriers with 53,600 dwt. As shown in Fig.1 the berth consists of 1 main-breasting dolphin, and 2 sub-breasting ones, and 4 mooring ones.

The north sub-breasting dolphin (B-3 in Fig.1) was damaged in the first collision in 1978, and the south mooring dolphin (M-1 in Fig.1) was again damaged in 1979.

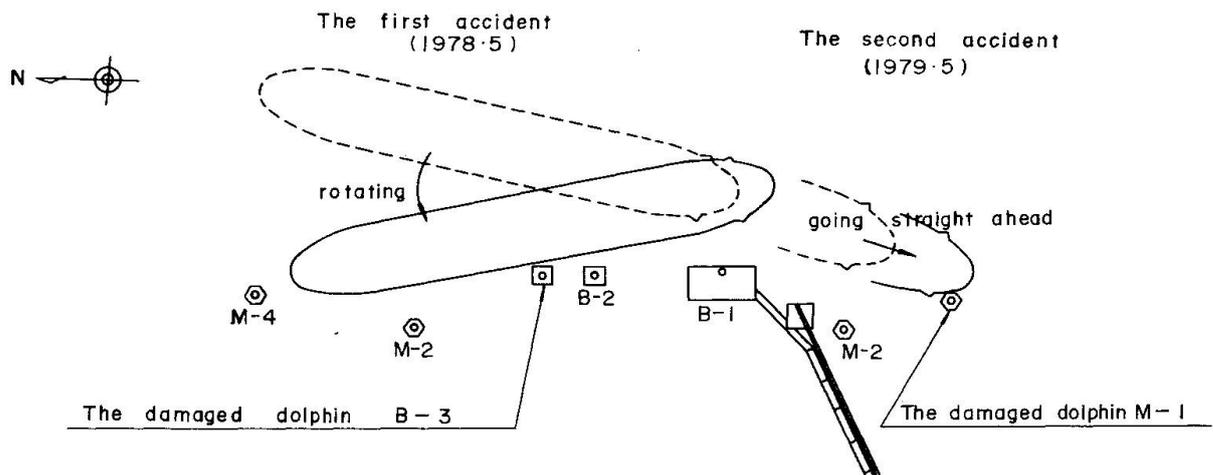
Fig.4 Geometry of the Collisions

The circumstances of the first collision accident in 1978 is described as follows: (See Fig.4)

While the vessel was approaching on her starboard side to the sea berth, the ship swung her stern towards the right side in order to maintain the correct direction for her berthing. After that, the side of the vessel collided with the fender on the corner of the north sub-breasting dolphin B-3.

The fender itself had no function to absorb the impact energy of ships, therefore, the inertia force of the moving ship was directly loaded on the dolphin structure, and the foundation piles were deformed.

As in the first accident the same cargo vessel, in 1979, lost proper speed while she was approaching the berth from the north, then collided with the south mooring dolphin M-1.

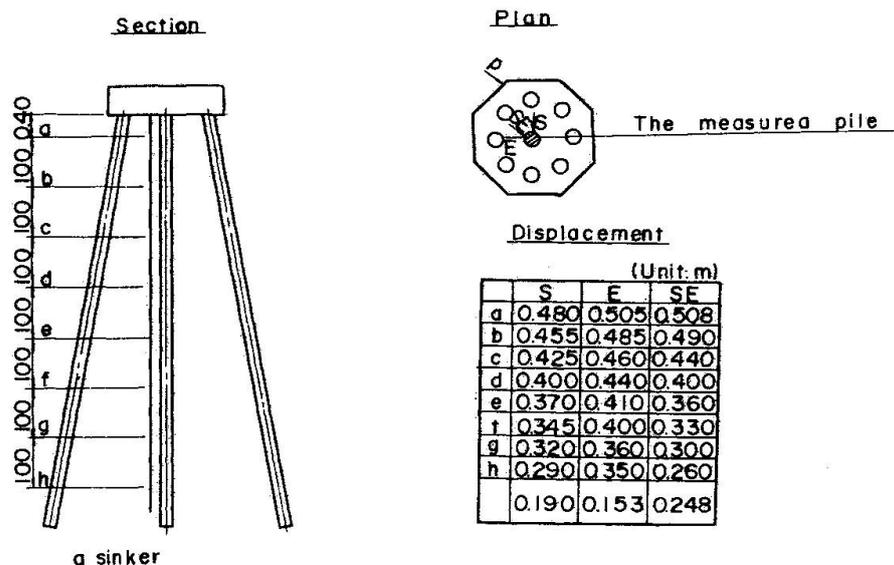
Fig.6 Deformation of Dolphin M-1

An opening made by the collision was found at the junction of the top concrete deck with the steel pipe piles. This opening was 20 cm at its maximum in a direction of north-west. At the same time a wedge from the shearing force (1.6 m in width, 0.2 m in height, and 0.4 m in depth) appeared in the concrete deck.

Upon measuring the deformation of the central vertical pile in three directions, the maximum displacement of 25 cm was observed in the direction of south-east. (See Fig.6)

Shells of barnacles and sea mussels had been torn off around the tidal zone at the top of the piles, and it indicated the hysteresis of deformation.
