## Vulnerability of Norwegian Bridges across Channels

**Per TAMBS-LYCHE**  
Director Bridge Division  
Public Roads Administration  
Oslo, Norway

The paper describes the procedures for protective actions taken for securing bridge foundations against ship collisions. Relevant loads used in the design are given. No major catastrophe has occurred. Some minor collisions causing relatively serious damage are described. A survey undertaken in 1982 to spot and evaluate the bridges that could be in danger of ship collision are presented.

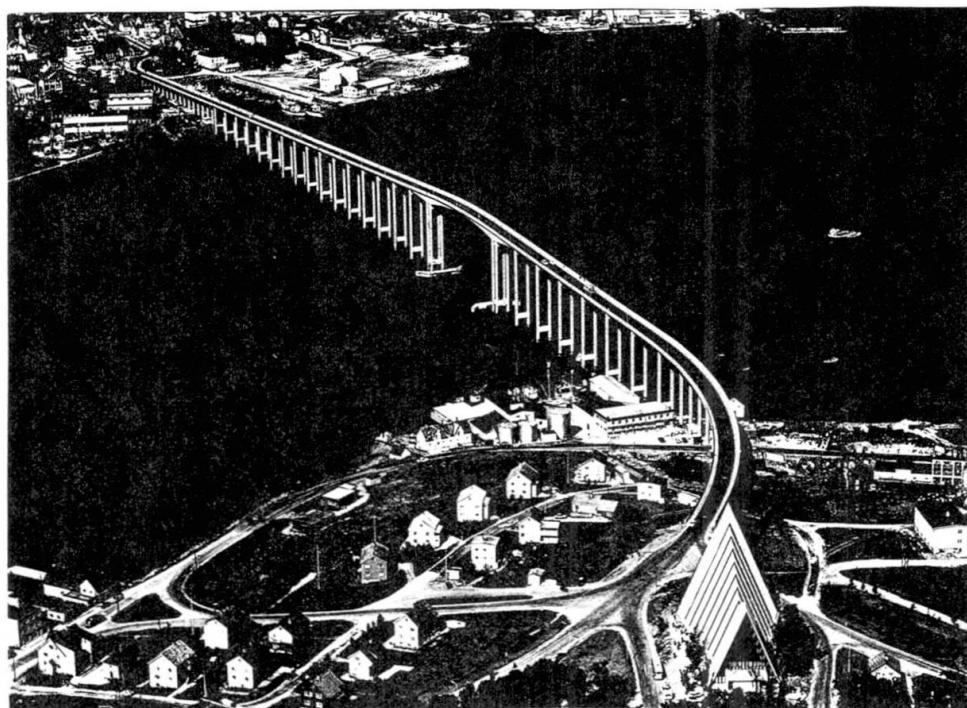
Fig. 2 Tromsø Bridge

To day, having learned by experience from several serious accidents around the world, and also a great number of smaller accidents in Tromsø Sound, we must state that the risk of collision between passing ships and the columns of Tromsø Bridge, was not satisfactorily judged when the bridge was planned.

The center to center distance between the two pairs of columns on each side of the main span is only 80 metres, and between fenders protecting these columns, the channel is only 60 metres wide. Between the main span and the abutments on the Tromsø side and the Tromsdal side respectively, the distance between the pairs of columns varies from 24 to 10 metres.

- I Installation of radar echo equipment along the main channel (on buoys of skerries).
- II Installation of navigation lamps and/or improving existing lighting systems on the bridge.
- III Installation of special warning devices to stop all the traffic across the bridge in case of serious damage to the structure.

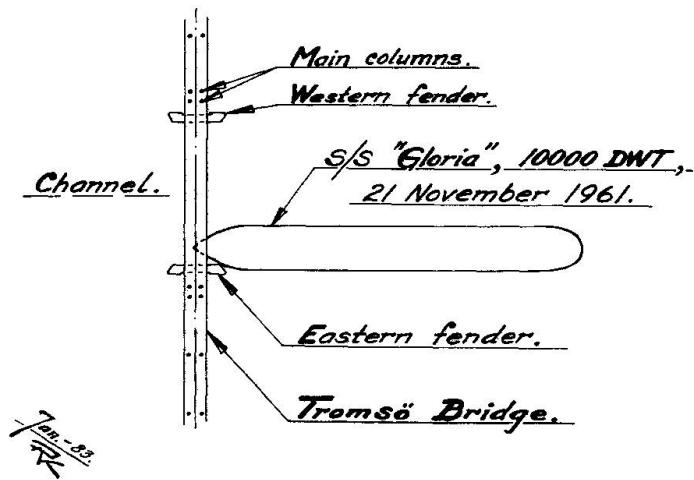
Danger of cracks in these stiff piles would occur if, during a collision, the fender slab was given a horizontal deformation of 30 centimetres only.

On the 21 November 1961, the 10 000 dwt. S/S "Gloria" ran into the eastern fender. The fender slab above the water as well as most of the concrete piles carrying the slab were completely destroyed and ended on the bottom of the sea. Fig. 3 shows the dimensions of the ship, the channel and the fenders.

Fig. 3 Tromsø Bridge:  
Collision, November 1961.  
Dimensions of ship,  
channel and fenders.

When the two fenders were rebuilt in 1962-63, hollow steel piles KP 35, filled with concrete, were used. The clearance between the fender slab and the nearest columns was 5 metres. Fracture of the piles were expected at a horizontal deformation of the fender of 4.3 metres. This would, approximately, be sufficient to stop a 10 000 dwt ship drifting into the fender at a speed of 0.5 m/sec.

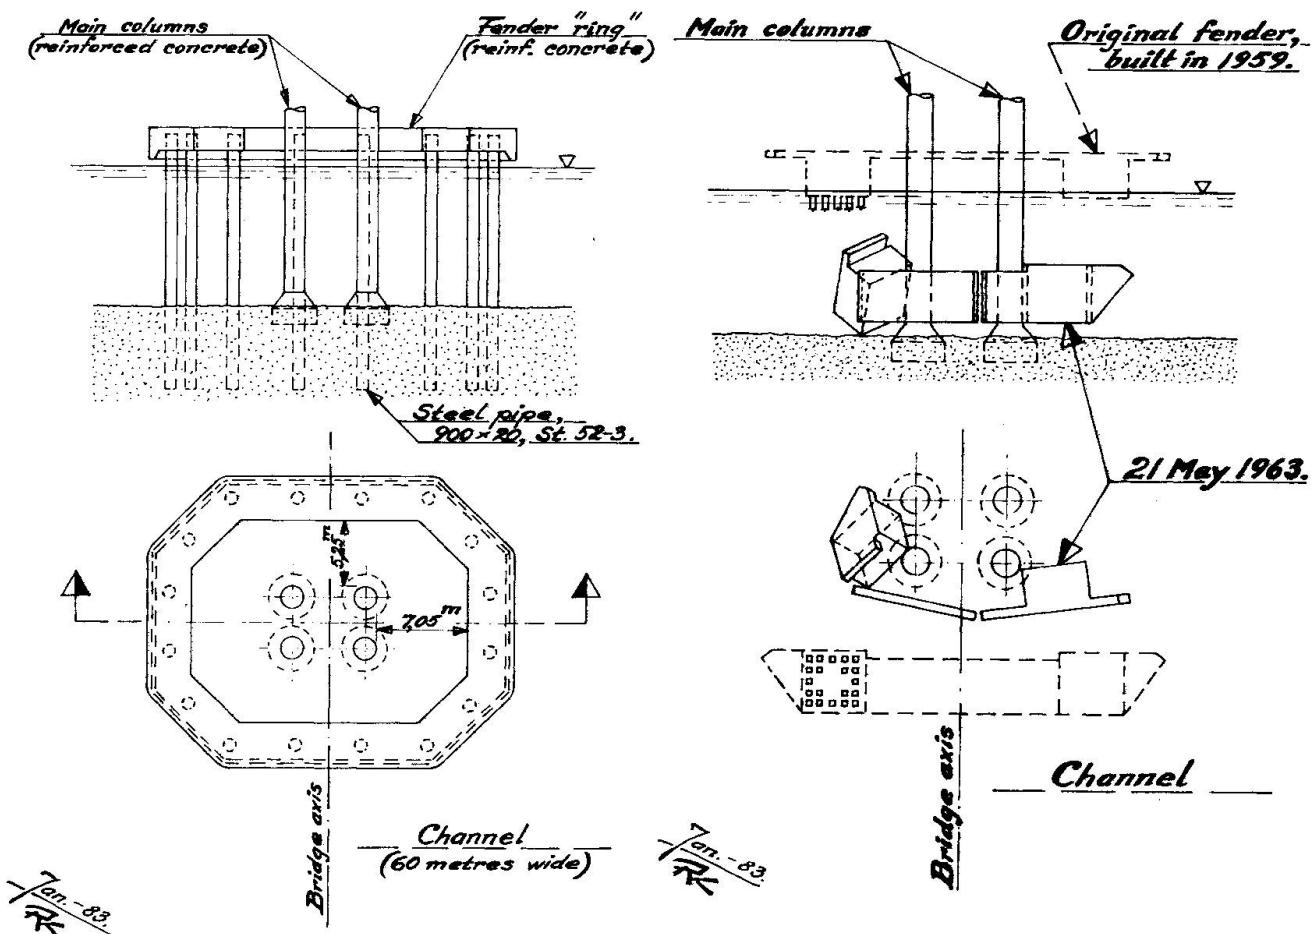
On the 21 May 1963 the western fender suffered the same fate as its easterly twin. M/S "Rotesand", a 1560 dwt ore-ship, then ran foul of the fender which collapsed and had to be removed. Fig. 4 shows the fender structure after the breakdown.

Fig. 4 Tromsø Bridge:  
Western fender before and  
after having been destroyed.  
(The destroyed fender was  
partly resting on heaps of  
broken piles, which are not  
shown on the figure).

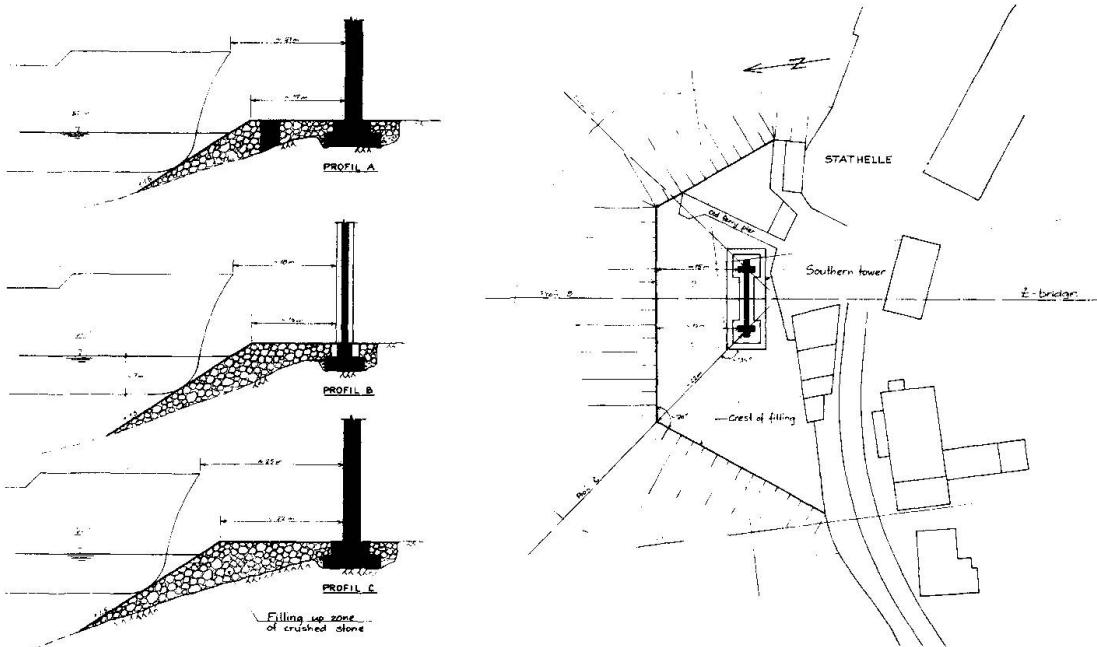
The southern tower of the main span has been regarded as vulnerable to the ship-traffic taking place through the channel. The navigational conditions are not the best ones through the shallow, narrow and tidal waters of the inlet, though certain equipment with regard to surveillance of the ships concerned has been in operation for some time.

Even though, incidents are now and then taking place in the channel including two cases of running aground close by the tower. One of the towerpiers was left with spalled concrete after one of these episodes. In addition three other close by incidents (agrounds within 20m from the tower) have been registered. All the run-agrounds in the bridge area have taken place while ships were leaving the harbour. According to attached figure 7 the tower is obviously most exposed to collision from ships moving in that direction. It should be emphasized that part of the tonnage passing the sound carries dangerous cargo, e.g. gastankers.

Fig. 7 Brevik Bridge; Filling up zone, southern tower

- I A proposed filling up zone as indicated in figure 7, will reduce sailing depths at the southern tower and will also provide an energy absorbing cushion for ships running aground.
- II Installation of warning devices to stop road traffic in case of serious damage to the structure.
